**DEPARTMENT OF ENVIRONMENTAL QUALITY  
AIR QUALITY DIVISION  
ACTIVITY REPORT: Self Initiated Inspection**

<b>FACILITY:</b> Wolverine Trailers, Inc		<b>SRN / ID:</b> P0927
<b>LOCATION:</b> 1500 Chanter Road, JACKSON		<b>DISTRICT:</b> Jackson
<b>CITY:</b> JACKSON		<b>COUNTY:</b> JACKSON
<b>CONTACT:</b> Kyle Johnson , Owner		<b>ACTIVITY DATE:</b> 06/07/2018
<b>STAFF:</b> Mike Kovalchick	<b>COMPLIANCE STATUS:</b> Non Compliance	<b>SOURCE CLASS:</b>
<b>SUBJECT:</b> Small coating operation.		
<b>RESOLVED COMPLAINTS:</b>

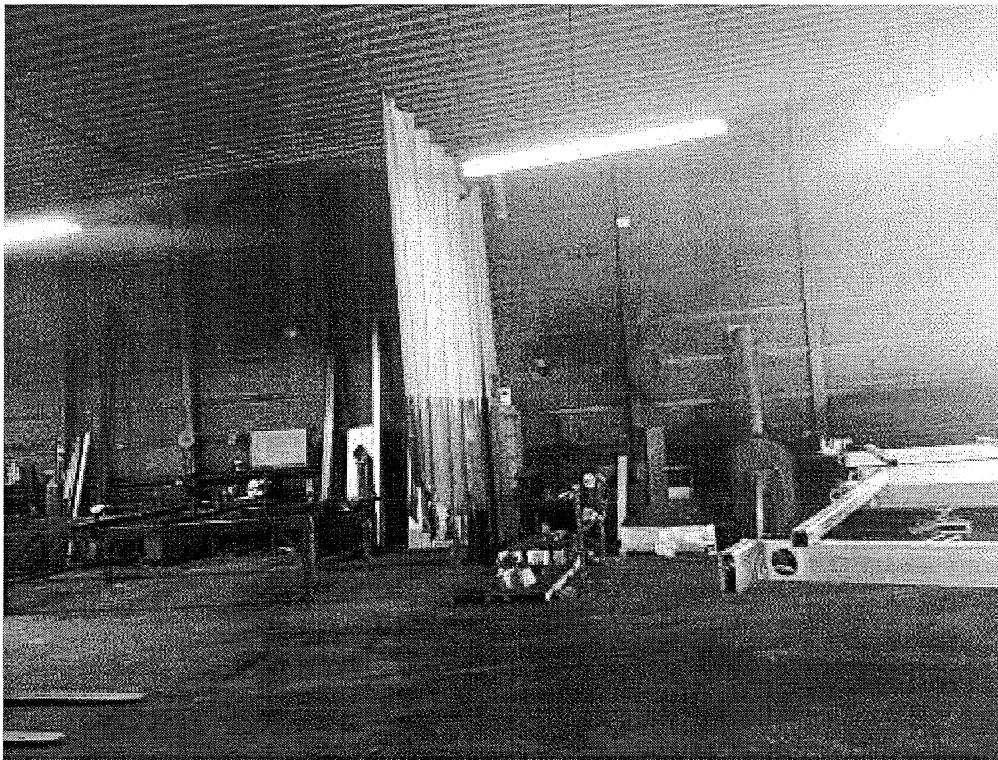
**Image 3(Movable curtain)** : Movable curtain in coating area

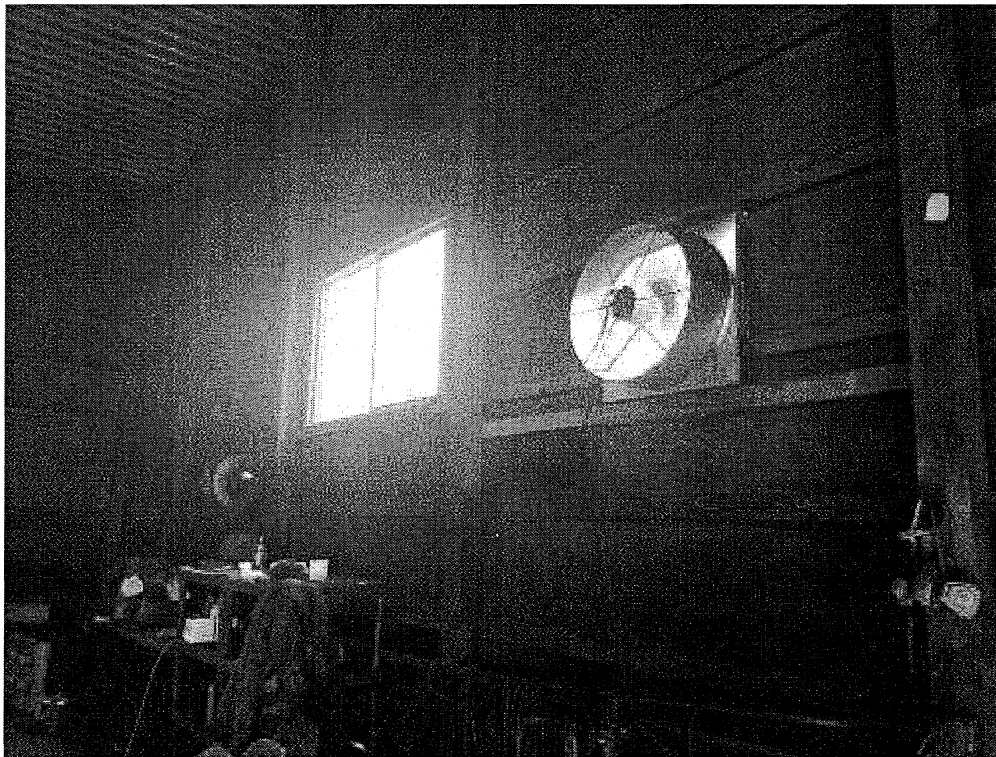
**Image 4(Side wall exhaust)** : Side wall exhaust fan-interior view

I held a brief post-inspection meeting with Lyle. I explained to him that the coating operation would be considered exempt from PTI requirements if they install some type of fabric filter system for the side wall exhaust fan and keep the bay doors closed when painting. I also noted open burning was prohibited. I thanked Lyle for his time and cooperation, and I departed the facility at approximately 9:30 am.

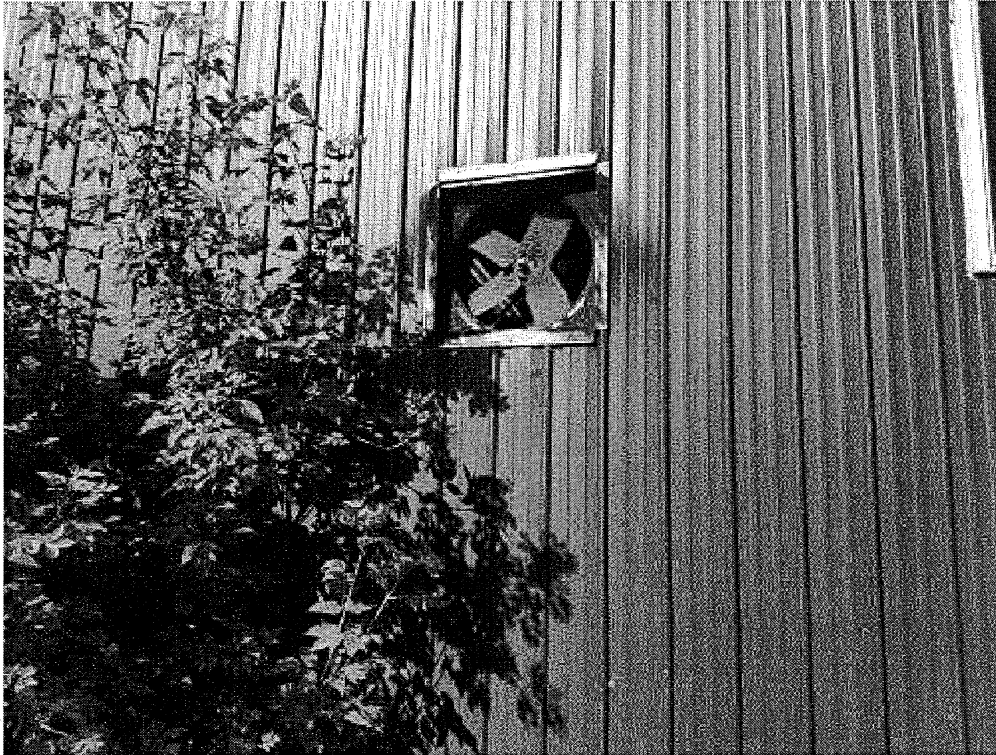
Next, Gary showed me the outside of the building, so I could see the side wall exhaust fan and bay doors. Both areas had evidence of paint overspray exiting the building.

**Image 5(Exhaust fan)** : Side wall exhaust fan exterior view

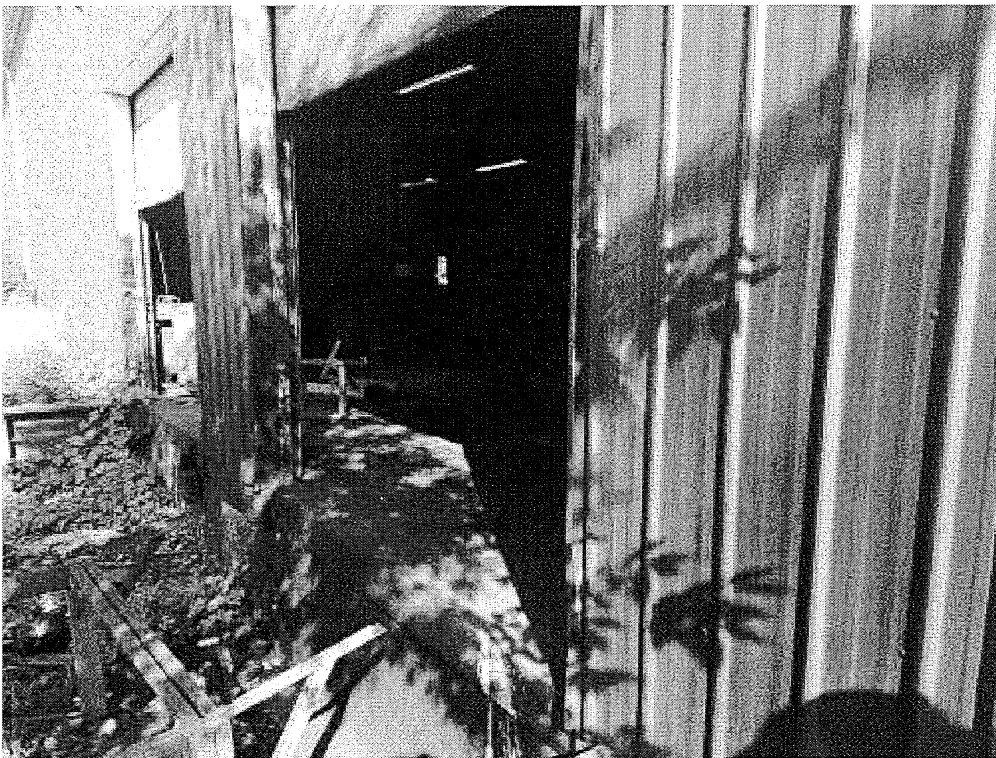
**Image 6(Bay doors)** : Bay doors to coating area with overspray on walls.

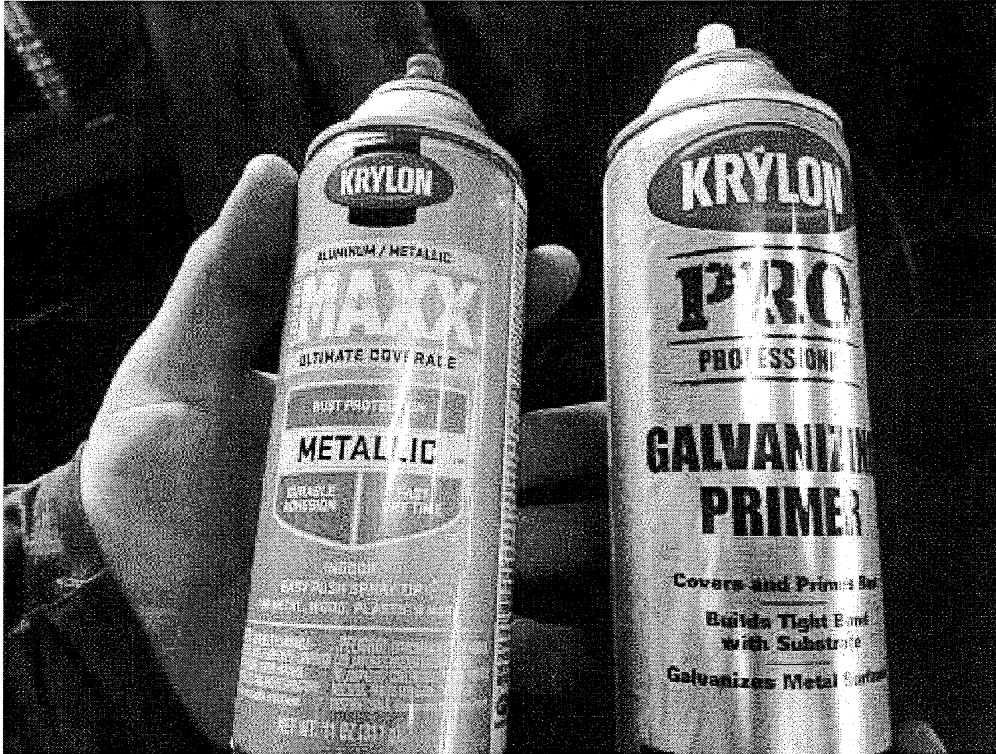
Gary explained that they use aerosol paint & primer cans to spray galvanized metal trailers. He estimated that they go through a pack of 24 cans once or twice a week. See attached photo of cans. In addition to the aerosol cans, they also apply paint using a paint gun. They first wipe the metal using xylene then spray it with paint. Xylene usage was estimated to be one 55-gallon drum every 3 months or so. See attached photo of xylene barrel. Paint usage was estimated to be one 55-gallon drum every 2 months. See attached photo of paint drum with paint content information. See Attachment (1) for MSDS of the paint. It is about 50% VOC's.

**Image 7(Paint cans)** : Paint can used to coat galvanized metal trailer beds

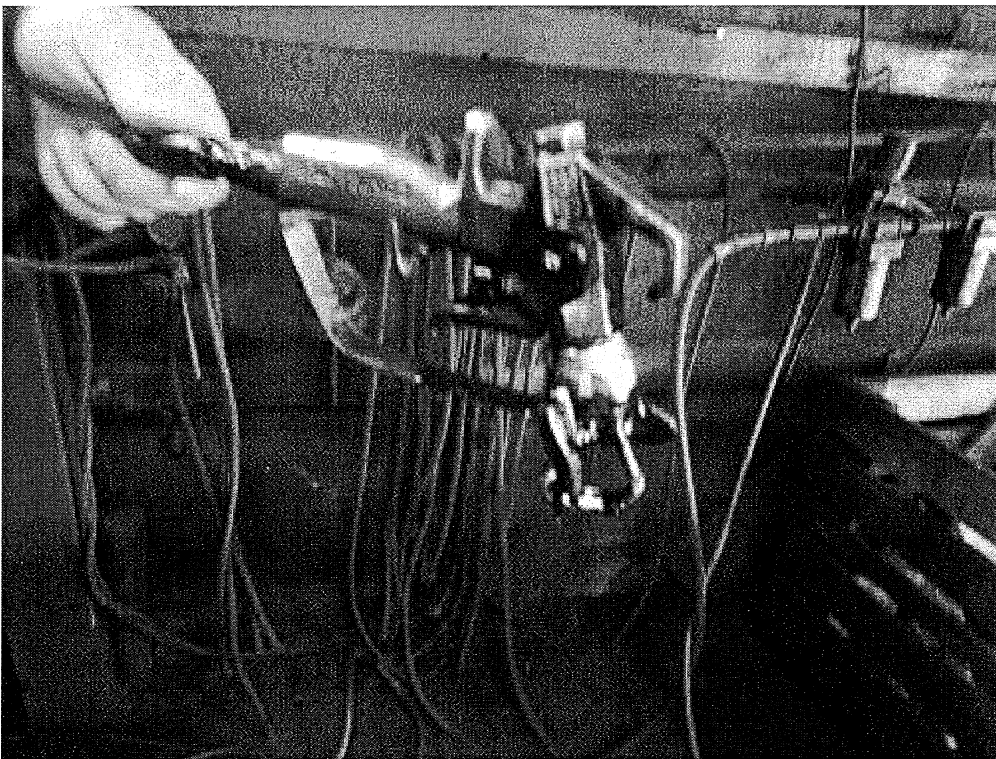
**Image 8(Paint gun)** : The one paint gun used to coat metal trailer bodies.

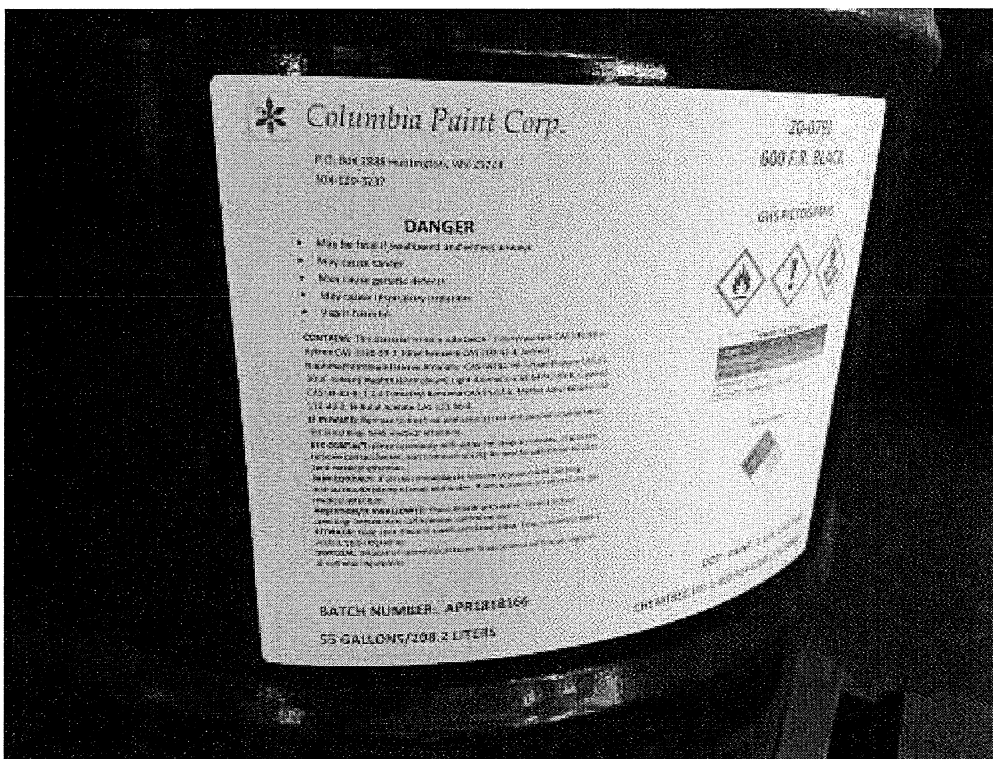
**Image 9(Paint Drum) :** Paint Drum with MSDS safety information on it.

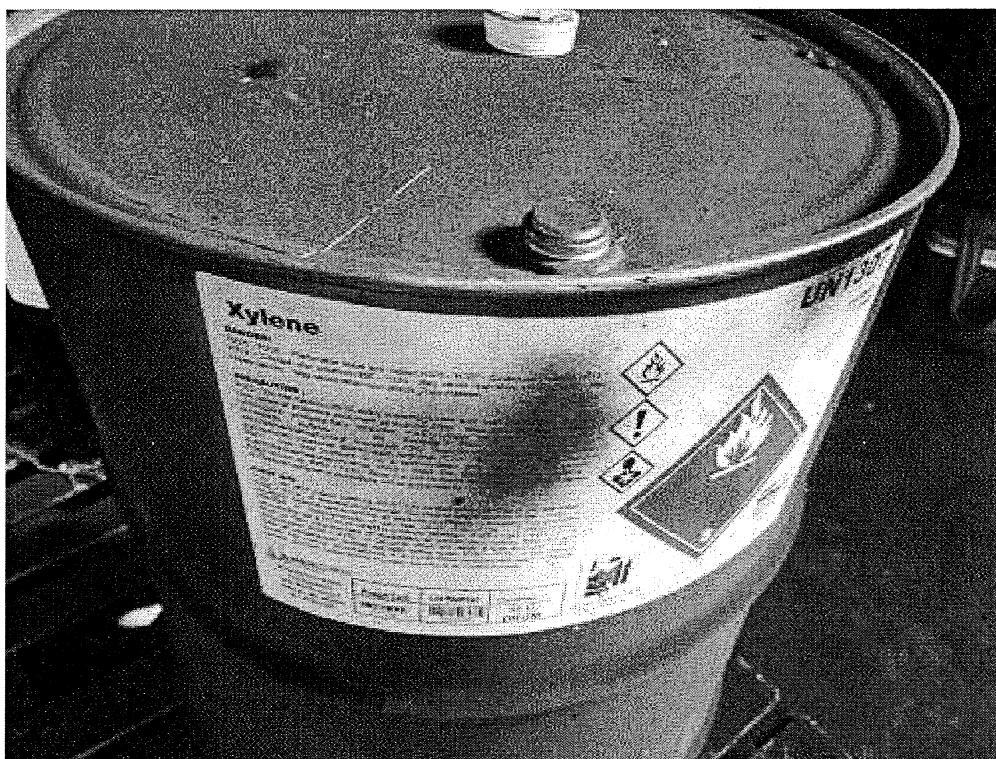
**Image 10(Paint Solvent)** : Paint solvent used to wipe trailers beds prior to coating

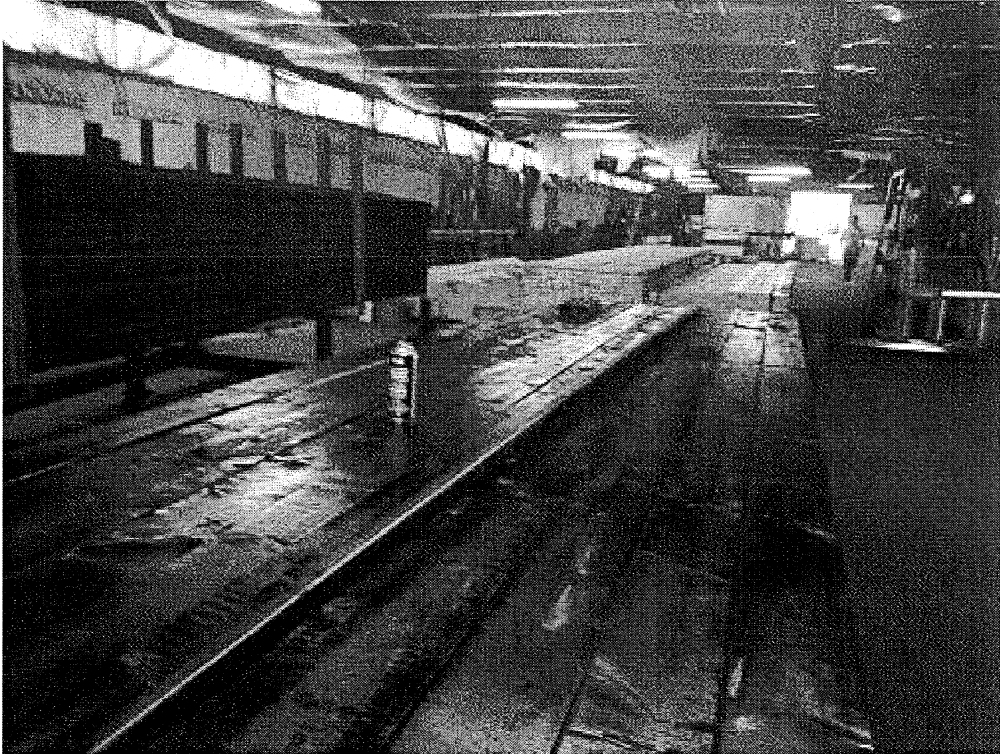
About this time, the owner arrived. Lyle accompanied us on the rest of the inspection. We then walked over to the other warehouse. It appeared that they do some wood working in there with a minor amount of painting using aerosol cans. See attached photo.

**Image 11(Wood warehouse)** : Wood working warehouse with small coating operation.
