DEPARTMENT OF ENVIRONMENTAL QUALITY
AIR QUALITY DIVISION
ACTIVITY REPORT: On-site Inspection

FACILITY: Southern Michigan Cremation Services R.O. Inc.		SRN / ID: P0932
LOCATION: 4839 Fernlee Avenue, ROYAL OAK		DISTRICT: Warren
CITY: ROYAL OAK		COUNTY: OAKLAND
CONTACT: Tom Perini , Operations Manager		ACTIVITY DATE: 12/15/2022
STAFF: Robert Elmouchi	COMPLIANCE STATUS: Non Compliance	SOURCE CLASS: MINOR
SUBJECT: Self-initiated inspection.		
RESOLVED COMPLAINTS:

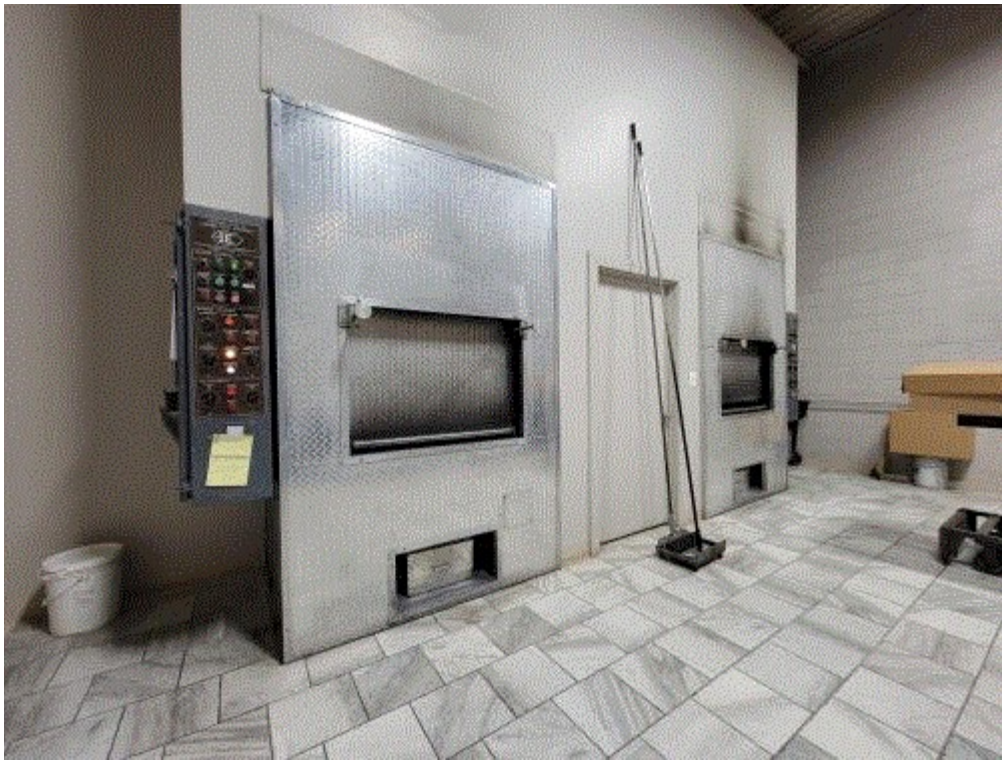
Image 1(20221215 092208) : EUCREMATORY4 (left) and EUCREMATORY3 (right) in the witness room.

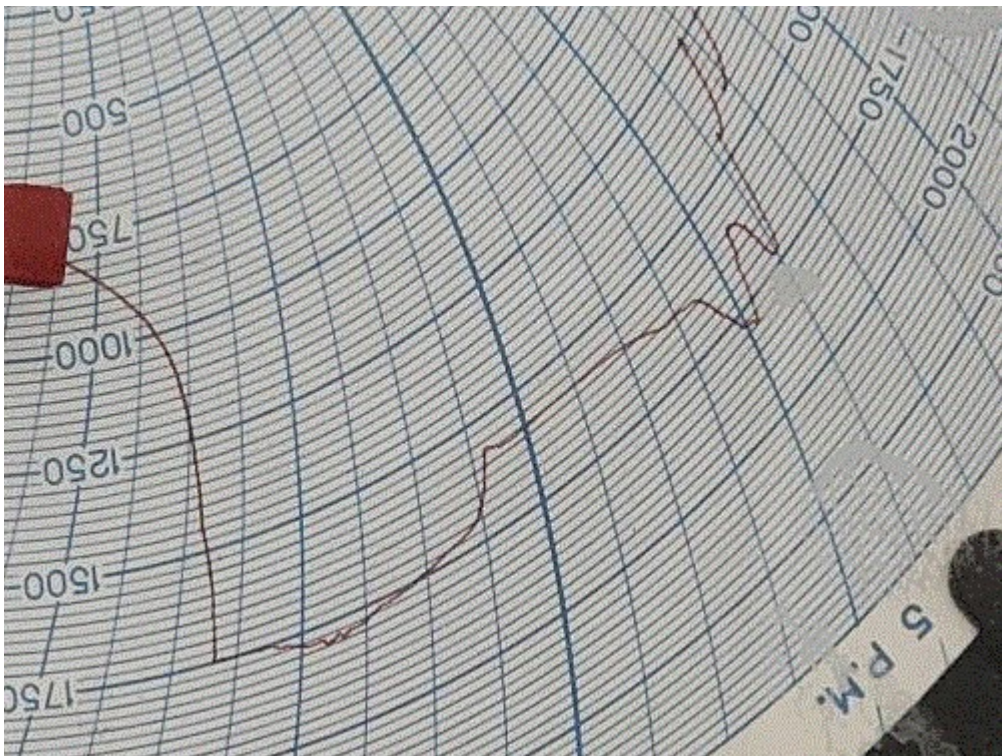
I observed that the temperature record for December 14, 2022, indicated that the permittee failed to maintain a minimum temperature of 1600°F in the EU-CREMATORY3 secondary combustion chamber. The December 14, 2022, record indicates that the temperature was approximately 1575°F for approximately 1-hour. I informed Tom that this constitutes a violation of PTI 113-18A, FG750, III.1, which states, *"The permittee shall not combust waste in any crematory in FG750 unless a minimum temperature of 1600°F and a minimum retention time of 1.0 seconds in the secondary combustion chamber are maintained."* Failing to maintain a minimum temperature of 1600 degrees F also constitutes a violation of R 336.1910, which

states, "An air-cleaning device shall be installed, maintained, and operated in a satisfactory manner and in accordance with these rules and existing law." These noncompliances shall be cited in a violation notice.

Image 2(20221215 092255) : Close-up of EUCREMATORY3 temperature chart. The record indicates that the permittee failed to maintain a minimum temperature of 1600°F. The December 14, 2022, record indicates that the temperature was approximately 1575°F for approximately 1 hour.

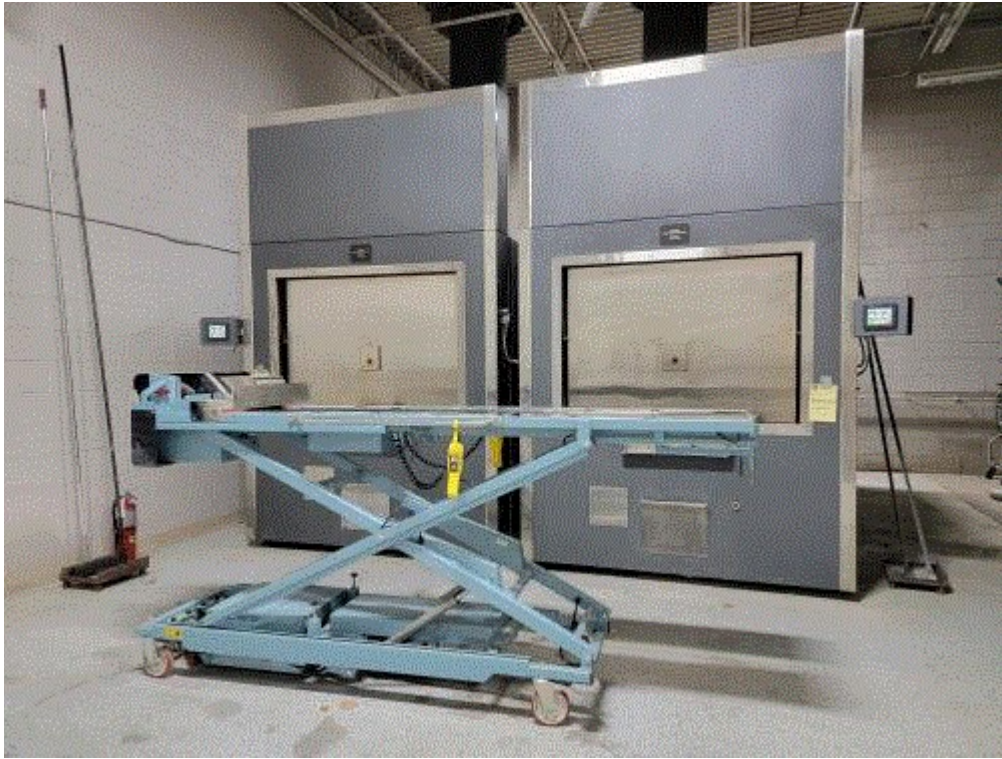
Image 3(20221215_094221) : EUCREMATORY6 (left) and EUCREMATORY5 (right), with a lift table in front. The lift table has a ram that is used as a mechanical assist when inserting a charge. The operator attaches the table to the cremation unit to maximize control.

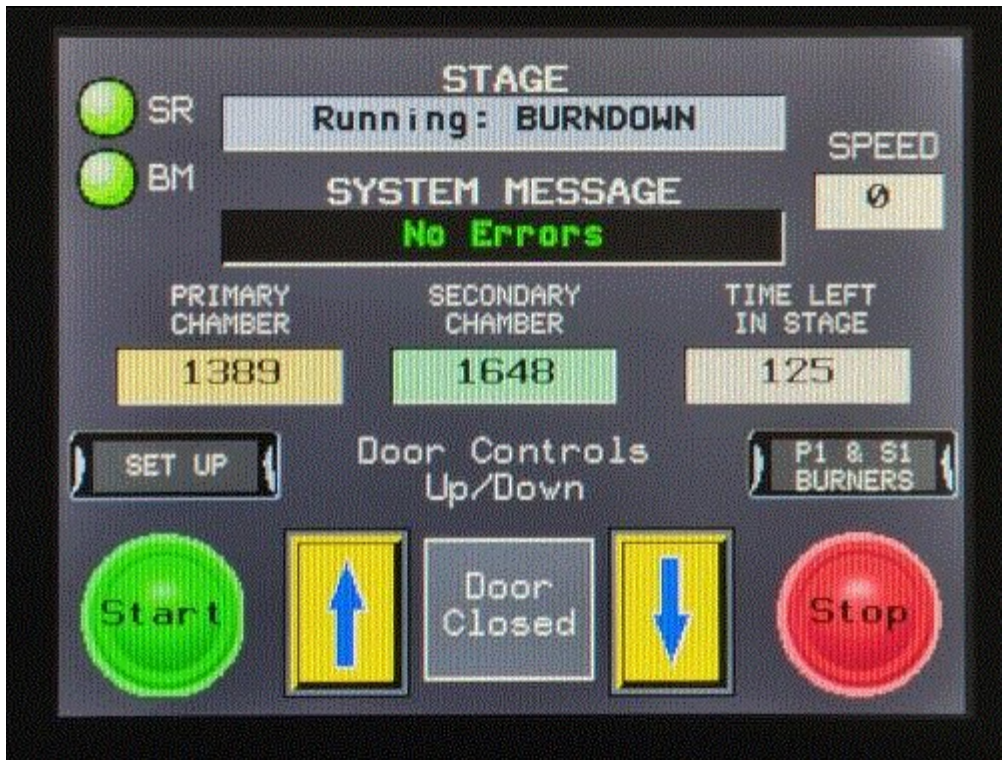
I observed EU-CREMATORY5 and EU-CREMATORY6 which appeared to be properly maintained. I observed the control panel on each emission unit. The EU-CREMATORY5 secondary combustion chamber was operating at 1648°F. EU-CREMATORY6 secondary combustion chamber was operating at 1649°F.

Image 4(20221215 094259) : Close-up view of EUCREMATORY5 digital control panel.

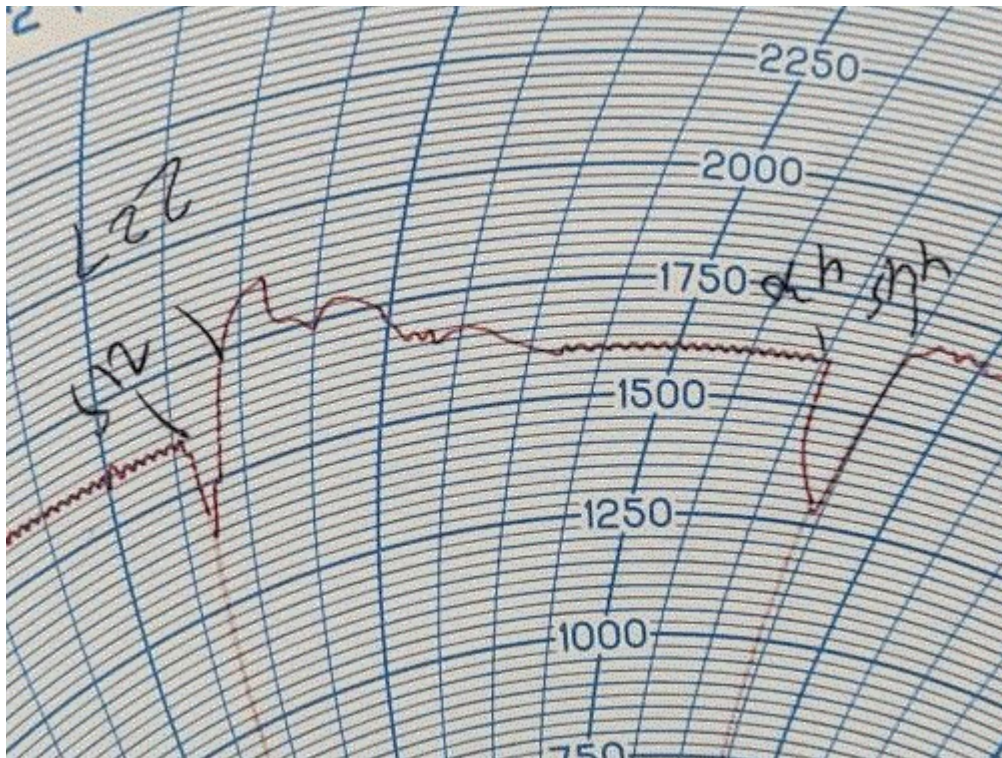
A review of the EU-CREMATORY5 temperature chart record for 12/14/2022 indicates that the permittee failed to maintain a minimum temperature of 1600°F in the EU-CREMATORY5 secondary combustion chamber. The record indicates the secondary combustion chamber temperature oscillated above and below 1600°F during multiple cremations. I informed Tom that this constitutes a violation of PTI 113-18A, FG1200, III.1, which states, "*The permittee shall not combust waste in any crematory in FG1200 unless a minimum temperature of 1600°F and a minimum retention time of 1.0 seconds in the secondary combustion chamber are maintained.*" Failing to maintain a minimum temperature of 1600 degrees F also constitutes a violation of R 336.1910, which states, "An air-cleaning device shall be installed, maintained, and operated in a satisfactory manner and in accordance with these rules and existing law." These noncompliances shall be cited in a violation notice.

Image 5(20221215 100103) : Close-up view of the EUCREMATORY5, which is incorrectly identified as No.3 on the temperature chart. The 12/14/22 chart indicates that the secondary combustion chamber temperature repeatedly oscillated below 1600F during multiple cremations.

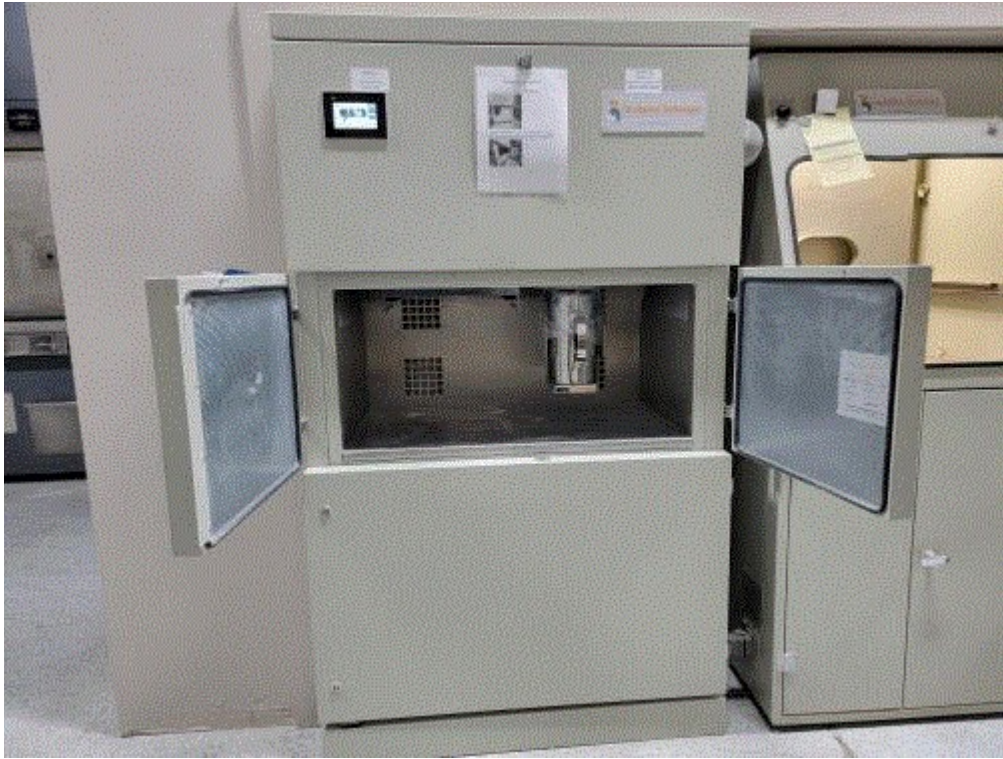
Image 6(20221215 093958) : A state-of-the art cremains processing center, with an air-tight processing chamber and particulate emission control.
