DEPARTMENT OF ENVIRONMENTAL QUALITY
AIR QUALITY DIVISION
ACTIVITY REPORT: Self Initiated Inspection

FACILITY: Bay Area Disposal		SRN / ID: P1104
LOCATION: 18657 Honor Highway, INTERLOCHEN		DISTRICT: Cadillac
CITY: INTERLOCHEN		COUNTY: BENZIE
CONTACT:		ACTIVITY DATE: 11/04/2020
STAFF: Jodi Lindgren	COMPLIANCE STATUS: Non Compliance	SOURCE CLASS: MINOR
SUBJECT: Inspection to verify the shredder is not in operation, discuss the late plans required by PTI 2-20, and discuss the lack of response to the 9/29/2020 ACO sent by AQD Enforcement Unit		
RESOLVED COMPLAINTS:

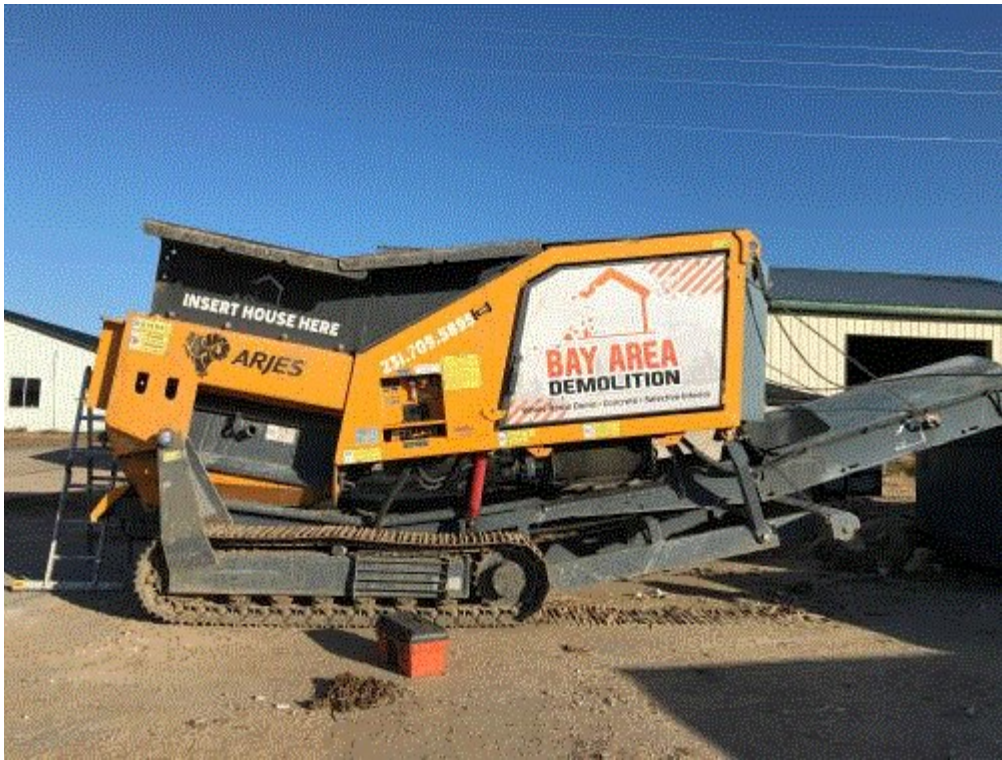
Image 1(Arjes 250 Shredder) : Permitted shredder on 9/4/2020

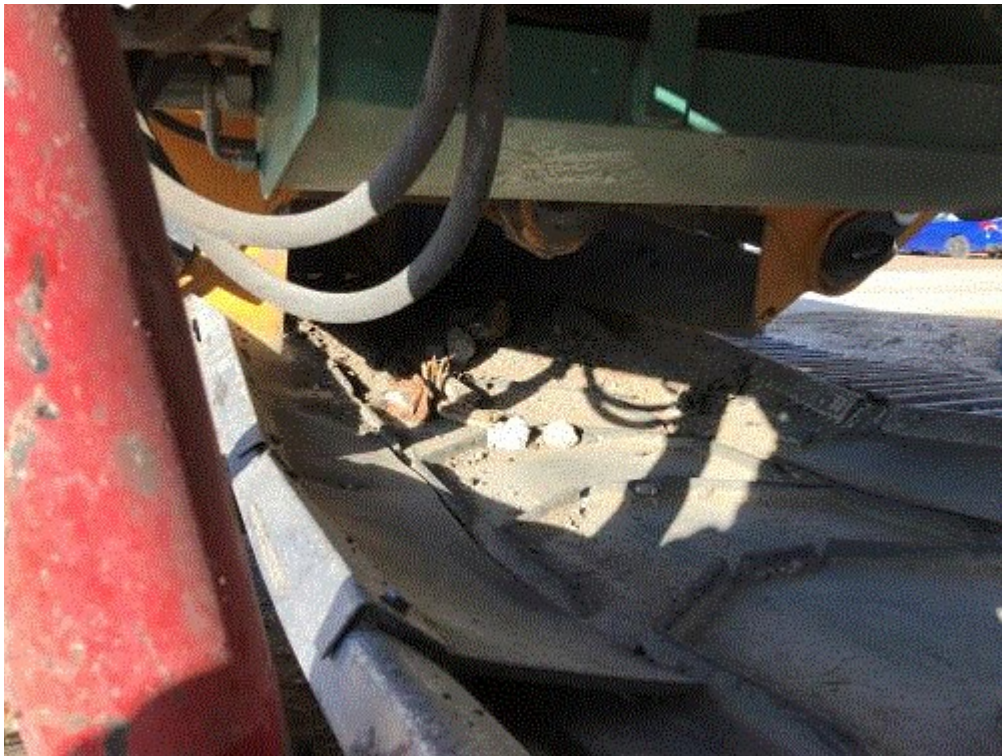
Image 2(Conveyor Belt) : Conveyor belt of permitted shredder on 9/4/2020

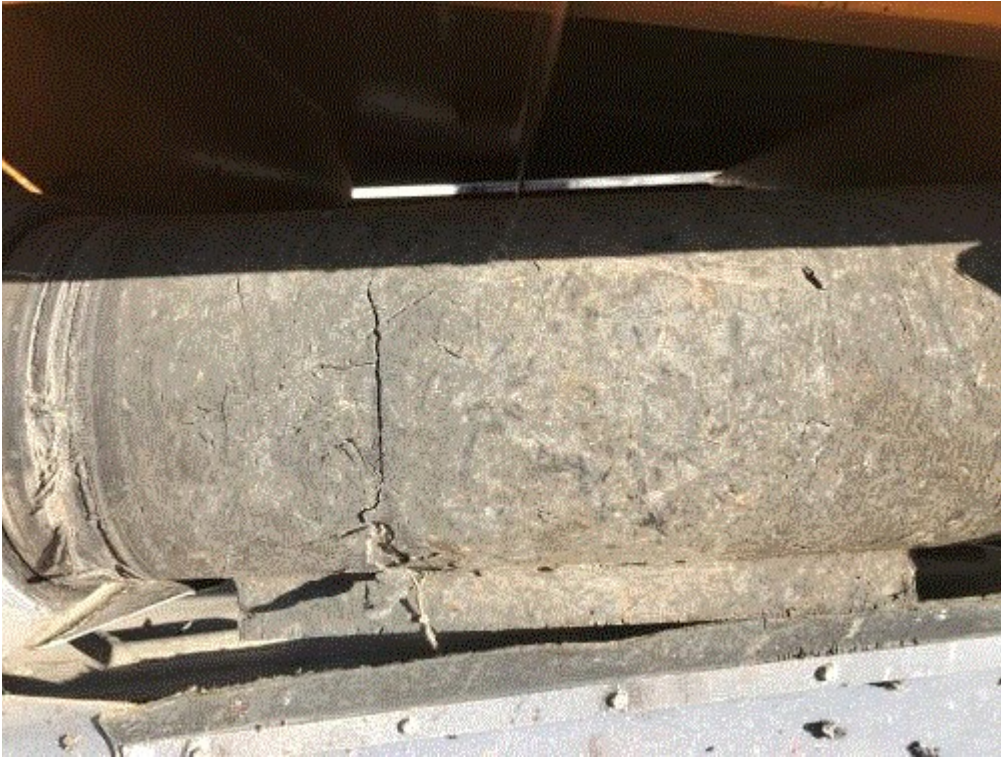
Image 3(End of Conveyor belt) : End of conveyor belt of permitted shredder on 9/4/2020

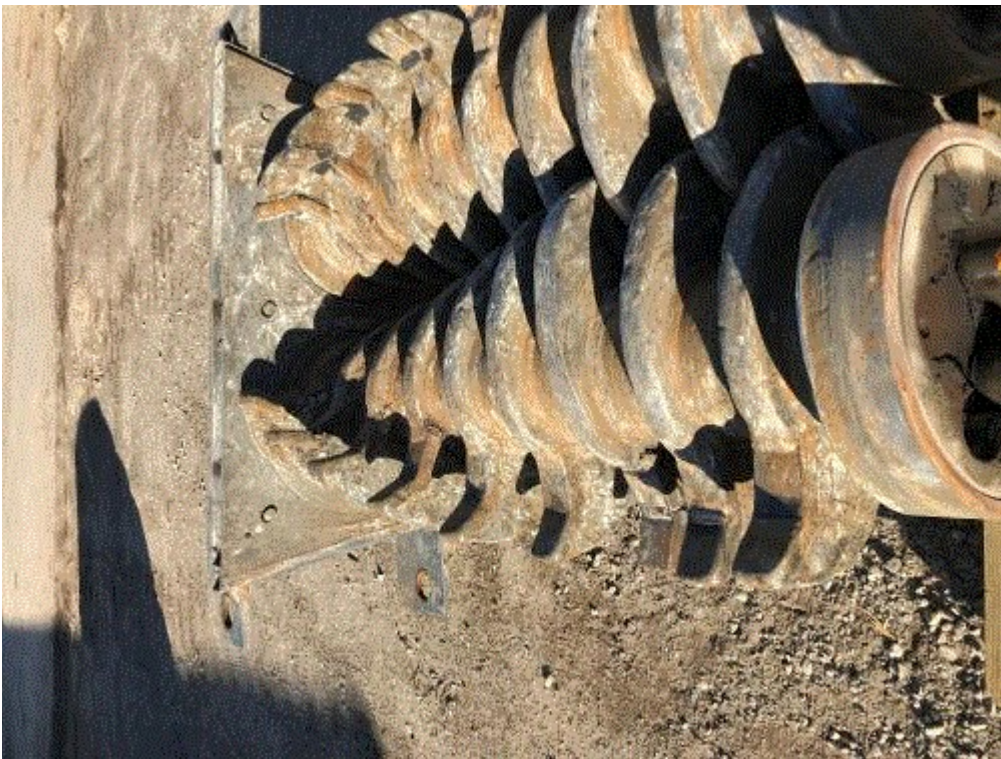
Image 4(Concrete shaft) : Concrete crushing shaft system with many welds 9/4/2020

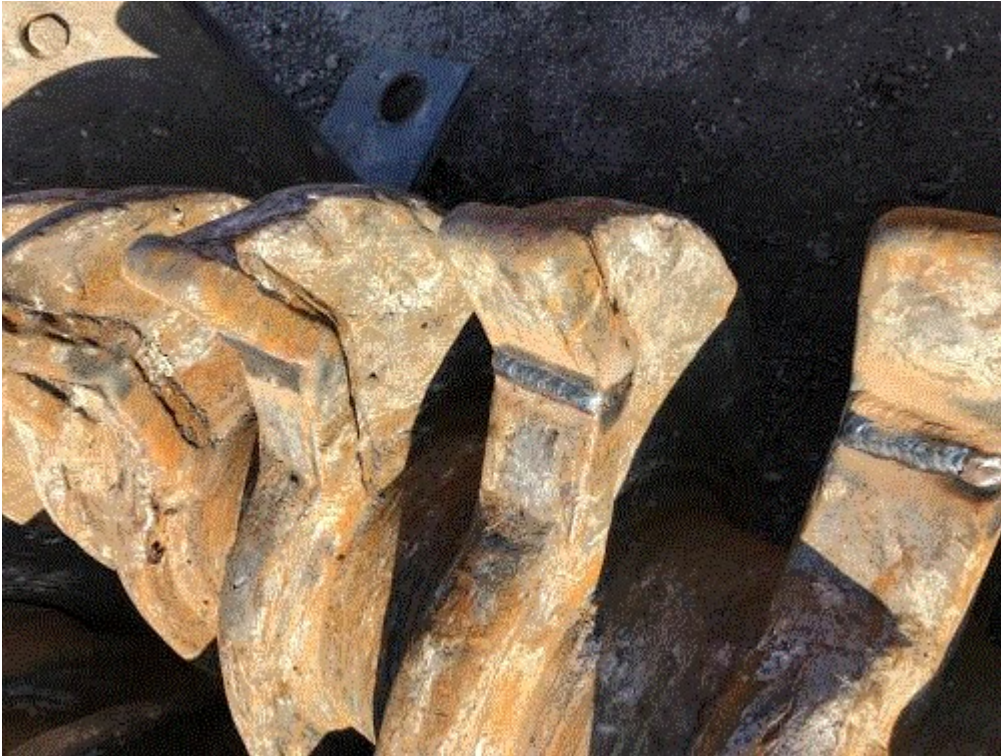
Image 5(fresh welds) : Closer image of fresh welds on the concrete crushing shaft system 9/4/2020

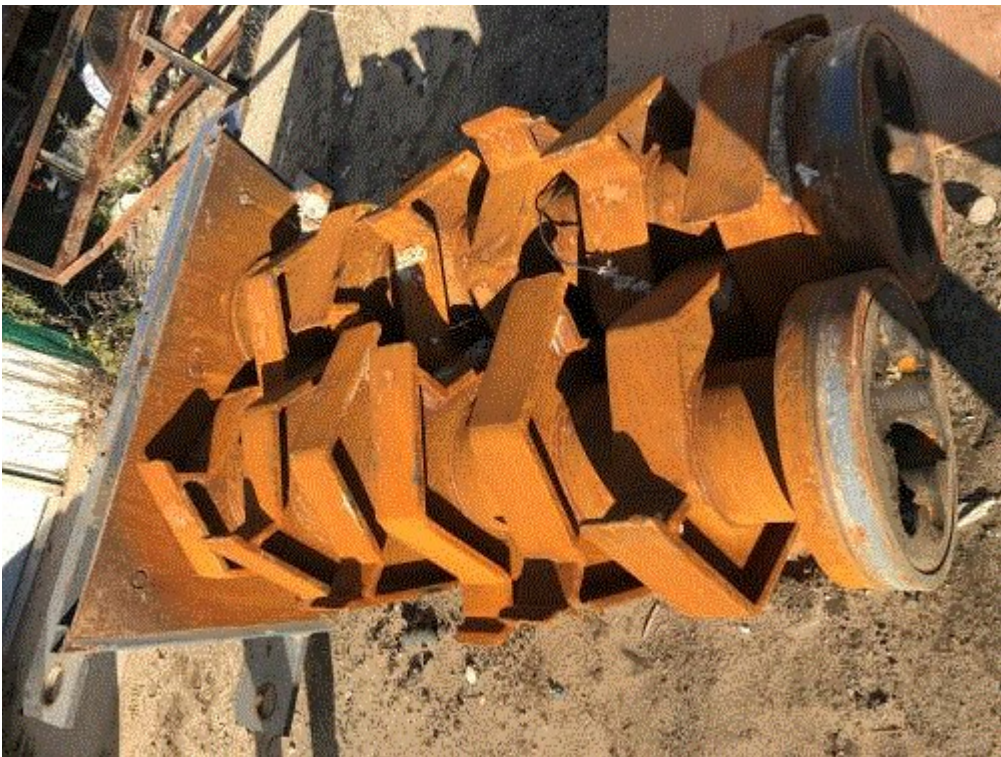
Image 6(Nonaggregate shaft) : Nonaggregate shaft with welds and weathering 9/4/2020
