DEPARTMENT OF ENVIRONMENTAL QUALITY
AIR QUALITY DIVISION
ACTIVITY REPORT: Complaint Investigation

FACILITY: Willbee Transit Mix Company, Inc.		SRN / ID: P1444
LOCATION: 2400 Brooklyn Road, JACKSON		DISTRICT: Jackson
CITY: JACKSON		COUNTY: JACKSON
CONTACT: Stephen Willbee ,		ACTIVITY DATE: 07/31/2024
STAFF: Stephanie Weems	COMPLIANCE STATUS: Compliance	SOURCE CLASS:
SUBJECT: Complaint investigation conducted in response to fugitive dust complaints.		
RESOLVED COMPLAINTS: C-24-01483, C-24-01488

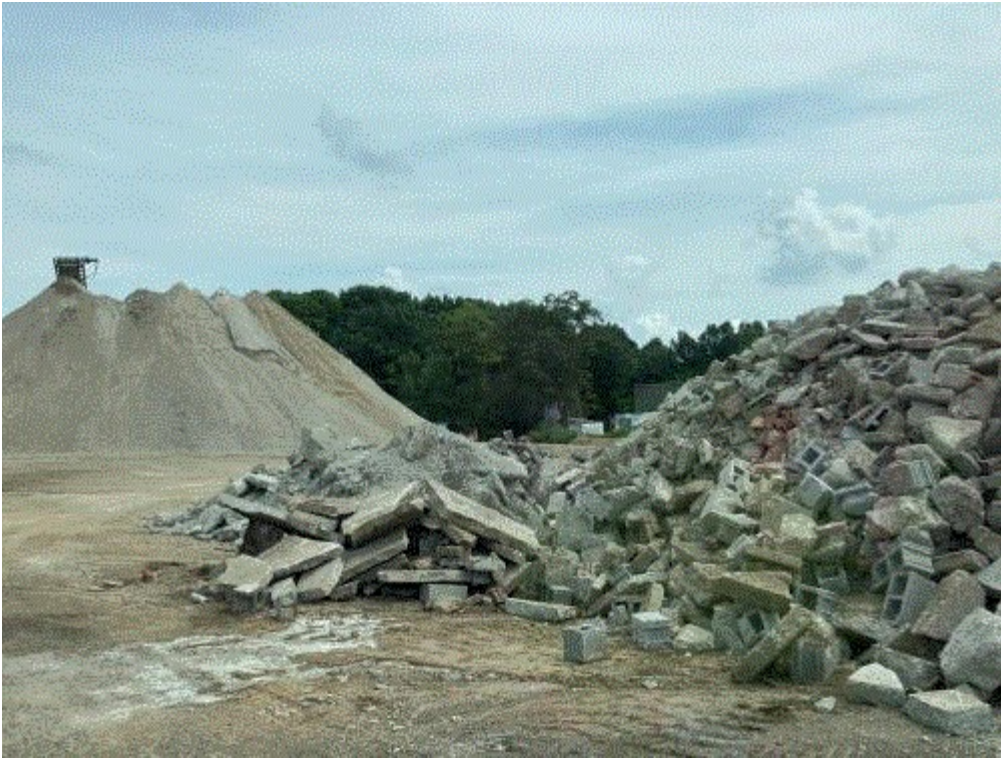
We then returned to the crusher location and pulled into the lot. It was evident that the crusher was not operating, and no dust was observed. See pictures attached.

Image 1(1) : View of yard.

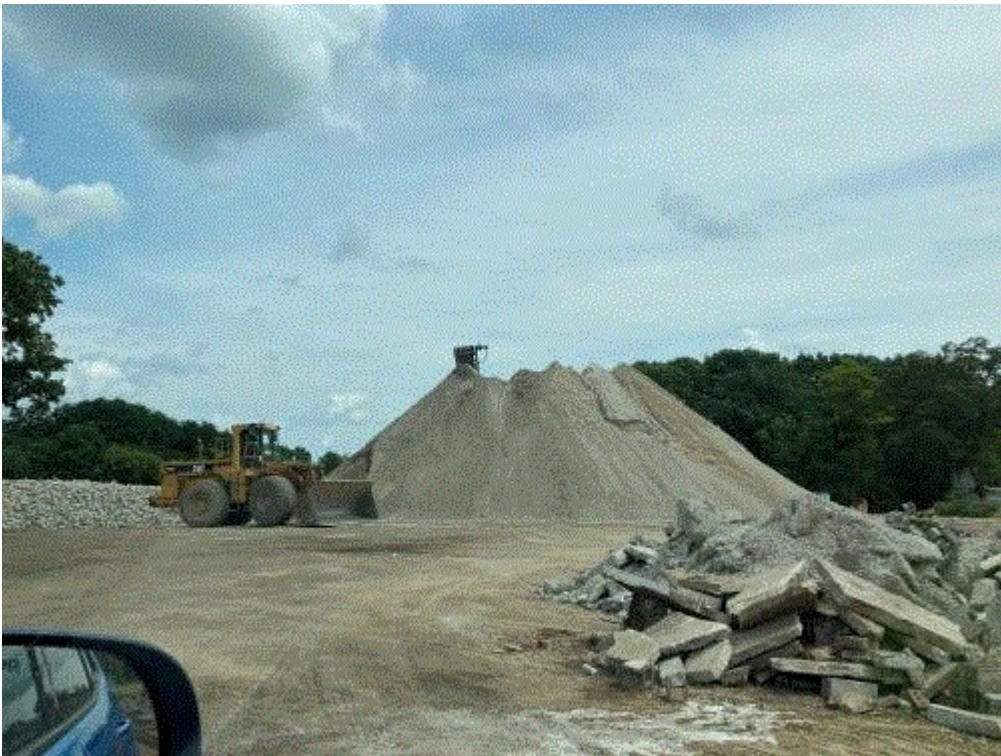
Image 2(2) : View of loader and pile of crushed material. Conveyor above material is from crusher and was not operating.
