FH ARC Abatement, Inc.  
225 South 12th Street  
Waco, Texas 76701

December 10, 2024

SRN/ID: U822405402; Wayne County

## **PRE-DEMOLITION ASBESTOS National Emissions Standard for Hazardous Air Pollutants (NESHAP) SURVEY for Eastman Solutia, Trenton, Michigan FACILITY BUILDINGS**

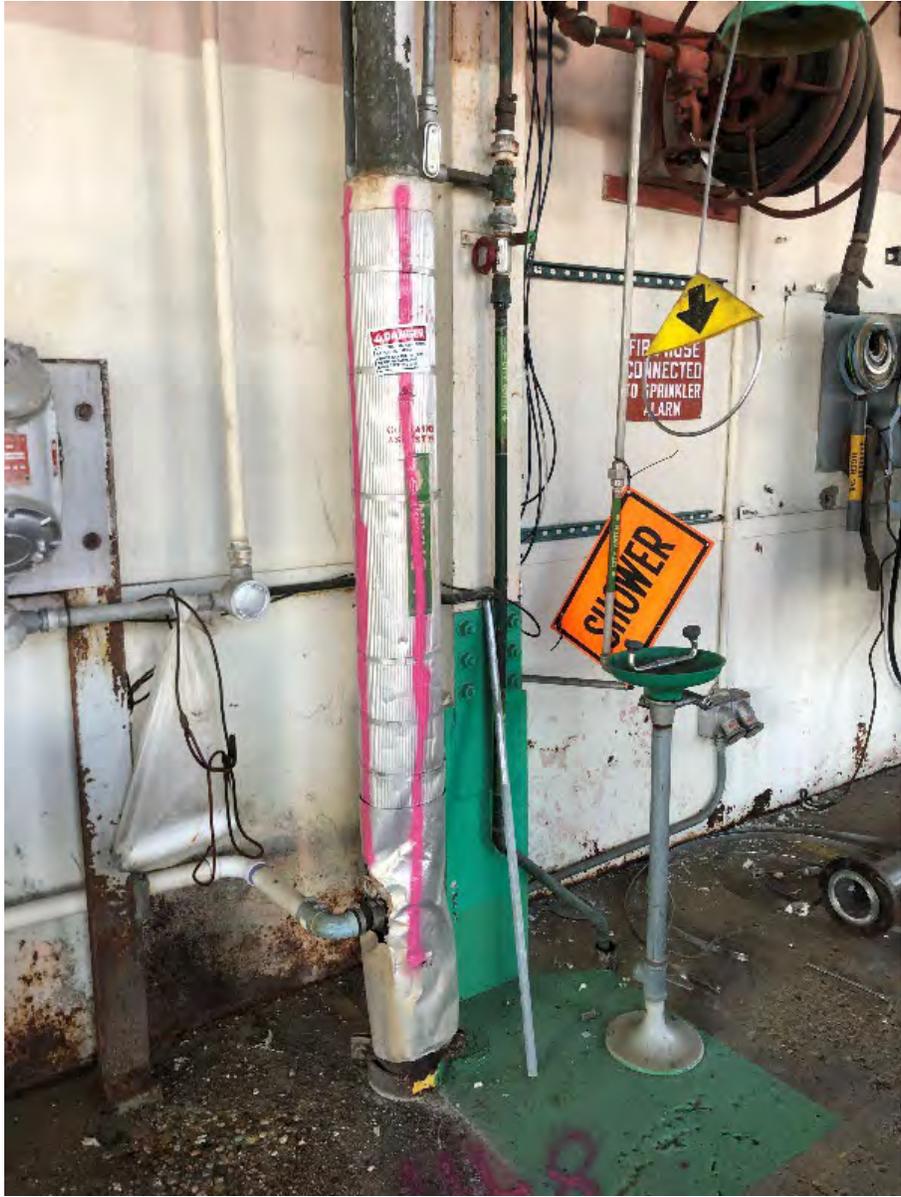
Example of demarcated HA (Butvar Bldg)

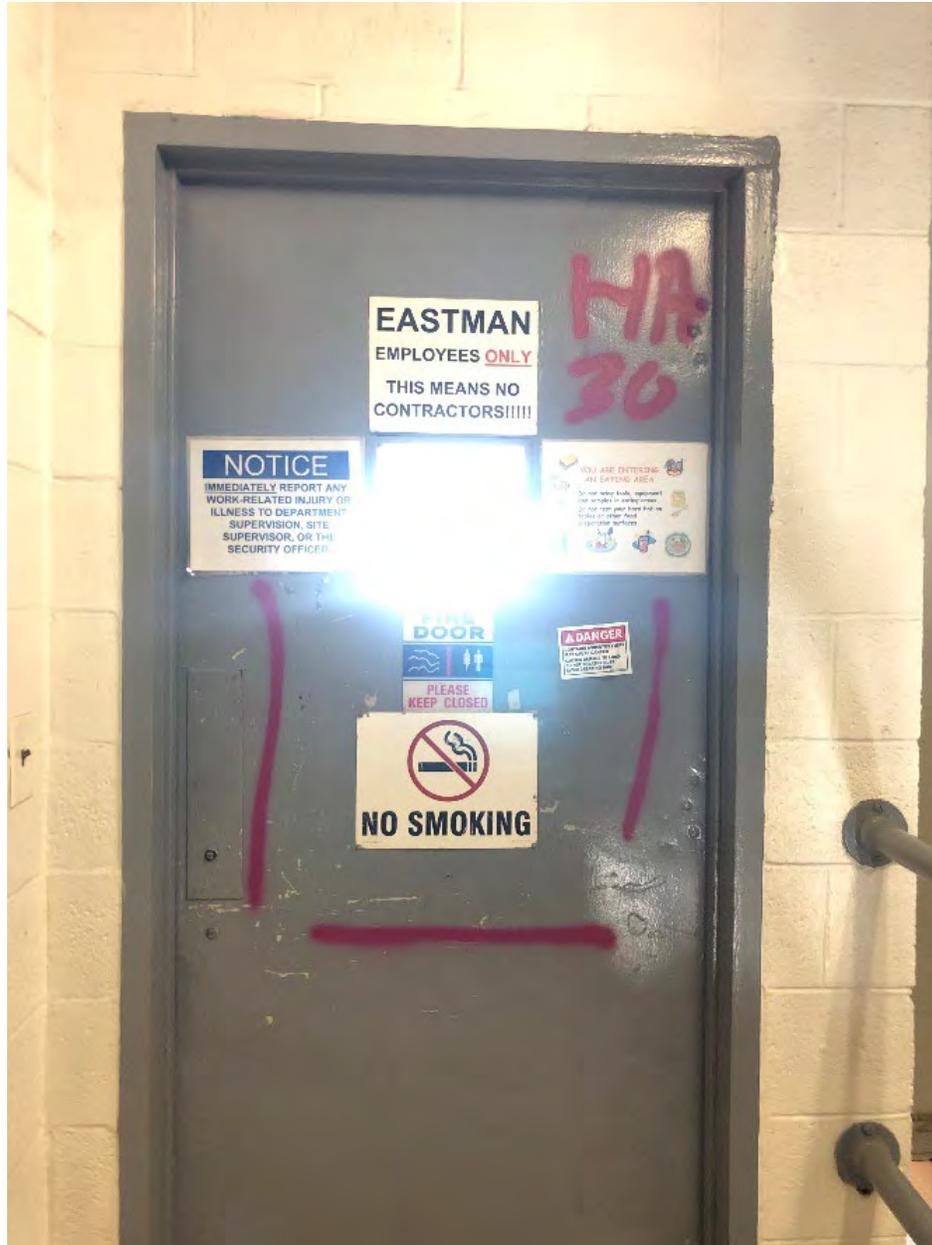
Example of demarcation on HA-30 (fire doors of Resin Admin)

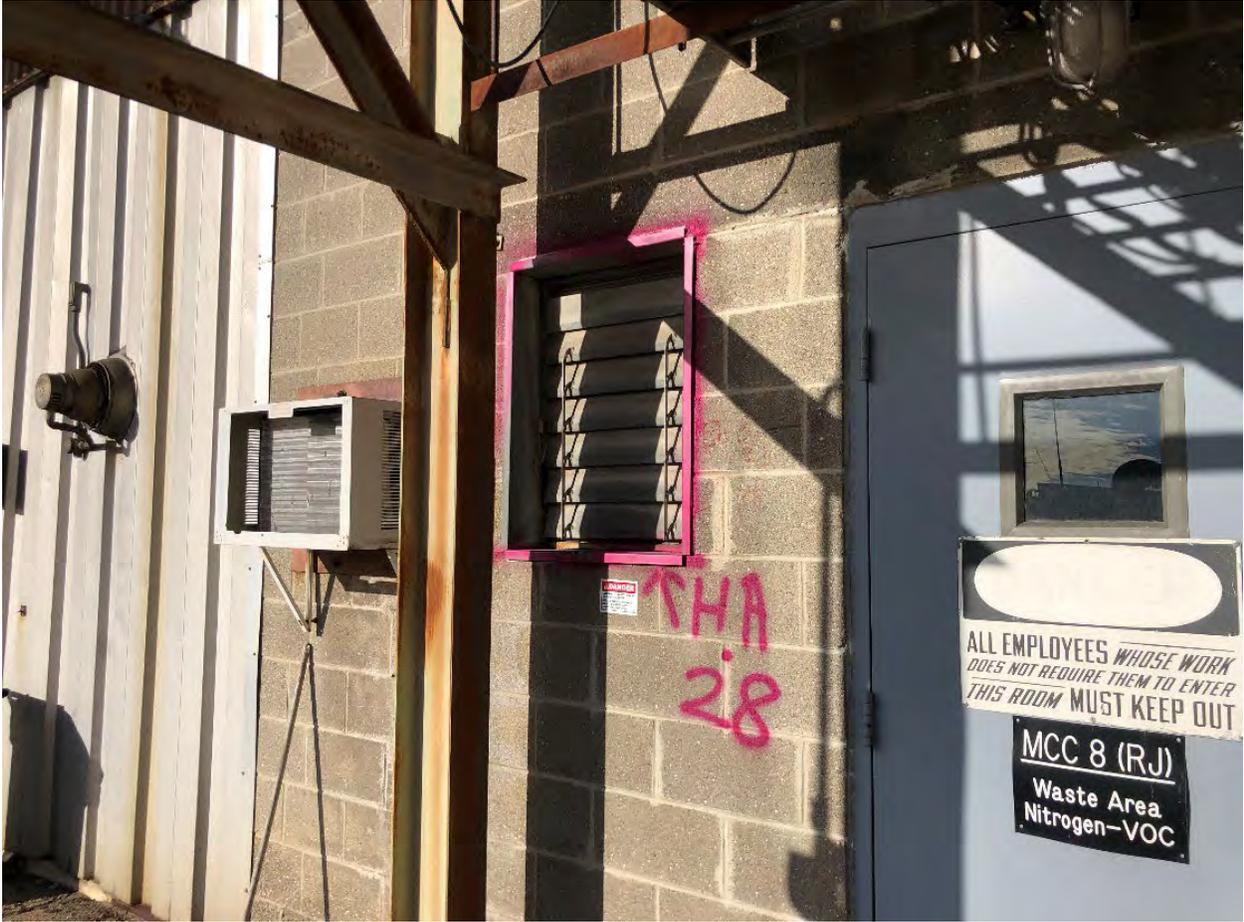
Example of demarcation on HA-28 (RJ Warehouse)

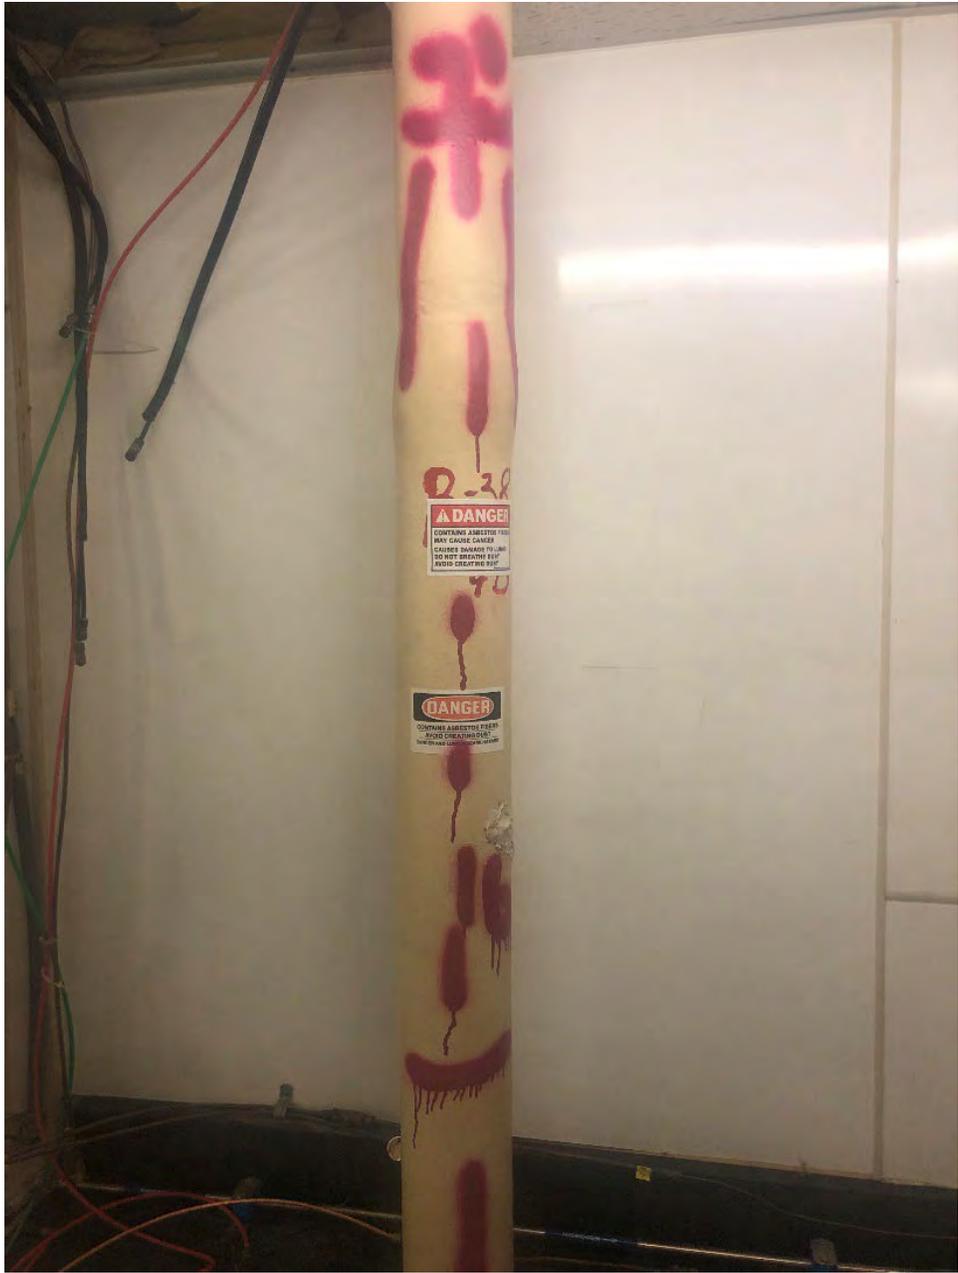
Example of HA demarcation and stickers (Resin Admin: Lab)

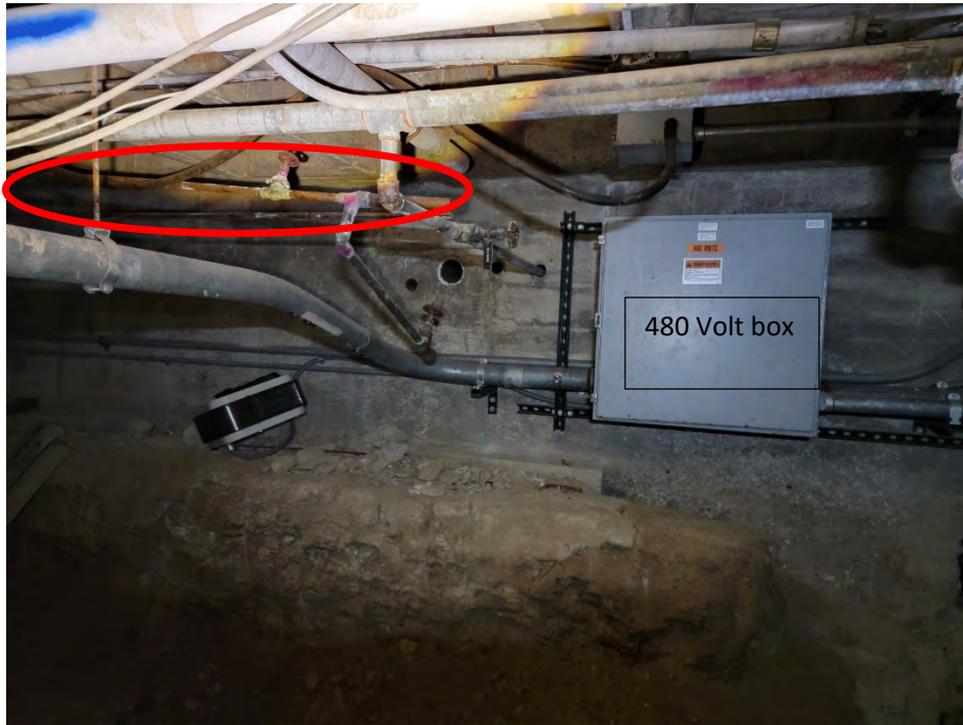
Photo 1 – View of crawl space piping, Copper Line that was abated using glove bag method  
Note location of 480V Box.

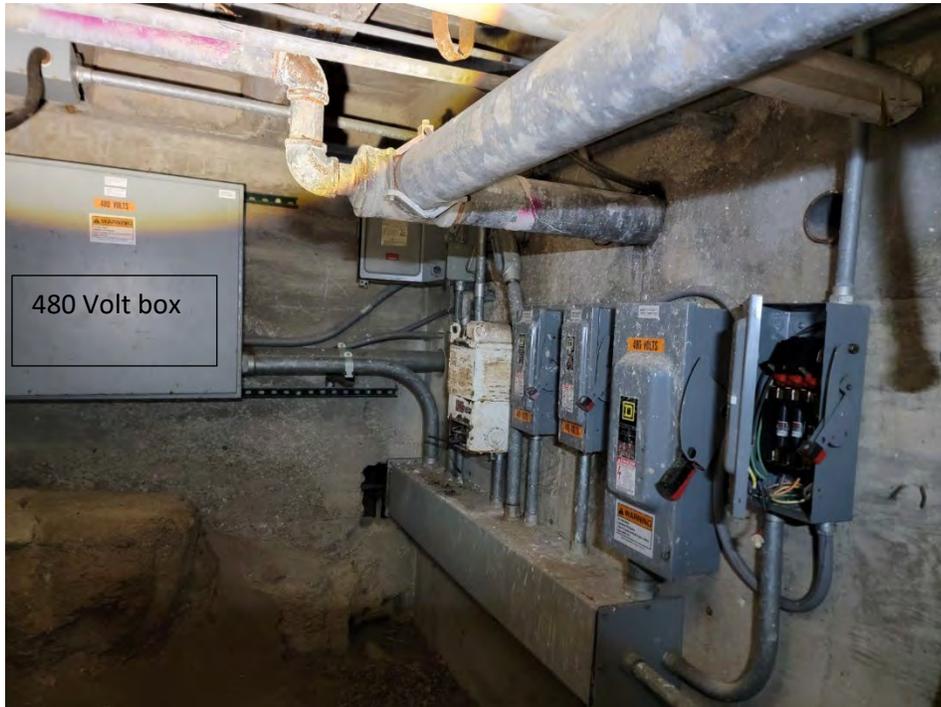
Photo 2 – Electrical Boxes with residual splatter not in ARC Scope. Note location of 480V Box.
