DEPARTMENT OF ENVIRONMENTAL QUALITY
AIR QUALITY DIVISION
ACTIVITY REPORT: Scheduled Inspection

P012445370

FACILITY: Admiral Petroleum		SRN / ID: P0124
LOCATION: 919 S Main St, EATON RAPIDS		DISTRICT: Lansing
CITY: EATON RAPIDS		COUNTY: EATON
CONTACT: Jim Sova, Senior Project Manager		ACTIVITY DATE: 07/25/2018
STAFF: Michelle Luplow	COMPLIANCE STATUS: Compliance	SOURCE CLASS: MINOR
SUBJECT: Announced, scheduled inspection to determine compliance with General PTI 127-10.		
RESOLVED COMPLAINTS:

Purpose

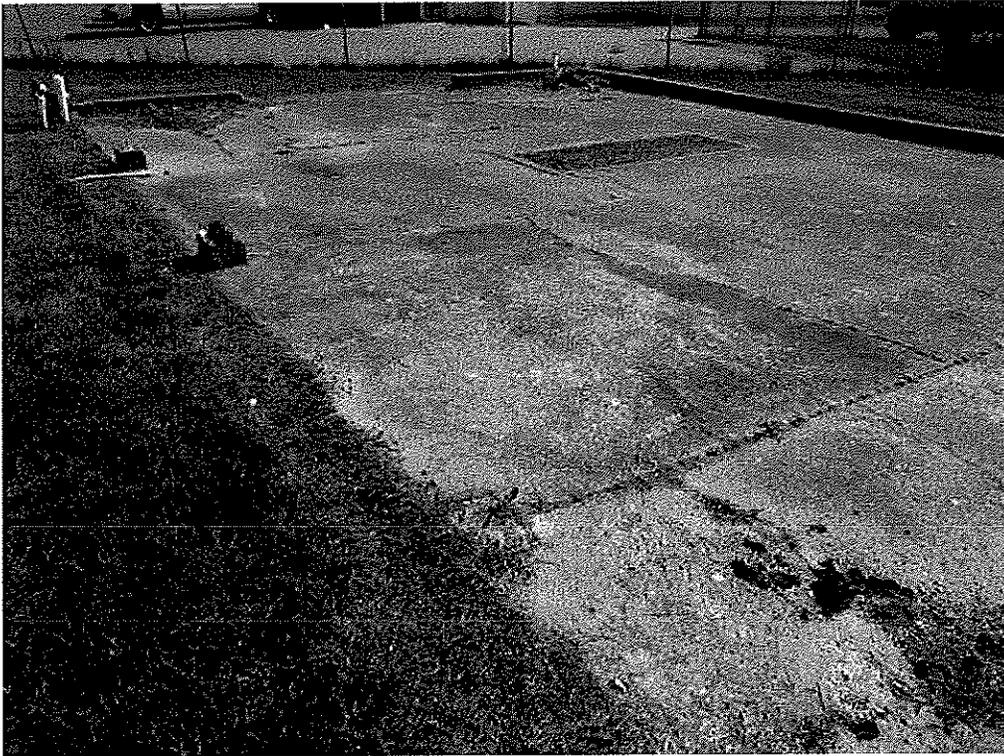
I verified with him that the air sparging equipment had been removed. There were only 2 concrete slabs present, in addition to the electrical feed conduit and 3 well heads. See attached photos.

Image 1(Concret Slab #1) : Facing north

I will request that PTI 127-10 be voided because the equipment has been removed from the site

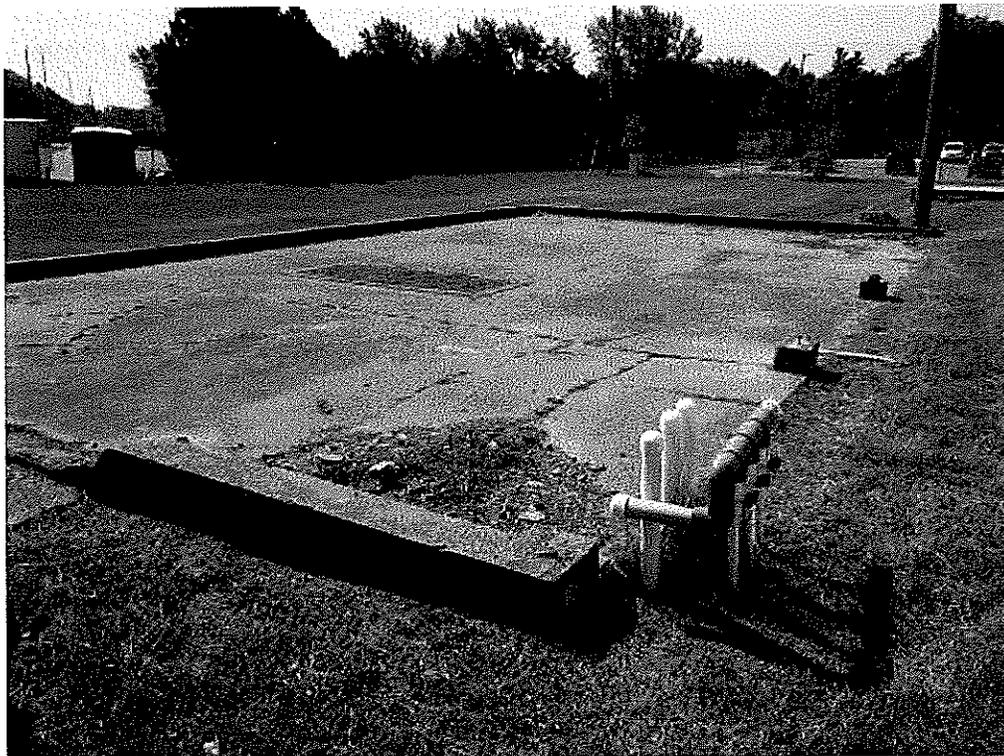
Image 2(Concrete Slab #2) : Facing South

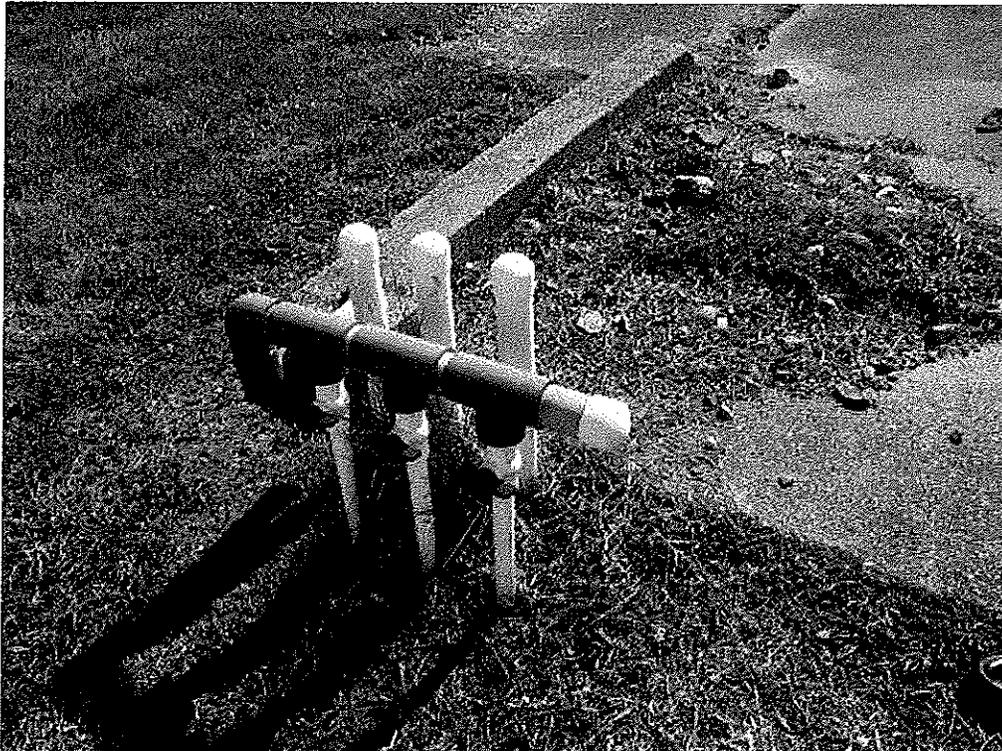
Image 3(Wellheads) : 3 wellheads still present

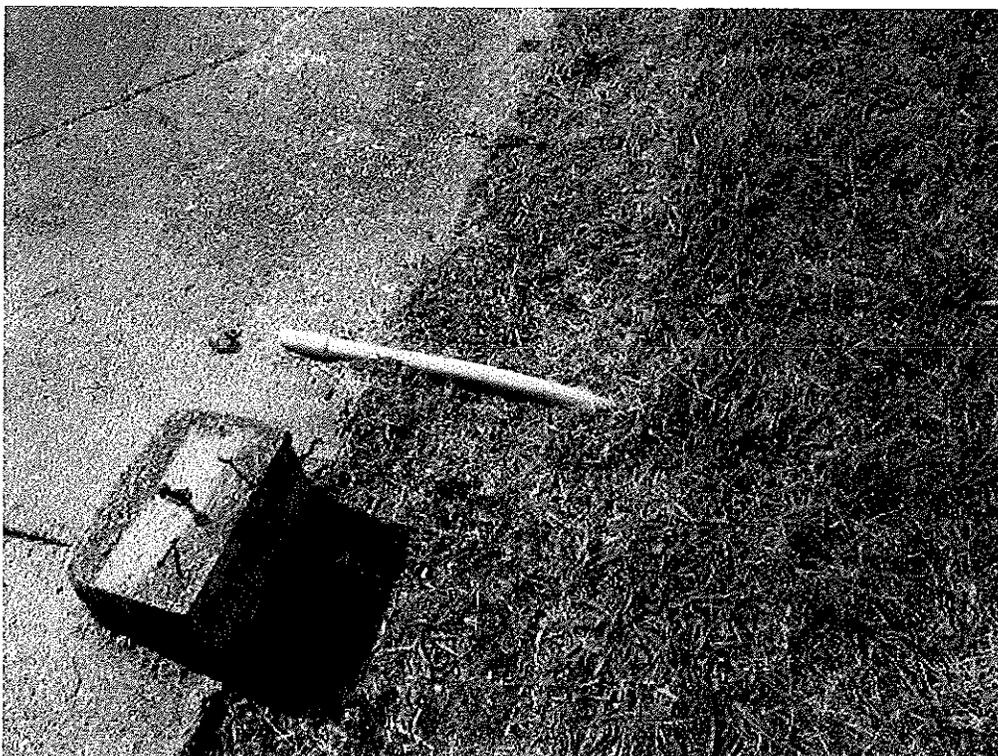
Image 4(Electrical Conduit) : Conduit for electricity to power system.
