DEPARTMENT OF ENVIRONMENTAL QUALITY AIR QUALITY DIVISION ACTIVITY REPORT: Self Initiated Inspection

| N268848383 | · · · · | |
|--|---|---|
| FACILITY: Advanced DisposalServices Arbor Hills Landfill Inc | | SRN / ID: N2688 |
| SUBJECT: Elevated Temperature | Landfill (ETLF) Event visit. | |

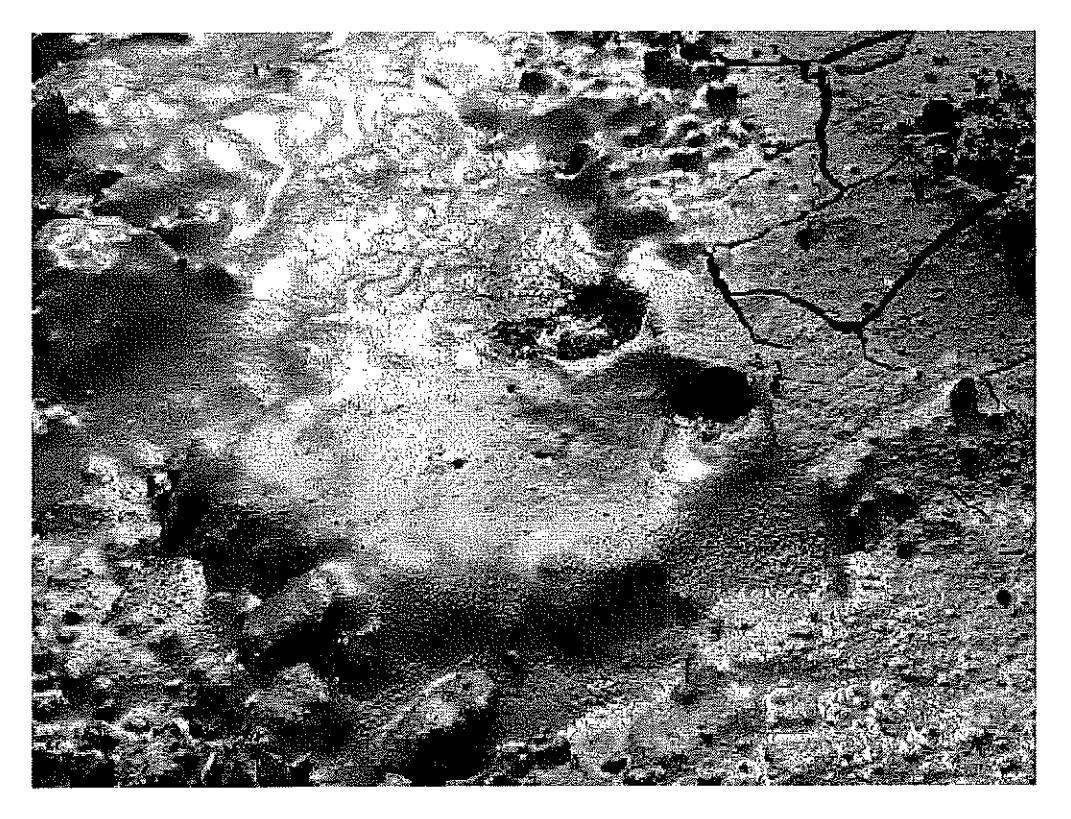
The area where we witnessed the small bubbling geyser last week was still active. It appears to have grown somewhat in size with several bubbling areas now present in a small line. It appears that they attempted to cover it up with more dirt but it seemly broke through again. Same acrid/burned gas smell as before. I tested it for methane and H2S. H2S came in at similar levels to last time. The methane meter quickly pegged out at its 10,000 ppm limit. Mark was surprised by this as it should contain little if any methane since methyl genesis had liked stopped. (I looked into this issue, it appears our meter likely mistook hydrogen for methane.)

Image 1(Boiling Gas) : Boiling gas coming out of the ground near subsidence area.

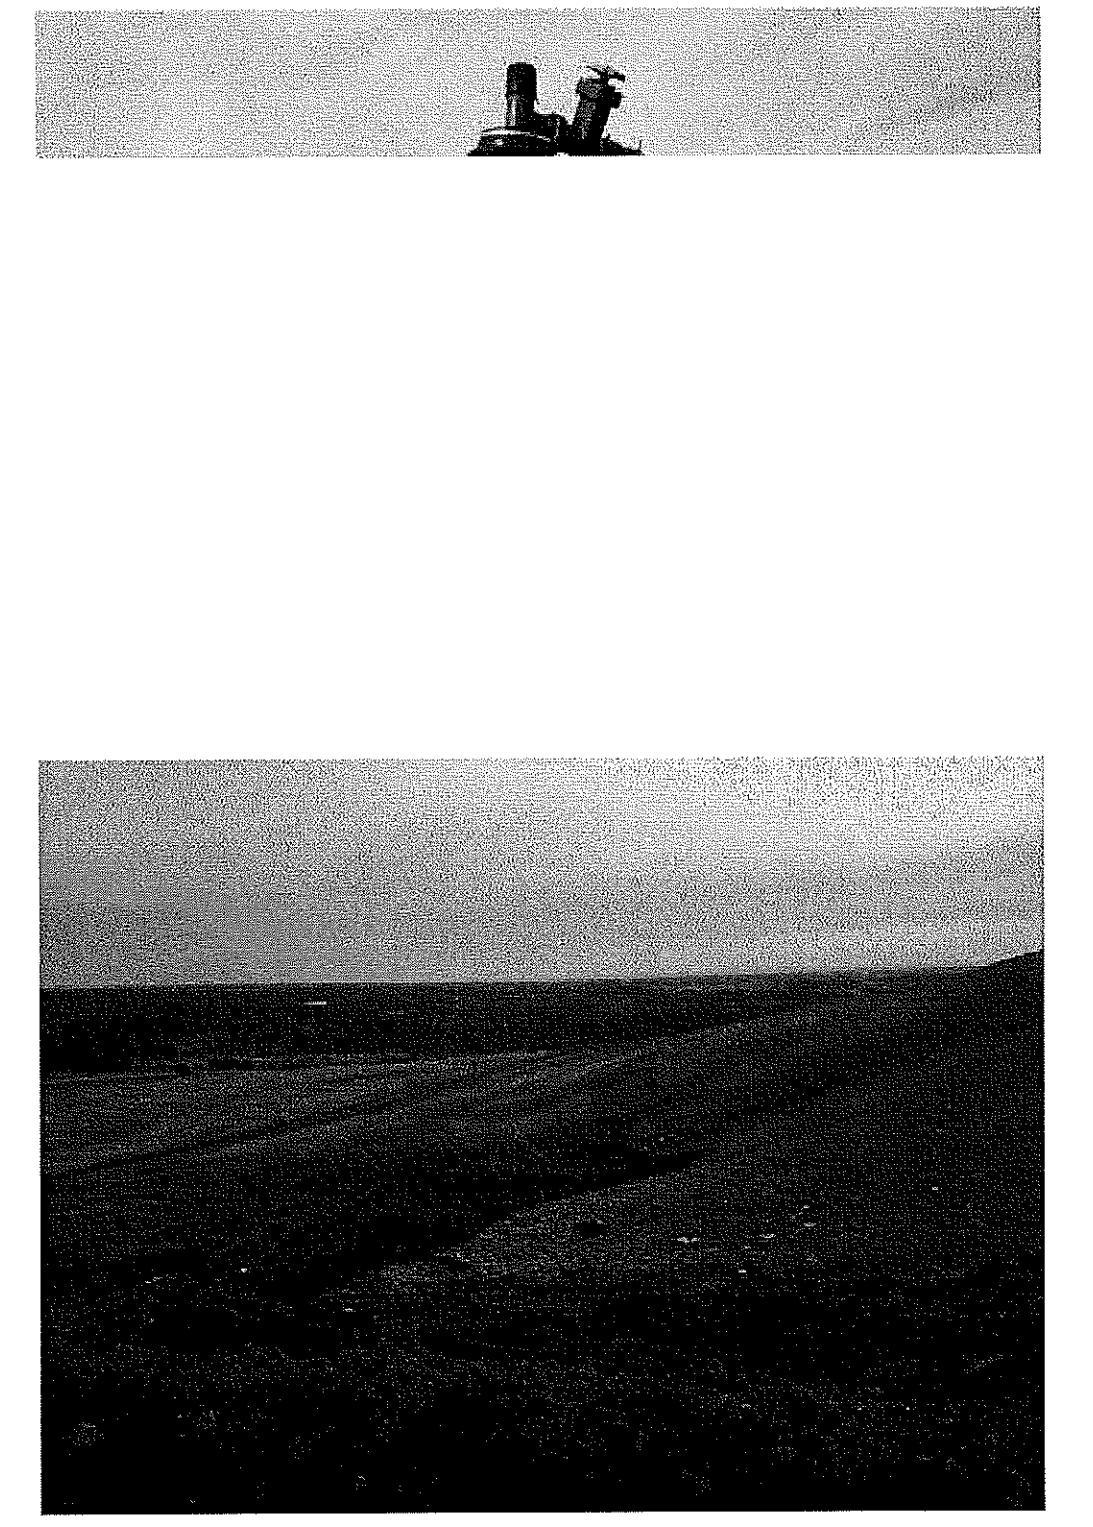
Took a brief trip to the subsidence area. I immediately noted a well adjacent to the subsidence area that was steaming. The well head had come off. Mark didn't know why it was off but suspected it was bumped off by a dozer. I asked if increased landfill gas pressure had caused it? (Common with ETLF's.) He said probably not. He attempted to place the well head back on but it immediately came off again. He mentioned he needed to go get a screw driver to secure it properly.

Image 3(Leaking gas well) : Gas well with well head knocked off releasing heated landfill gas into the atmosphere.
