**DEPARTMENT OF ENVIRONMENTAL QUALITY
AIR QUALITY DIVISION
ACTIVITY REPORT: Scheduled Inspection**

FACILITY: Merrill Fabricators		SRN / ID: A1346
LOCATION: 520 REPUBLIC ST, ALMA		DISTRICT: Lansing
CITY: ALMA		COUNTY: GRATIOT
CONTACT: Jesse Willoughby , Safety Coordinator		ACTIVITY DATE: 03/26/2018
STAFF: Michelle Luplow	COMPLIANCE STATUS: Compliance	SOURCE CLASS: MINOR
SUBJECT: Scheduled, unannounced inspection to determine compliance with Merrill Fabricators' General PTI 95-17		
RESOLVED COMPLAINTS:

General PTI No. 95-17: 3 Coating Lines

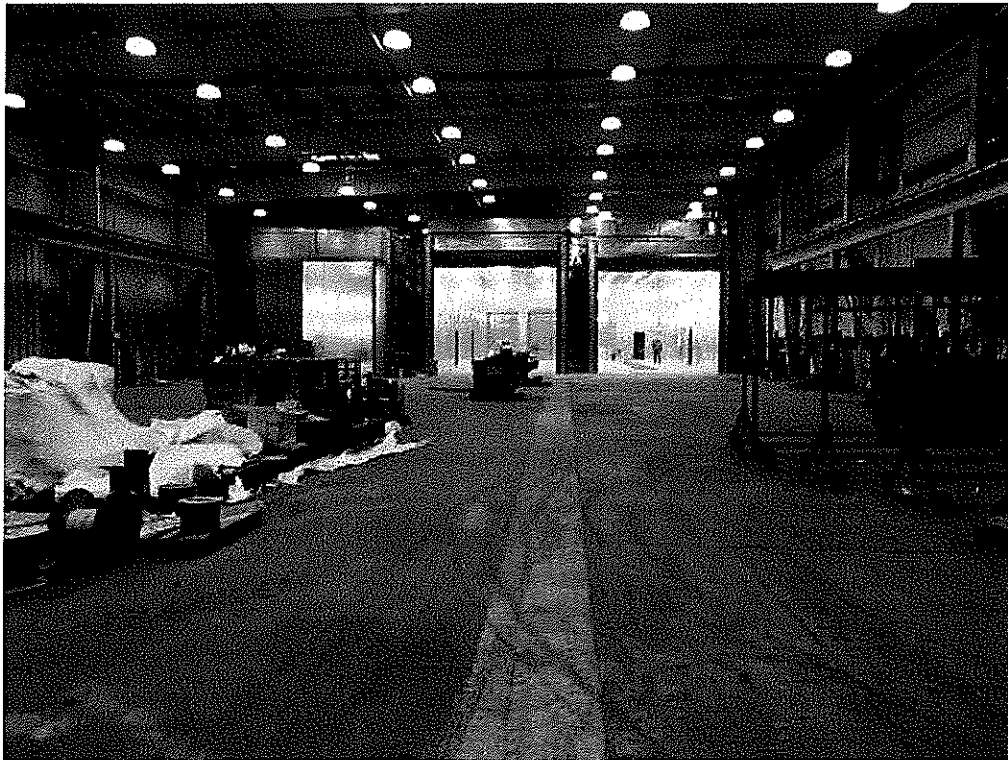
Image 1(New Booths) : L to R: new sand blasting booth, 2 new paint booths for train car coating operations

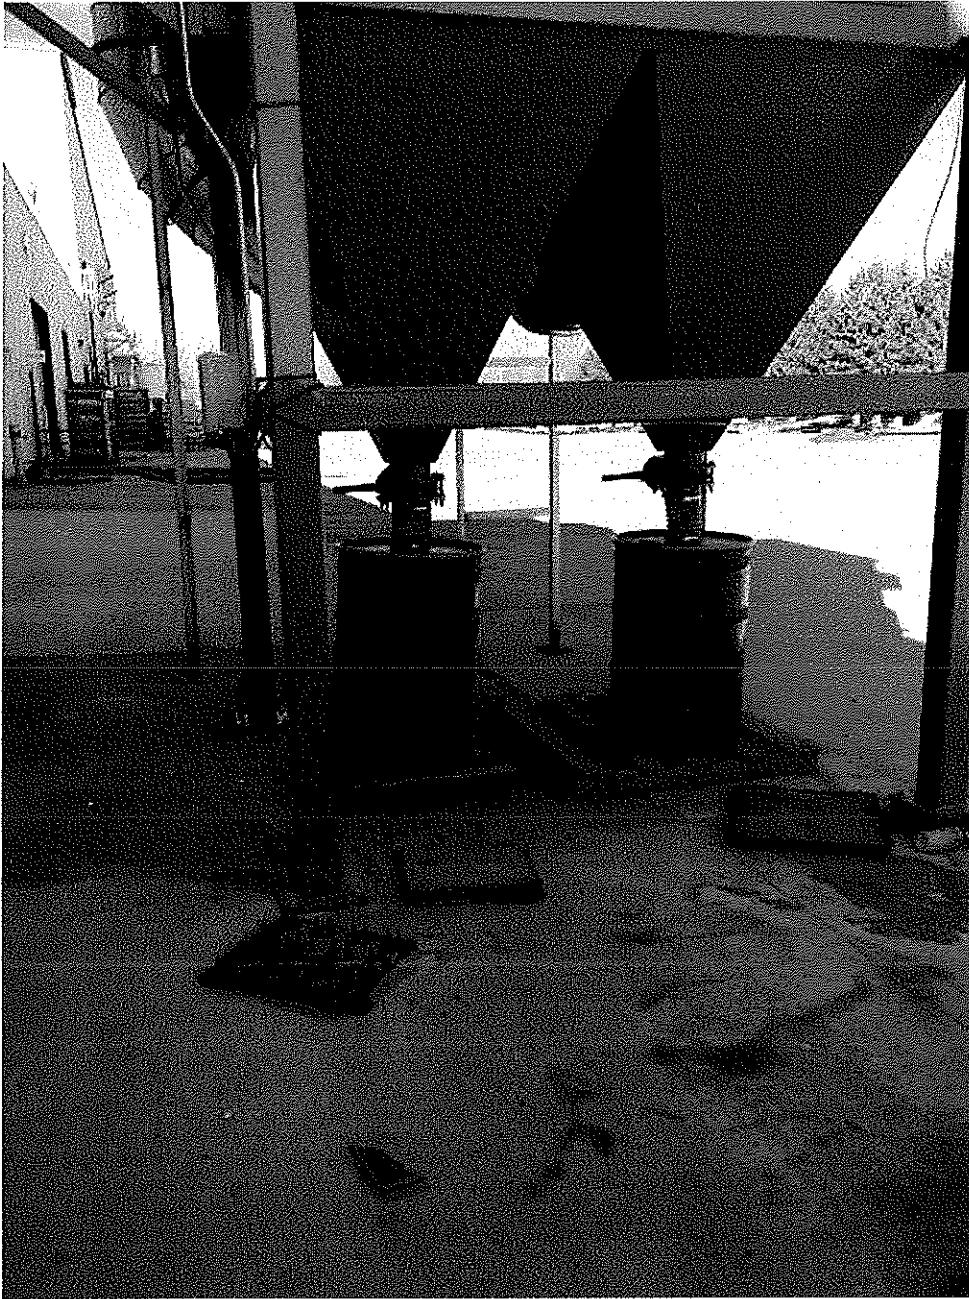
We went outside and found that the waste sand blasting media was on the ground underneath the baghouse and surrounding the roll-off Billy's waste bin. Additionally, the waste sand blasting media in the Billy's waste bin was exposed to the outdoor air and above the fill line on the bin (see attached photos).

J. Willoughby said the particulate spillage is caused by transfer or media from the 2 55-gallon collection bins to the Billy's waste bin, and specified that the spillage we saw during the inspection was because Merrill staff had not cleaned it up yet. He also said that during the winter they do not clean up spillage. I reminded him that this should be cleaned up immediately and at all times and recommended that a program for housekeeping be implemented to ensure particulate is being captured according to good air pollution control practices. He said that such a program would be implemented.

Image 2(Sand Blast Baghouses) : Note the waste particulate from sand blasting on the ground: both the sand blast media itself and the particulate removed from metal parts

I informed J. Willoughby that the waste sand blasting media and other particulate from the blast process needs to be swept up to ensure it is not being entrained into the ambient air. Additionally, I mentioned that there should be a lid on the Billy's waste bin to prevent entrainment into the ambient air.

J. Willoughby made a verbal commitment to have the particulate and associated waste blast media removed from the ground and disposed of properly, in addition to putting a lid on the Billy's waste bin. I requested that he send me pictures when these items have been fixed. As of 4/3/18 I have not heard from him and will proceed to issue a VN if cleanup has not been conducted by 4/4/18.

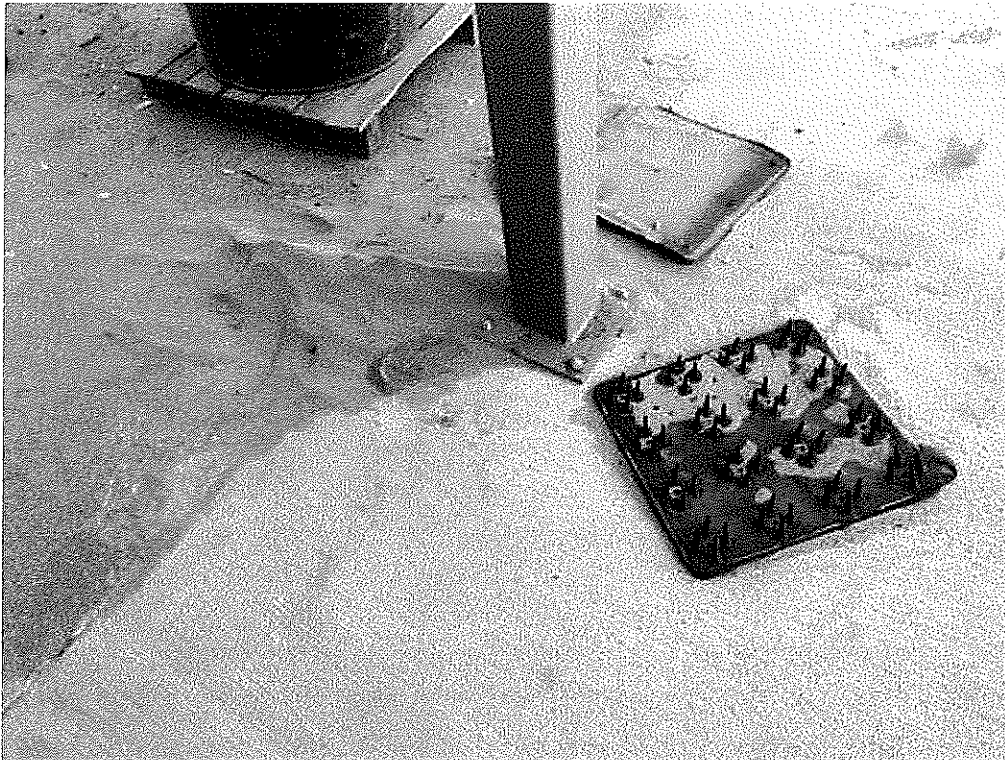
Image 3(Shot Blast media) : Close-up view of sand blast media (pink) and metal particulate (gray)

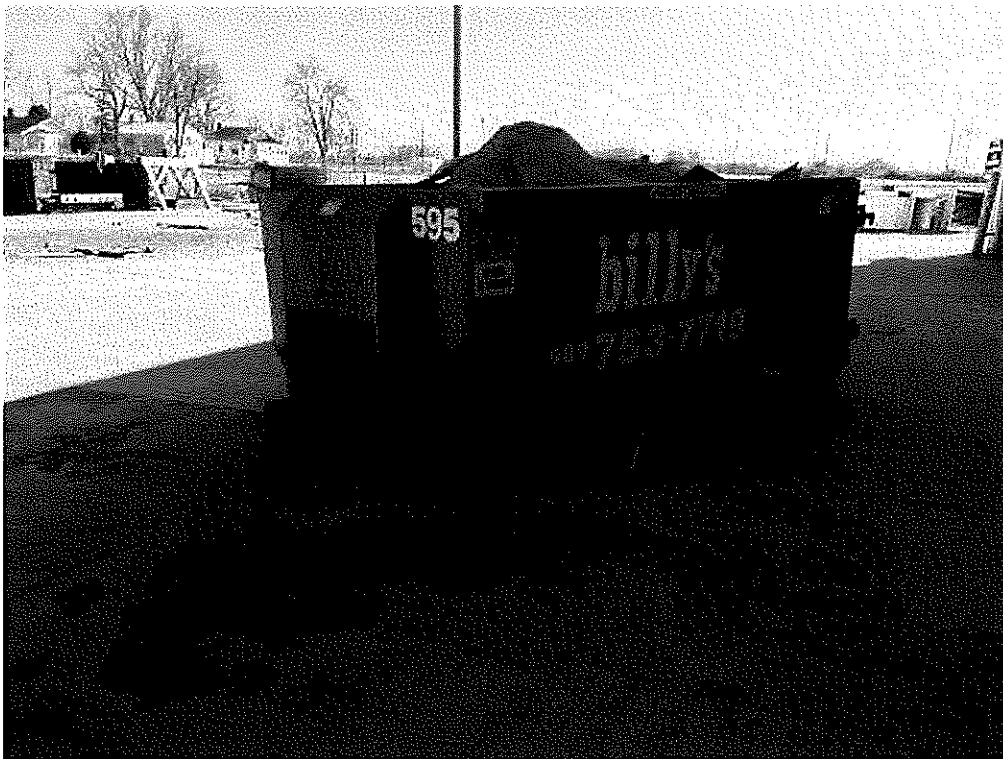
Image 4(Waste bin) : Billy's waste bin uncovered/open to atmosphere with particulate (sand blast media and waste metal particulate) on the ground surrounding the bin.
