DEPARTMENT OF ENVIRONMENTAL QUALITY AIR QUALITY DIVISION ACTIVITY REPORT: Scheduled Inspection

FACILITY: Forterra Brick, LLC		SRN / ID: A6497	
LOCATION: 3820 E. Serr Rd., C	CORUNNA	DISTRICT: Lansing	
CITY: CORUNNA		COUNTY: SHIAWASSEE	
CONTACT: Jerry Greger, Supe	rvisor	ACTIVITY DATE: 05/15/2017	
STAFF: Michelle Luplow	COMPLIANCE STATUS: Compliance	SOURCE CLASS: MAJOR	
	nced inspection to determine compliance with Merid	ian Brick's ROP, MI-ROP-A6497-2015.	
RESOLVED COMPLAINTS:	······································

Purpose: Conduct an unannounced, scheduled, partial compliance evaluation (PCE) inspection by determining compliance with Meridian Brick's ROP, MI-ROP-A6497-2015. This activity was done as part of a full compliance evaluation (FCE).

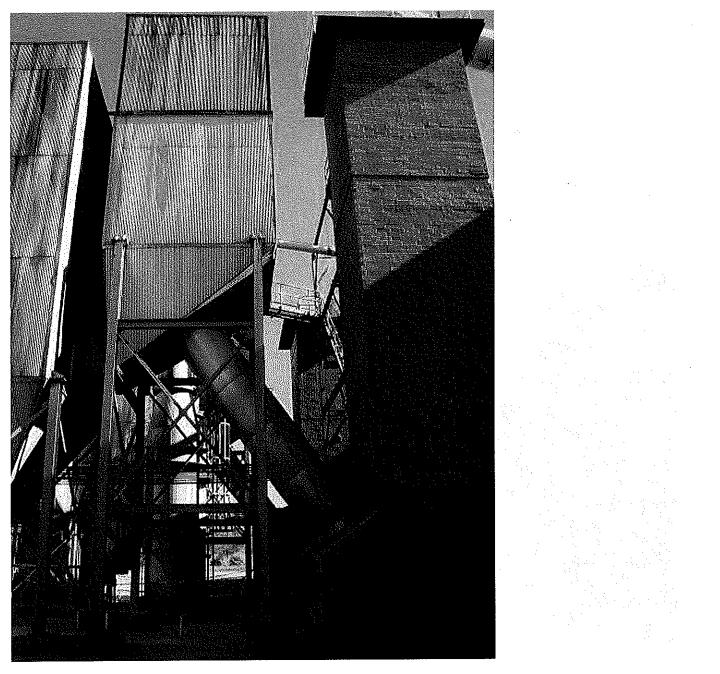
Image 2(Cooling Tunnel) : (Center structure). Lime-laden exhaust air sent to cooling tunnel to be cooled prior to entering baghouse.

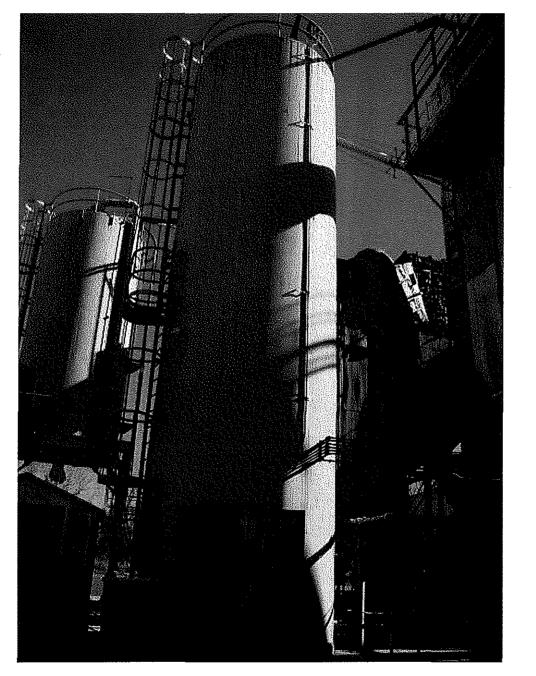
Image 4(Lime Feed Tower) : Lime is stored and transferred from this location into exhaust stream via piping.

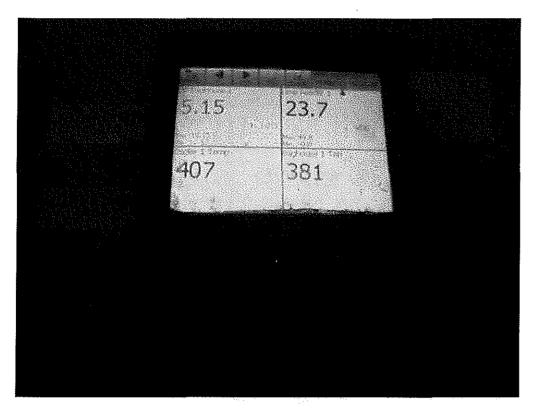
B. Stevens showed me the digital continuous monitor readout screens which contain baghouse pressure drop, baghouse temperature, lime feed rate, and cooling tower temperatures for both kiln systems (see attached photo). Additionally, the data from these continuous monitors can be uploaded to a computer (see attached photo). Prior to the digital monitors, Meridian had strip chart recorders to record the data. Meridian Brick is meeting all Design/Equipment Parameter requirements at this time.

Image 5(Continuous Monitors) : Monitors that continuously monitor pressure drop, lime feed rate, baghouse temperature and cooling tower temperature. High limits are posted near monitor.

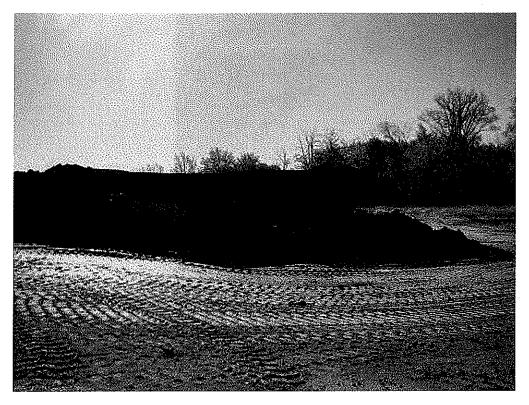
Storage piles must generate no more than 5% opacity. I saw no opacity generated from the storage piles during the inspection. J. Greger said that they've never had to water the storage piles because there is enough water in the material to keep the piles from releasing fugitive dust. I observed while onsite that the piles do appear to retain moisture, and fugitive dust is not released.

Image 7(Shale Storage Piles) : Mined shale storage piles. Note 0% opacity.

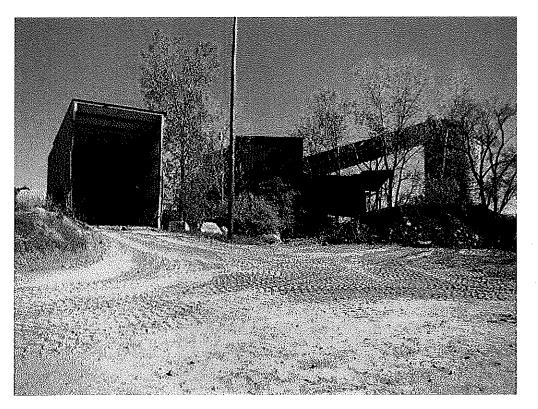
The primary crusher is located underground and the grinding plant feed belt is an enclosed conveyor located on the outside of the building. The secondary crusher is equipped with a baghouse which exhausts to the in-plant environment.

Image 8(Crushing structure) : Structure (left) is where loaders will dump mined shale into a pit which conveys shale to crusher underneath. Crushed shale is then sent to the crushing building
