DEPARTMENT OF ENVIRONMENTAL QUALITY
AIR QUALITY DIVISION
ACTIVITY REPORT: Off-site Inspection

FACILITY: Meridian Brick		SRN / ID: A6497
LOCATION: 3820 E. Serr Rd., CORUNNA		DISTRICT: Lansing
CITY: CORUNNA		COUNTY: SHIAWASSEE
CONTACT: Jerry Greger , Plant Manager		ACTIVITY DATE: 01/27/2021
STAFF: Michelle Luplow	COMPLIANCE STATUS: Non Compliance	SOURCE CLASS: MAJOR
SUBJECT: Virtual, announced compliance inspection to determine compliance with MI-ROP-A6497-2015 and PTI 170-18		
RESOLVED COMPLAINTS:

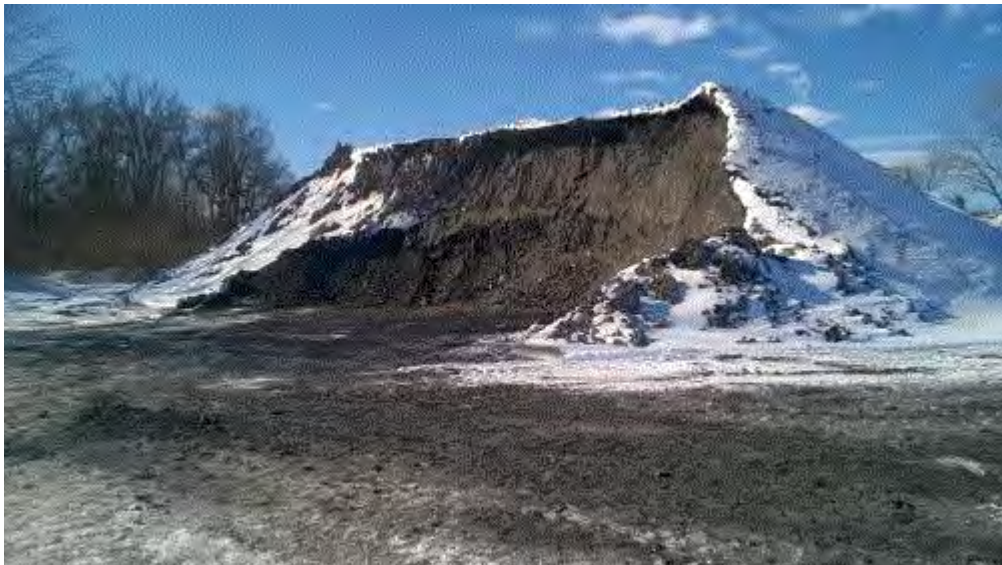
Image 1(Active Storage Pile) : Storage Pile that is being actively harvested during the inspection. No opacity/fugitive dust. Photo Credit: Bill Stevens, Meridian Brick

Stockpiling of all shale is to be performed to minimize drop distance and control potential dust problems and the storage piles shall be watered as needed to meet the opacity limit of 5%. Stockpiling of the nonmetallic minerals occurs behind the facility. I did not witness the process of stockpiling during the virtual site visit and therefore could not determine compliance with the requirement to conduct stockpiling with a minimum drop distance; however, the storage piles were covered with snow, and those piles being harvested for crushing appeared to be saturated with moisture; I saw no signs of fugitive dust from any of the storage piles during the inspection. **See attached photo.**

J. Greger said that they've never had to water the storage piles because there is enough water in the material to keep the piles from releasing fugitive dust.

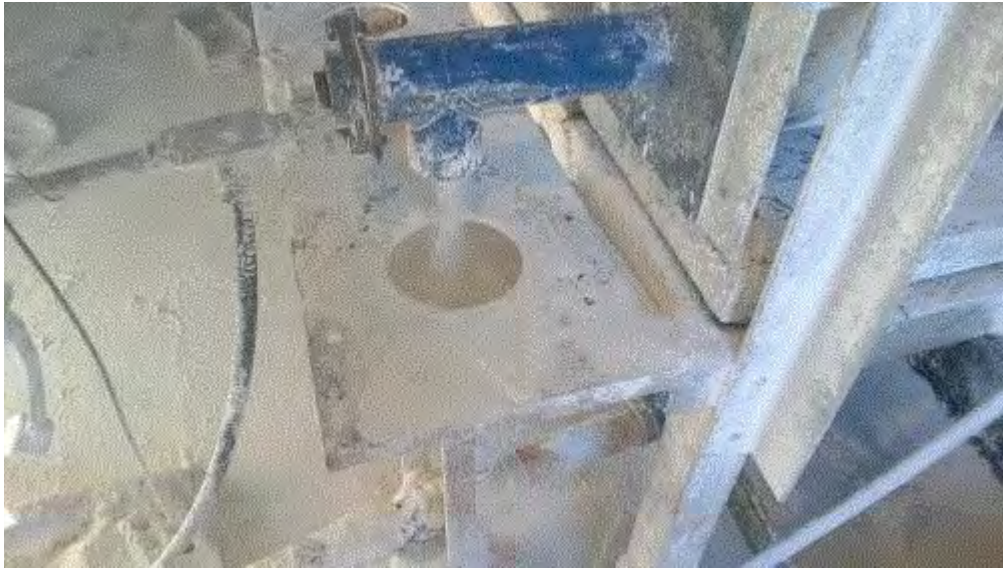
Image 2(Lime Feed) : Location where lime is collected from the process to determine lime feed rate. Photo Credit: Bill Stevens, Meridian Brick.

The lb/hr lime feed rate is typically correlated with a dial number on the lime feed rate monitoring system. For example, "40" on the lime feed rate monitor during the inspection would equate to 66 lb/hr. The feed rate is therefore monitored continuously; however it is not monitored in any type of units nor is it recorded continuously (every 15 minutes). To address these issues, I asked Meridian Brick to check the lime feed rate once every charge (approximately every 2 hours) and record this rate. By doing this, Meridian Brick ensures that the lime feed is maintained at the level that is required.

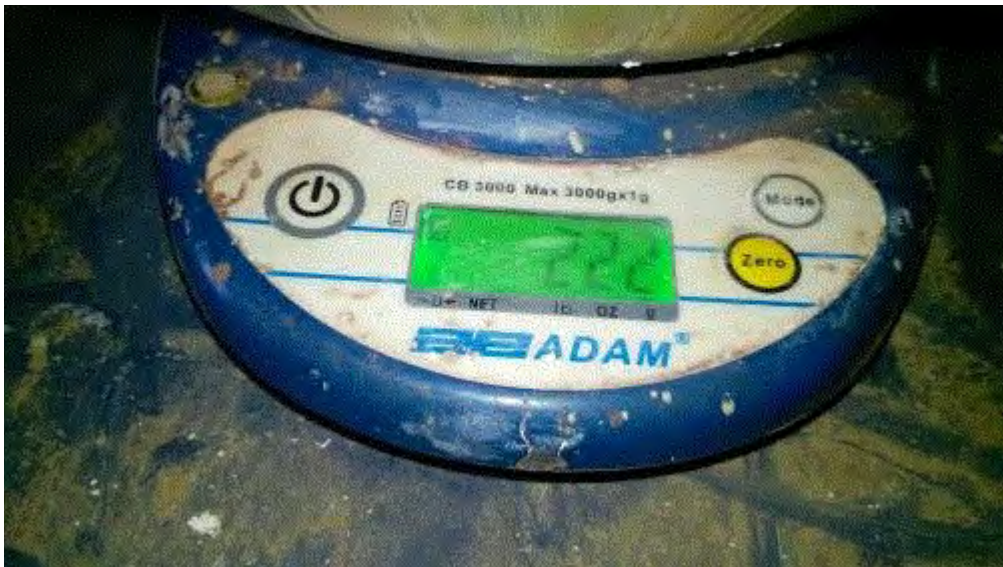
Image 3(30-sec Lime Weight) : After lime is collected, it is weighed. During the inspection, a 30-second collection of lime yielded 0.222 g. Photo Credit: Bill Stevens, Meridian Brick.

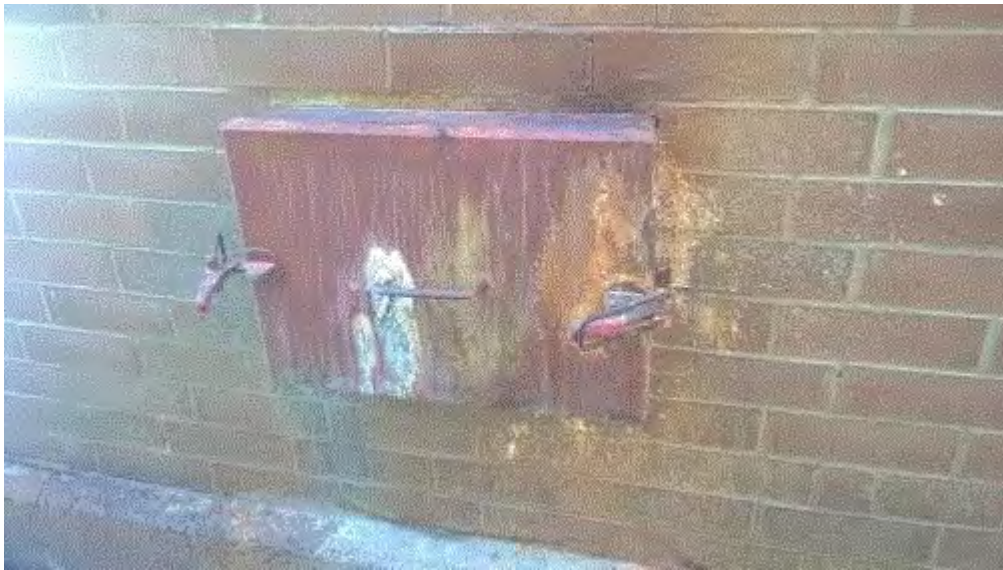
Image 4(Cooling Tower Door) : Cooling tower door (where ambient air is let into cooling tower to maintain a safe temperature for the baghouse). Closed during inspection. Photo Credit: Bill Stevens, Meridian Brick

During the June 2018 stack test, Tom Gasloli (TPU) and I observed that the small door on the side of the cooling tower tunnel was open halfway, which allows ambient air to flow through the cooling tower, into the baghouse, and out the stack. T. Gasloli and I discussed that this door should never be open greater than halfway at any time, as this would allow more air to flow through the stack and change emission rates. Maximum routine operations would therefore include keeping the door a maximum of halfway open. During the inspection the door was completely closed (I observed B. Stevens taking a photo of this for me during the virtual inspection and is attached), and therefore would be considered part of maximum routine conditions.
