DEPARTMENT OF ENVIRONMENTAL QUALITY
AIR QUALITY DIVISION
ACTIVITY REPORT: Scheduled Inspection

FACILITY: PIONEER FOUNDRY CO INC		SRN / ID: B1661
LOCATION: 606 WATER, JACKSON		DISTRICT: Jackson
CITY: JACKSON		COUNTY: JACKSON
CONTACT: Bob Lefere , President		ACTIVITY DATE: 11/22/2016
STAFF: Mike Kovalchick	COMPLIANCE STATUS: Non Compliance	SOURCE CLASS: MINOR
SUBJECT: Scheduled Inspection over a 2 day period.		
RESOLVED COMPLAINTS:

Opt-Out Source Inspection

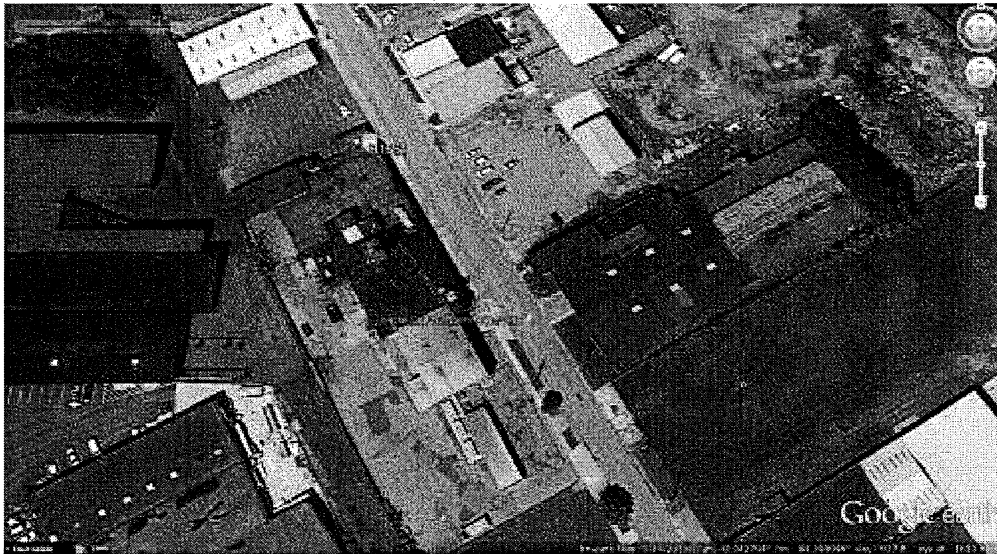
Image 1(Aerial photo) : Aerial photo

The facility is located in the city of Jackson. It is surrounded by commercial/industrial establishments on all sides. See attached photo.

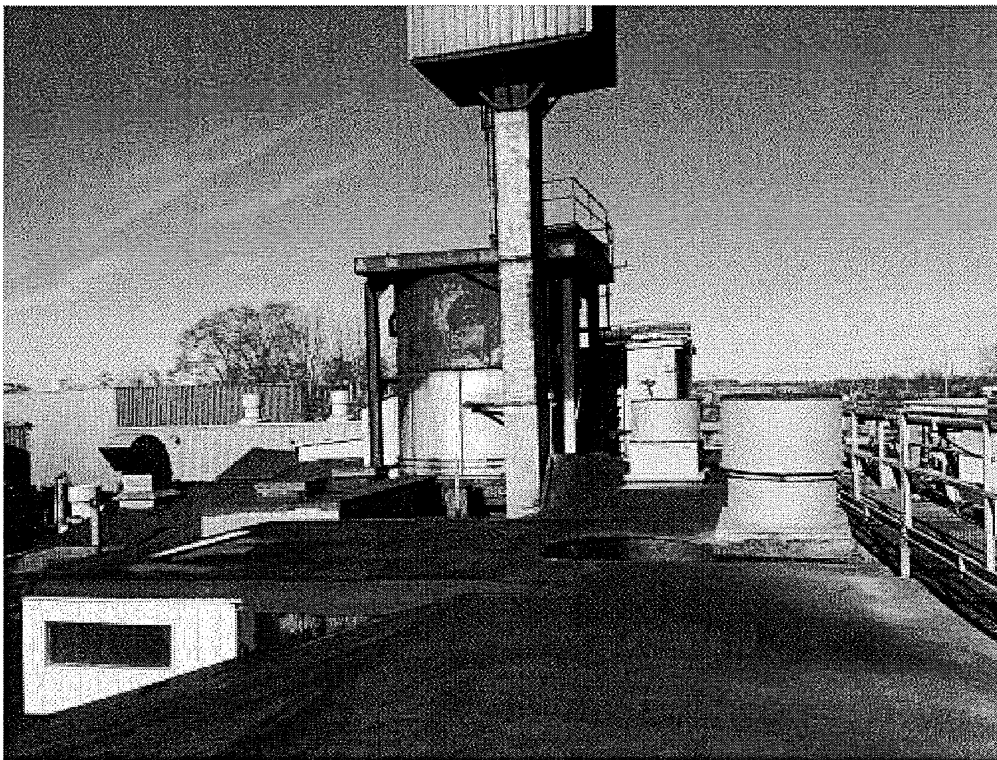
Image 2(Roof 1) : Roof 1

BL then produced a ladder and we went up on the roof. The roof and ventilation equipment appeared to be fair to good shape. Some of the roof gutters contained sandy fallout material although no recent fallout material was visible on the roof itself.

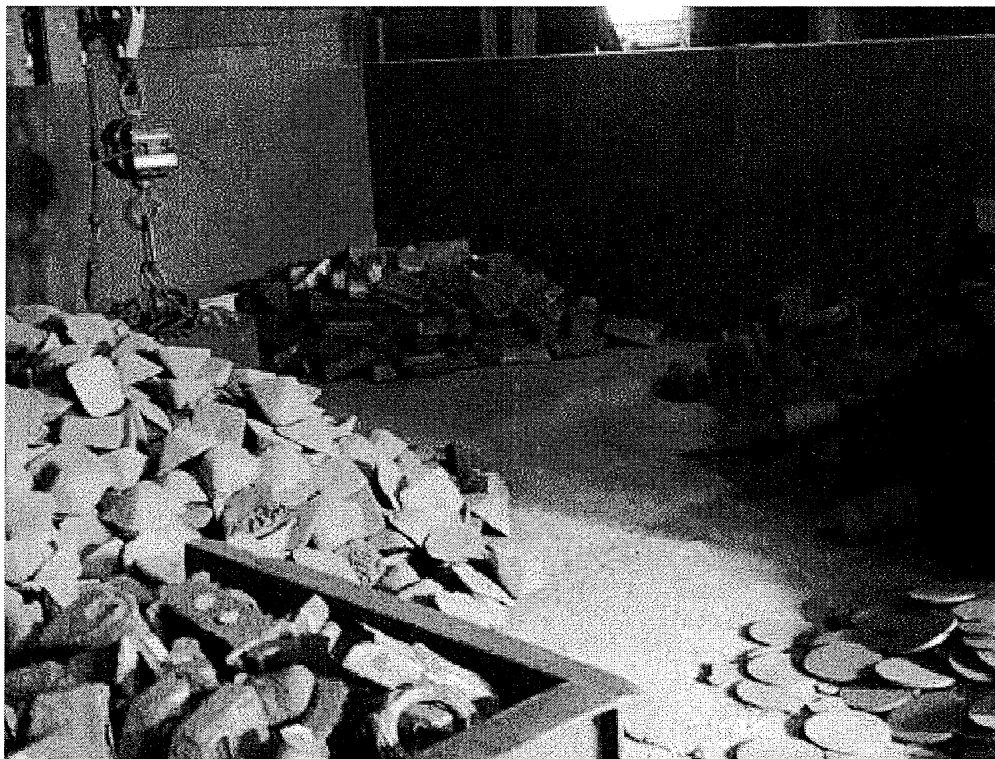
The scrap is obtained from nearby Omnisource. It appeared to be clean metal. BL reports that scrap comes originally from Eaton Rapids and passes through Omnisource and is very consistent in nature. See attached photo. They take some from each pile shown in the photo and add it to a metal bin/tray conveyor before being added to a 2500 degree F. electric induction furnace. (They measure the molten metal temperature with a hand-held probe.) The furnaces were not operating on the first day of the inspection. The furnaces have no hoods. On the ceiling directly above the furnaces are roof vents. There are 4 roof fans located in the same area of the roof above the furnaces that exhaust outside vertically to the roof. BL reports that smoke is generated for about a 20 minute period during the melting and also another 20 minutes when the molten metal is poured into approximately 5 or 6 molds. BL reported that smoke is almost completely dissipated prior to reaching the roof vents. The metal is poured in the same room as where the furnaces are located but at some distance so any smoke that is generated goes out through different roof vents. A ladle is moved by a hoist to pour in each mold. Several of the molds were being prepped for tomorrow's melt during the inspection. Directly next to where the molds are poured is a shake-out operation. After cooling for at least ten hours, the molds are set into the machine where it separates the metal from the sand molds. The machine recycles the sand through a storage tank system outside or on the roof of the facility. After the shake out operation, the molds are moved to a separate room and go through a shot blast machine to further clean the metal castings. The shot blast machine looked quite old and generally in poor condition. It is used for an hour every other day. The ventilation system to the baghouse collector that is located outside is turned on when the shot blast machine is in operation. BL reported that the room starts to get dusty if they don't turn on the ventilation. In the same room as the shot blast operation, workers grind any remaining irregularities to the castings after coming out of the shot blast using hand held grinders. The metal castings sit on the floor during this process. It takes approximately 15 minutes to 2 hours to grind clean each metal casting. This operation was active during the inspection. 2 workers were using grinders. No visible particulate emissions could be seen but the room was noticeable dusty as there was no dedicated exhaust system for this operation. (During the Summer months, a large door is left open immediately adjacent to the grinding allowing particulate emission an easier way to escape.) After this step, the final product is ready to ship.

Image 6(Scrap Metal) : Scrap metal before being added to furnaces.

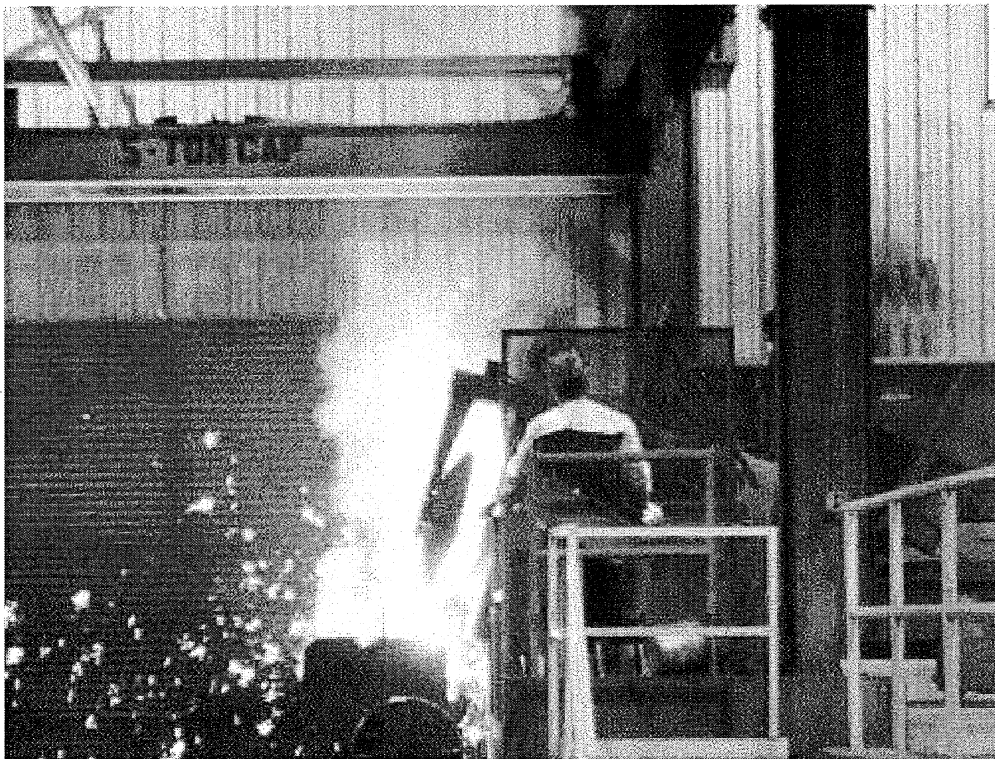
Next we observed the furnaces; one of which was being operated. The pivoting conveyor that charges the furnace had completed metal addition and lid was reapplied for a short time to allow the melt to complete. We then observed an operator place a bucket of inoculant into the bottom of the ladle and then observed the furnace being tipped/pouring the molten metal in the ladle. (See attached photos.) A considerable amount of smoke was being generated before the pouring started and especially during the pouring into the ladle. The smoke went straight up to the ceiling and exited the building via the 2 roof fans that were operating at the time. Just before the pouring occurred, we both went outside to across the street to see if any smoke was visible. No smoke was visible coming from the roof although the sky contrast was very poor. We then went back inside to observe the pouring. The higher amounts of smoke that were being generated during the pour only lasted about a minute. The opacity of the smoke near the ceiling was probably no more than 20% so it was assumed that smoke outside the building is probably even less especially if it was averaged over the required 6 minute averaging time. We then left the building and briefly discussed going forward in BL's office. I promised to follow-up with BL when compliance determinations had been made.

Image 8(Pouring) : Pouring from the furnace into a ladle.
