DEPARTMENT OF ENVIRONMENTAL QUALITY
AIR QUALITY DIVISION
ACTIVITY REPORT: Scheduled Inspection

FACILITY: Jackson Industrial Coating Services		SRN / ID: N0977
LOCATION: 3600 Scheele Drive, JACKSON		DISTRICT: Jackson
CITY: JACKSON		COUNTY: JACKSON
CONTACT: WH Hopkins , Vice President		ACTIVITY DATE: 11/16/2017
STAFF: Mike Kovalchick	COMPLIANCE STATUS: Non Compliance	SOURCE CLASS:
SUBJECT: Unannounced compliance inspection of a powder coating facility.		
RESOLVED COMPLAINTS:

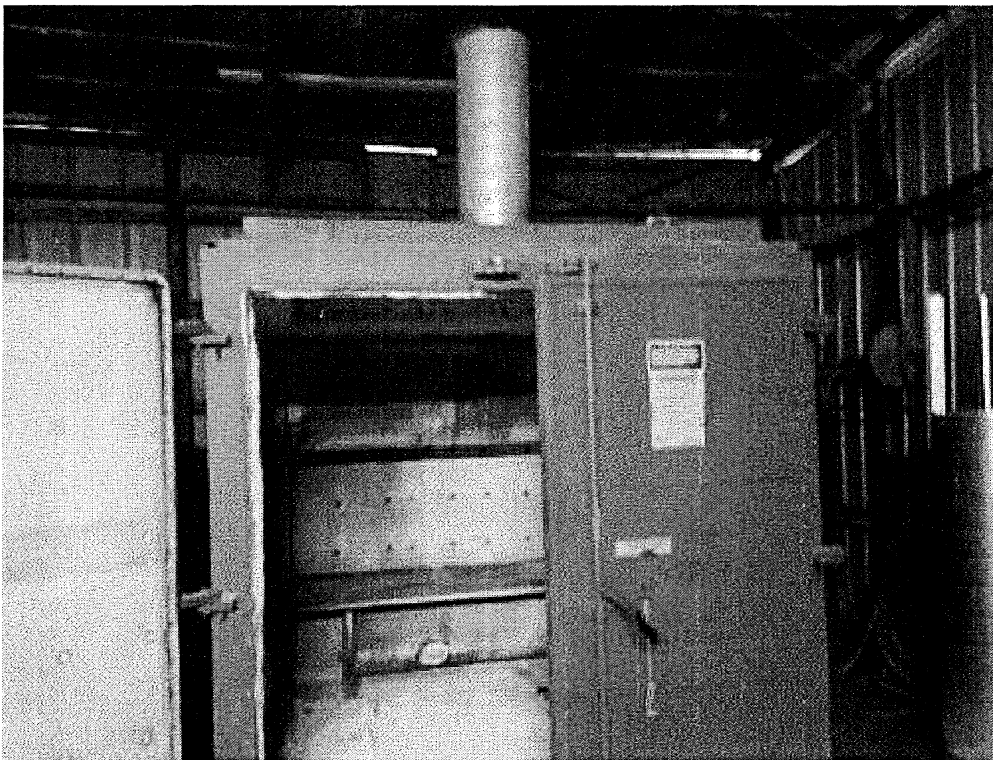
WH gave me a brief tour of the facility. He first showed me the burn off oven. (See attached photo.) It was not operating. The setpoints on the device showed that the oven is operated at 820 degrees F. and the afterburner was set for 1420 degrees F. There was no chart recorder. A check of the exhaust stack showed that it was at least twice as high as the building and had a rain cap. WH showed me a no-loss rain cap next the bake-off oven that had yet to be installed. WH indicated that when the bake oven is operated there is never any smoke. There is interlocked device of the oven/afterburner so they can only be operated at the same time. The BTU ratings of the oven/afterburner was not readily available.

Image 2(Burn-off oven) : Burn-off oven.

I held a brief post-inspection meeting with WH. I indicted to him that the burn off oven required a PTI permit. (Rule 290 is not applicable as the Company was not maintaining required records/emission calculations.) I suggested that he might be eligible for a general permit and I gave him instructions on where to find the appropriate forms online. To be eligible, he would need to install the no loss stack on the burn-off oven and install a chart recorder so that records could be kept on the afterburner temperature when the oven was in operation. I also noted that the open burning of wooden pallets was prohibited.

Rule 201-No permit to install for the bake-off oven.

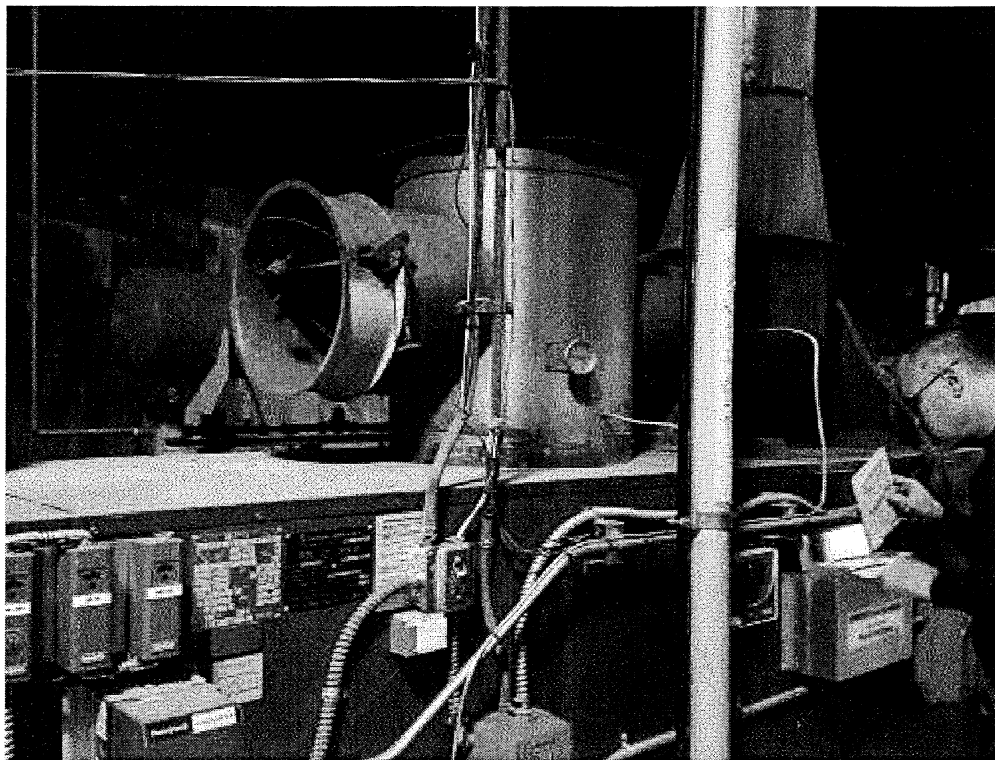
Next, he showed me the parts washer line. WH indicated they were half way through a project to refurbish the line. Adjacent to the parts washer line, was a new 4 mm BTU/hour boiler. See photos.

Image 3(New boiler) : New boiler.

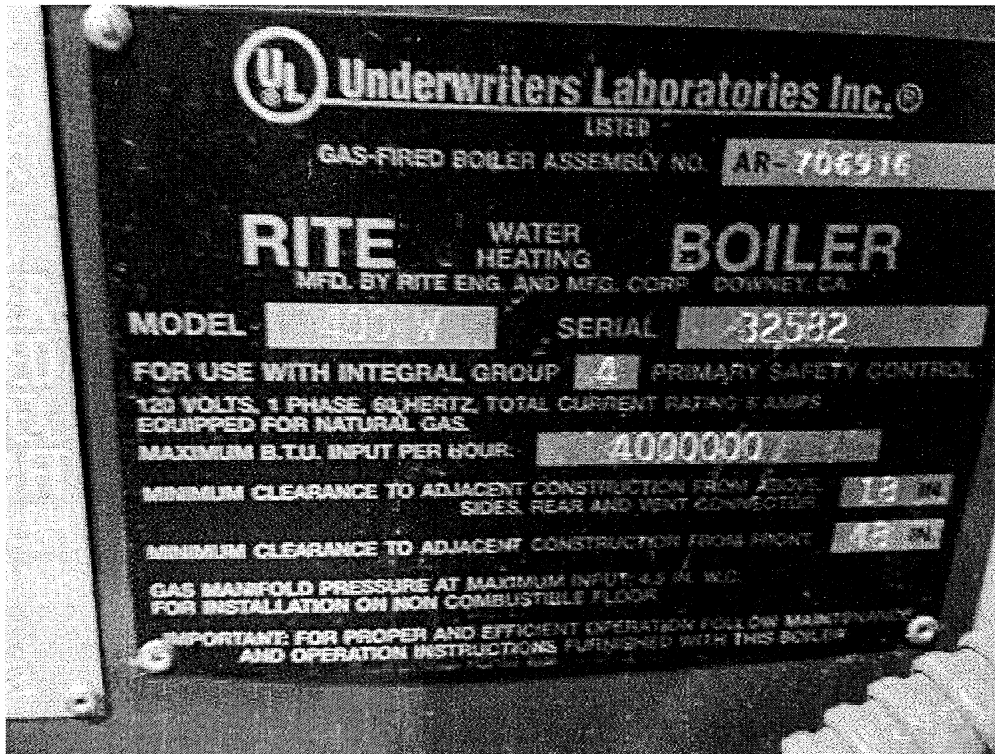
Image 4(Boiler specs) : Boiler specs.

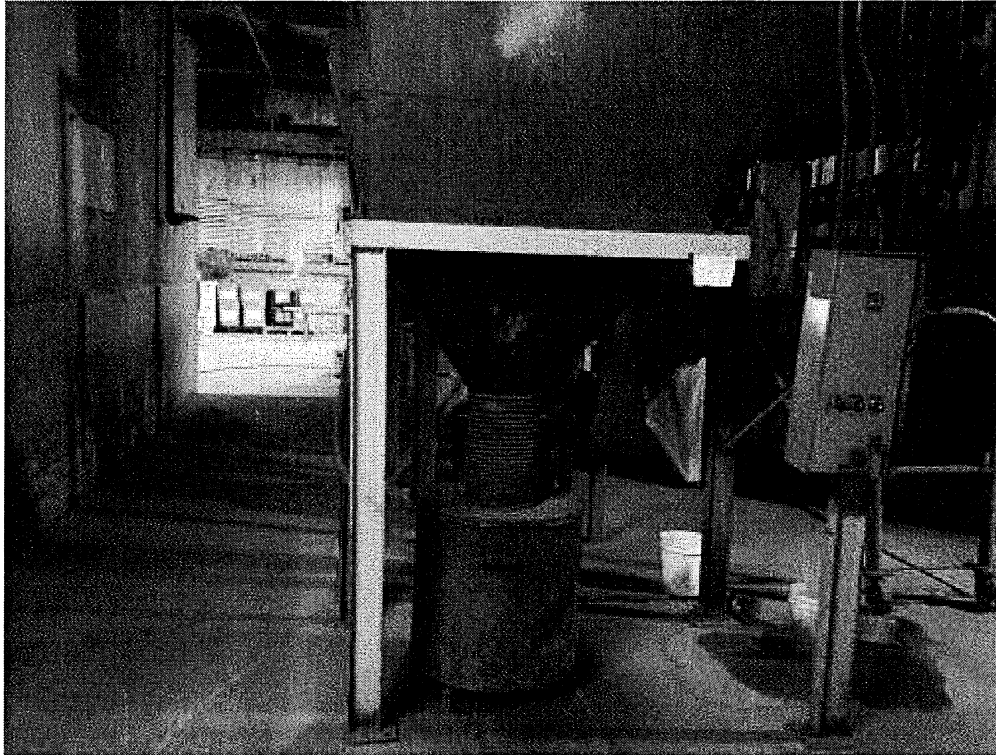
WH showed me the 2 ovens, the 2 powder coat booths and the cyclone/dust collector that is used to collect the excess particulate from the powder coating. (See attached photos.) The line was operating. The temperature of the curing oven was noted to be 410 degrees F.

Image 5(Cyclone) : Cyclone for powder booths.

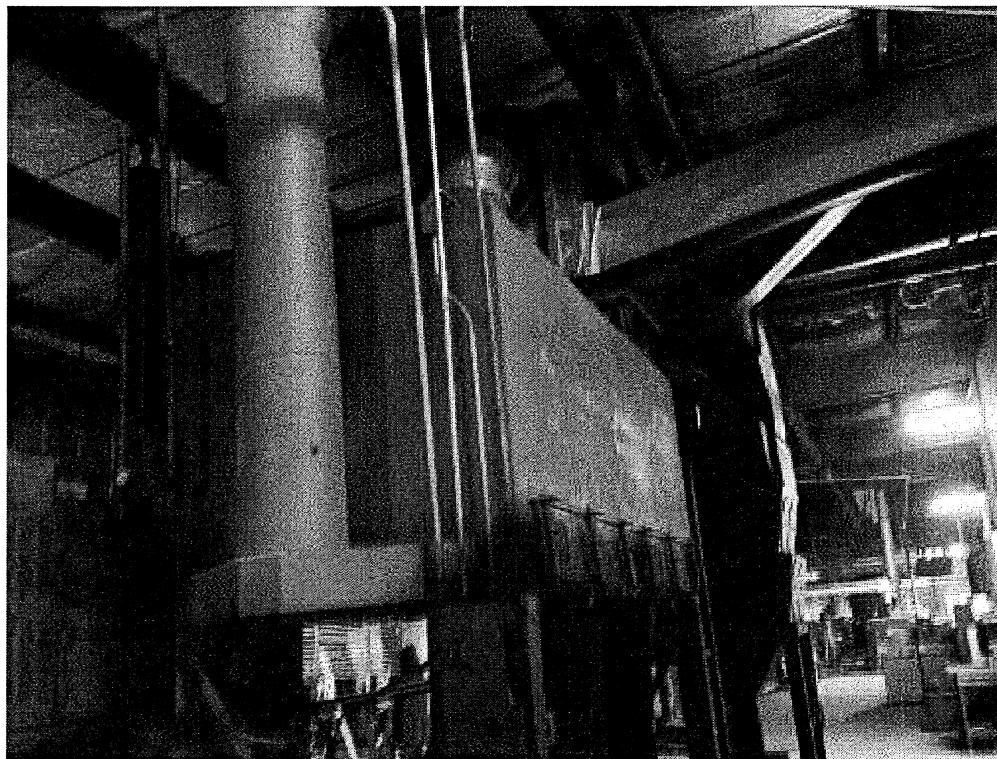
Image 6(Dust collector) : Dust collector for powder booths.

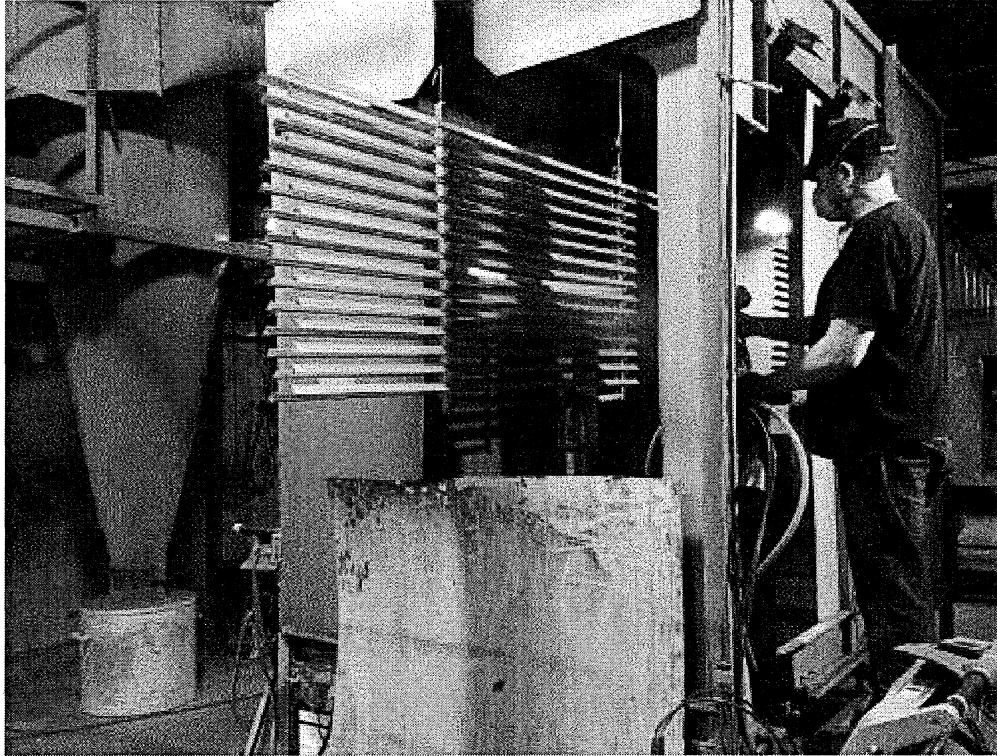
Image 7(Powder coat booths) : One of two powder coat booths.

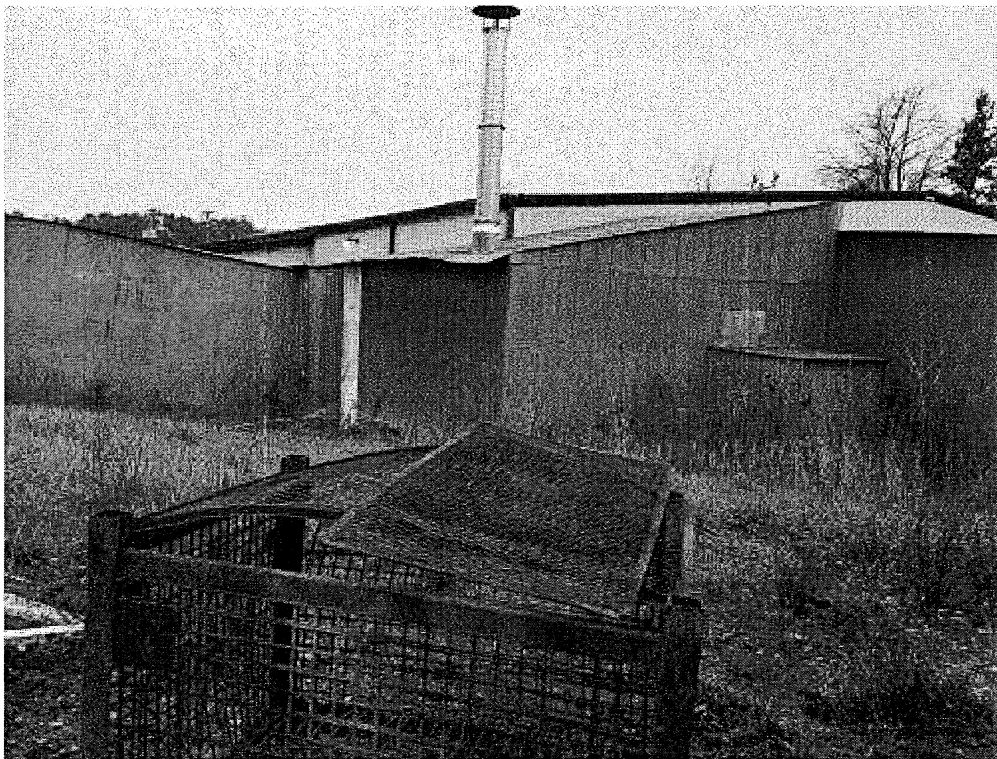
WH showed me the outside courtyard area on the North side of the facility. I noted a metal cage like structure that contained ash. WH indicated to me that they burn used pallets. (See attached photo.)

Image 8(Metal cage) : Metal cage used to burn wooden pallets. In the background is the stack for the burn-off

oven.

Rule 310-Open Burning
