**DEPARTMENT OF ENVIRONMENTAL QUALITY
AIR QUALITY DIVISION
ACTIVITY REPORT: Self Initiated Inspection**

N166236702

FACILITY: KIRCHHOFF Van-Rob Tecumseh		SRN / ID: N1662
LOCATION: 1200 E. Chicago Blvd., TECUMSEH		DISTRICT: Jackson
CITY: TECUMSEH		COUNTY: LENAWEE
CONTACT: Kenneth Gummow , EHS Administrator		ACTIVITY DATE: 09/20/2016
STAFF: Mike Kovalchick	COMPLIANCE STATUS: Unknown	SOURCE CLASS: MINOR
SUBJECT: To inspect facility due to aerial photos that showed recent stack additions on facility's roof along with associated roof discolorations adjacent to the new stacks.		
RESOLVED COMPLAINTS:

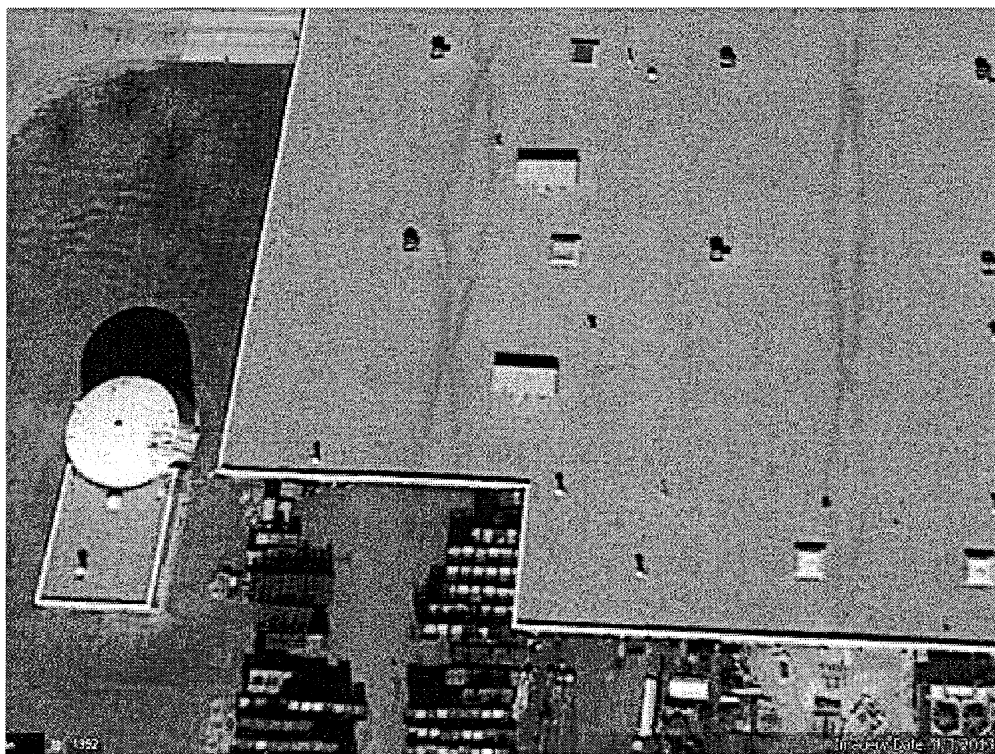
Prior to the inspection, aerial photographs of the roof of the facility was reviewed. A Google Earth photo taken 4-3-2013 (Attachment 1) was compared to a 7-14-2015 photo. (Attachment 2) The more recent photo showed that additional stacks have been added to the SW corner of the facility with roof discoloration present adjacent to the new stacks. No other changes were noted.

Image 1(4-3-2013 Roof Photo) : Attachment (1) Roof aerial photo taken from Google Earth dated 4-3-2013

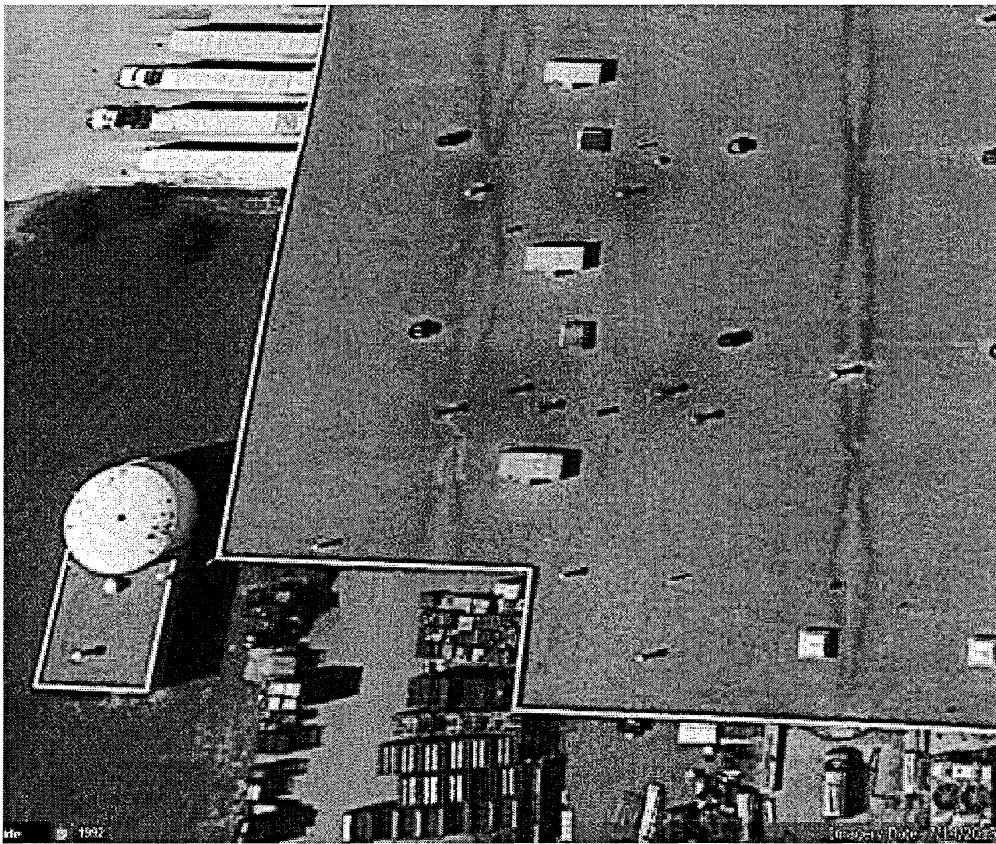
Image 2(7-14-2015 Roof photo) : Attachment (2) Roof photo from Google Earth taken 7-14-2015 showing additional stacks and roof discoloration. (Easiest to see in color version of photo.)

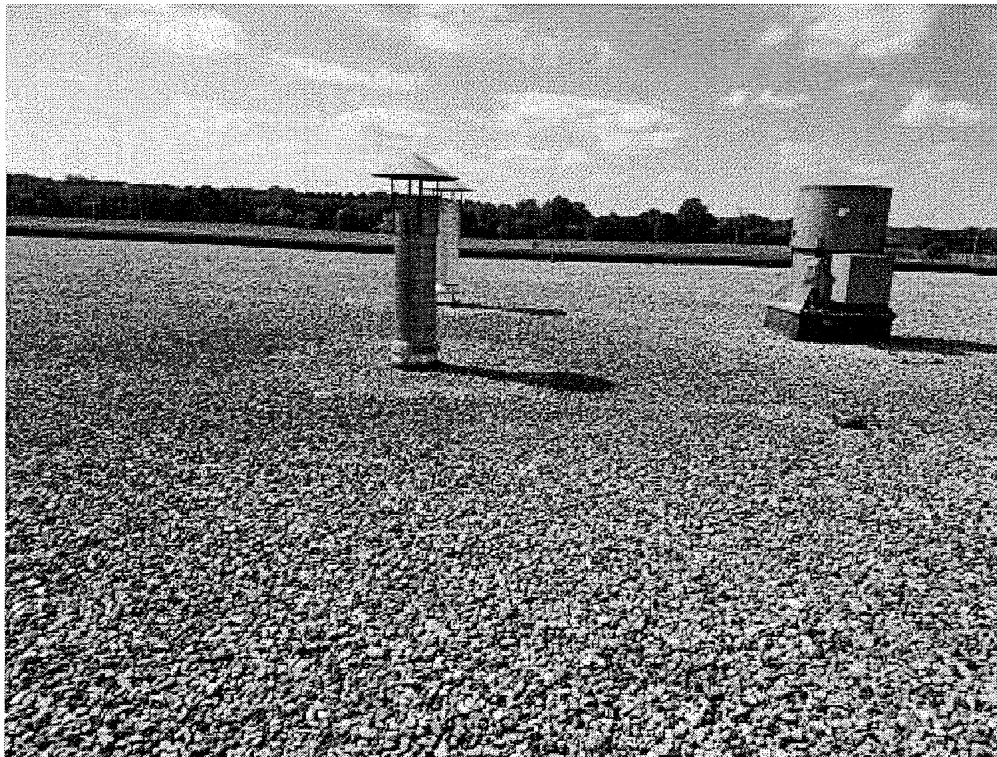
An inspection of the roof was conducted. (See Photo/Attachment 6.) On the SW side of the facility, several newer stacks were evident that were surrounded by discolored roof gravel and at least one of the stacks was discolored/corroded as well. What caused the roof gravel discoloration was unknown but emissions from those stacks appeared to be coming from laser welding booths.

Image 3(Roof Discoloration): Attachment (6) Several relatively news stacks with rain caps were noted that were ducting emissions from laser cutting booths. Roof gravel and stack were discolored for unknown reason; either from an acidic emission or particulate emission.
