DEPARTMENT OF ENVIRONMENTAL QUALITY
AIR QUALITY DIVISION
ACTIVITY REPORT: Scheduled Inspection

N170329106

FACILITY: Superior Vault Company		SRN / ID: N1703
LOCATION: 345 East Mahoney Street, MERRILL		DISTRICT: Saginaw Bay
CITY: MERRILL		COUNTY: SAGINAW
CONTACT: Howard Crevia , Owner		ACTIVITY DATE: 04/08/2015
STAFF: Gina McCann	COMPLIANCE STATUS: Non Compliance	SOURCE CLASS: MINOR
SUBJECT: Inspection of 2 permitted (263-05 and 244-02) human crematories. glm		
RESOLVED COMPLAINTS:

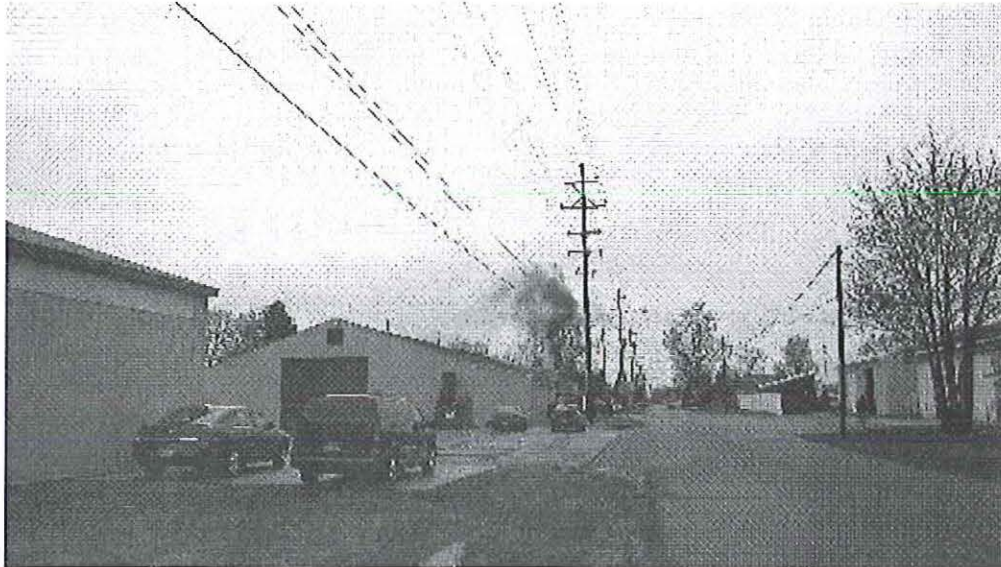
As I approached the facility from the East on M-46 I could see a plume of black smoke drifting through the residential area. Weather conditions are noted on the observation sheet. I parked and performed a Method 9 observation, see *attached*. The highest 6-minute average was 87% opacity, see *attached*. A violation is being sent citing R336.1301.

Image 1(View from McBride) : Overview of opacity from McBride Street which is East of the facility. The furthest stack or Unit #2 was the stack exhibiting opacity. glm

The violation notice will be sent citing R301 and R910. An adequate response should include prevention of the violations reoccurring.

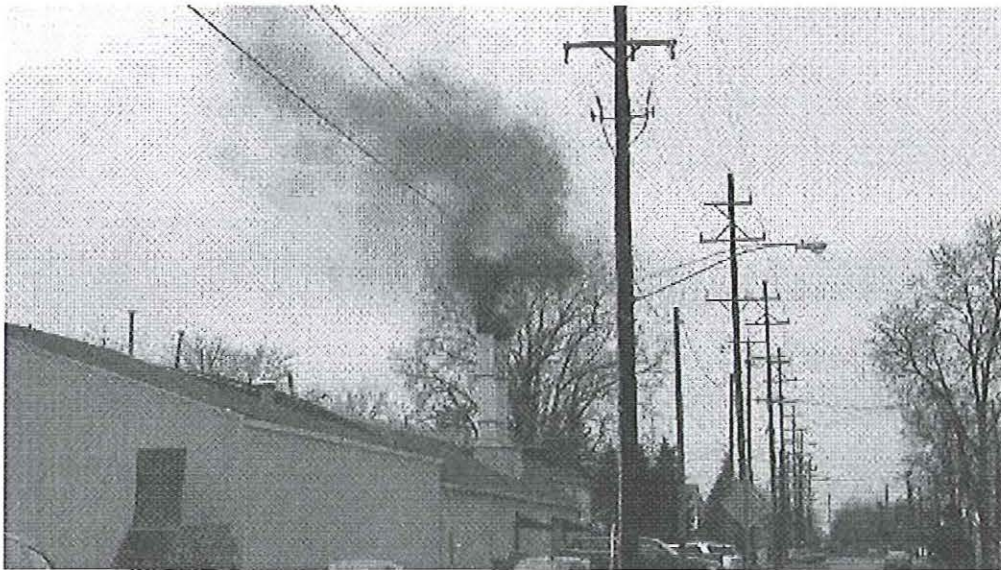
Technician error was the suspected cause of the opacity. Per the manufacturer's recommendation, larger remains should be loaded anterior end first. The burner used to ignite the container and the remains is near the charge door. Positioning the remains posterior end closest to the burner assists in controlling the process. The technician had not placed the remains anterior end first and also had the hearth, or primary chamber, air open. The excess hearth air was feeding the process faster than the permitted retention time in the secondary chamber, or afterburner, therefore adding to the excess opacity. A violation for R336.1910 will also be sent for improper operation of the control device.

Image 2(Looking West) : Opacity from Unit #2. Observer standing East of the facility. Time taken 10:06. glm

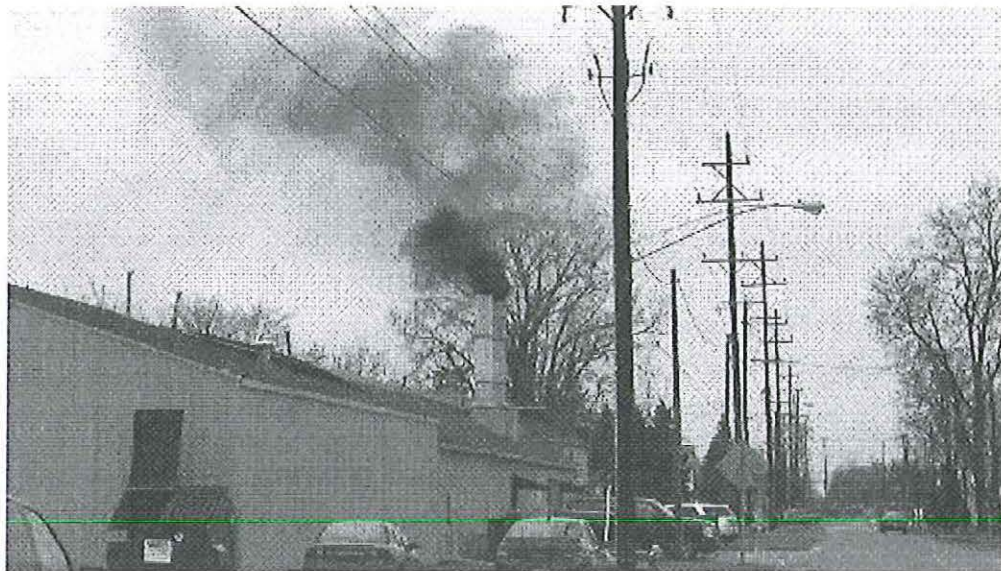
Image 3(Looking West 2) : Additional picture of opacity on Unit #2, looking West towards the facility. Time taken 10:06. glm
