DEPARTMENT OF ENVIRONMENTAL QUALITY
AIR QUALITY DIVISION
ACTIVITY REPORT: Scheduled Inspection

FACILITY: Cretens Brothers Waterbeds, Inc		SRN / ID: N5116
LOCATION: 5954 Perkins 305 Road, PERKINS		DISTRICT: Upper Peninsula
CITY: PERKINS		COUNTY: DELTA
CONTACT: Mathew Cretens , President		ACTIVITY DATE: 01/11/2016
STAFF: Joe Scanlan	COMPLIANCE STATUS: Compliance	SOURCE CLASS: MINOR
SUBJECT: Unannounced scheduled inspection to determine compliance with PTI# 1327-91		
RESOLVED COMPLAINTS:

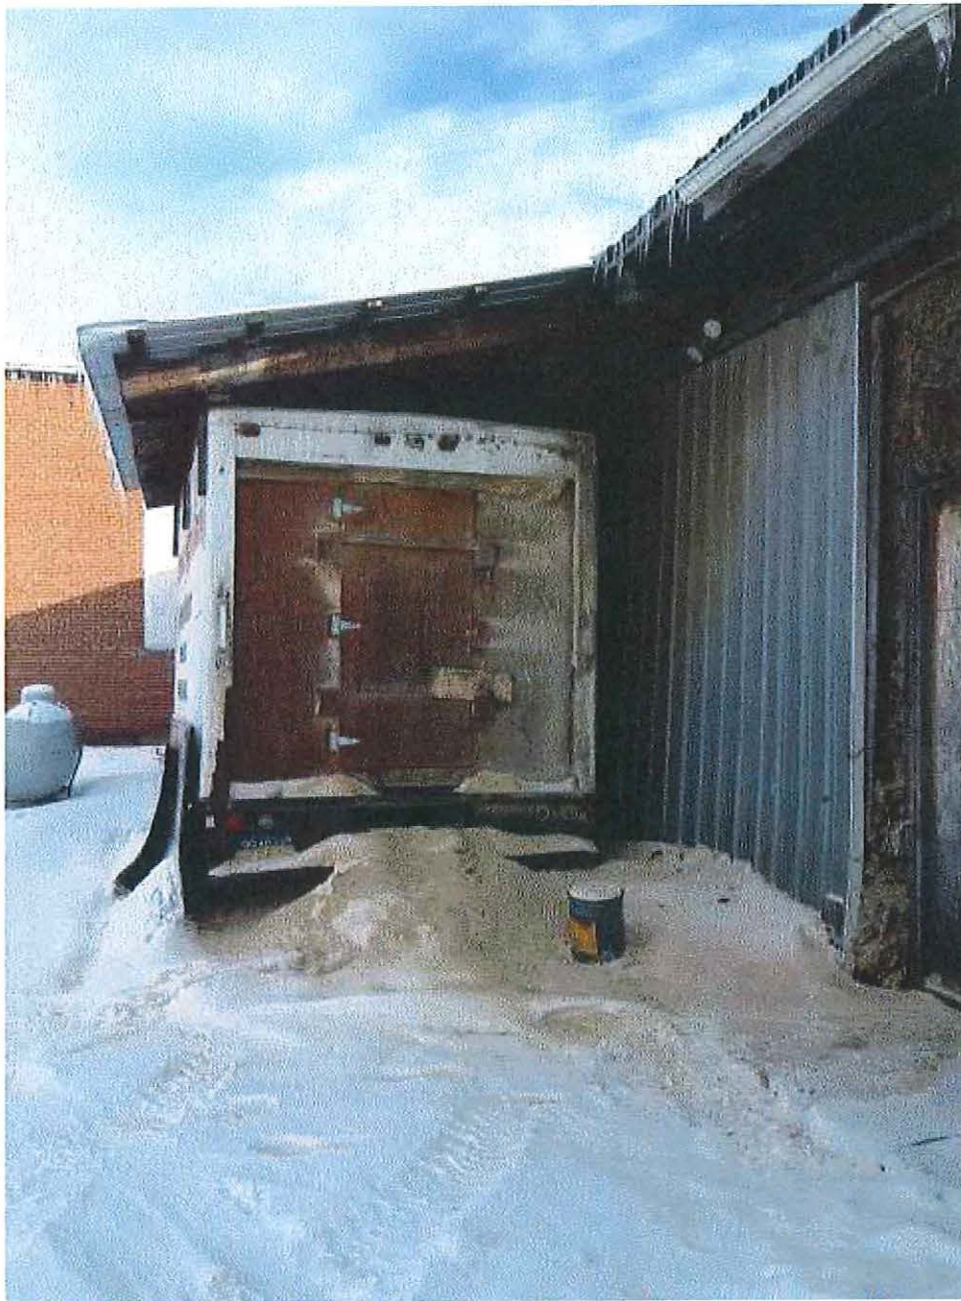
truck cargo box outside (chip bin), where it is stored until further use. The collection system is then ducted from the chip bin back inside the production area and into a bag-type filter which captures leftover fines.

Image 1(CF6) : Chip bin for wood waste

The wood waste handling system appears to meet the applicable requirements set forth in Special Conditions #'s 15 through 20. In regards to Special Condition #21, permittee needs to maintain better housekeeping where the wood waste is removed from the chip bin outside; with certain dry, windy conditions in the summer months the excessive amount of sawdust on the ground can become airborne fugitive dust. This is an easily correctable situation.

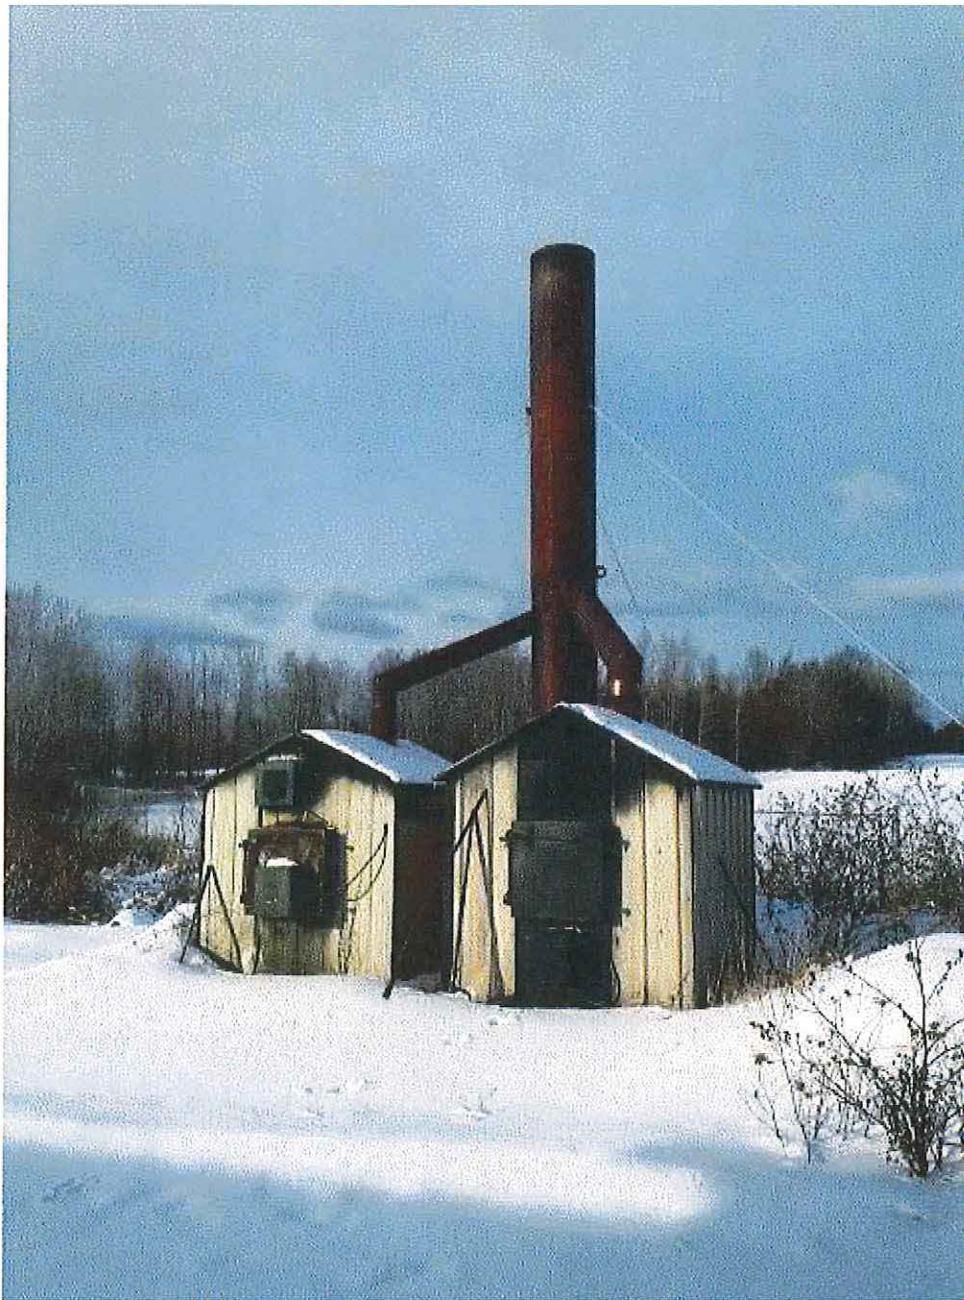
Image 2(CF7) : Retired hydronic heaters

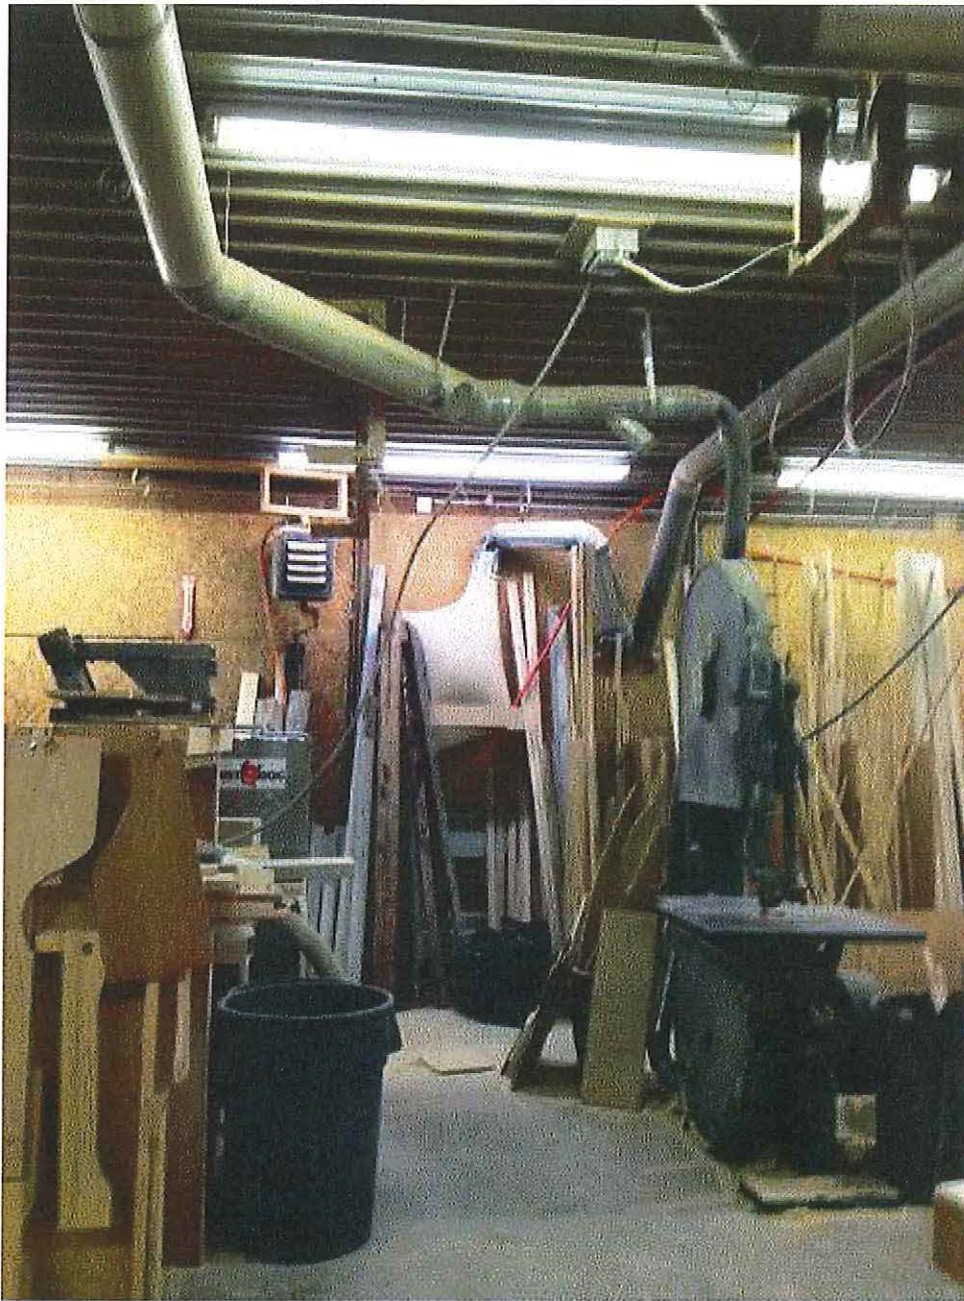
On 11/06/2015 I conducted an unscheduled visit of Cretens Furniture. PPE worn during this inspection included steel-toed boots. I met Cretens Furniture's president, Mr. Matthew Cretens, upon first arrival at the facility. Mr. Cretens provided me with a tour through the production area and allowed me a visual inspection of the wood waste collection system (wood chip handling system), which appeared to be operating efficiently. The wood waste collection system is pneumatically powered (negative pressure) and the main duct is mounted overhead with smaller collection ducts connecting to the various pieces of production equipment in the shop (i.e., bandsaw, jointer/planer, etc.). Wood waste is moved via the duct system from inside the shop to a fully-enclosed repurposed

Image 3(CF1) : Wood waste collection system

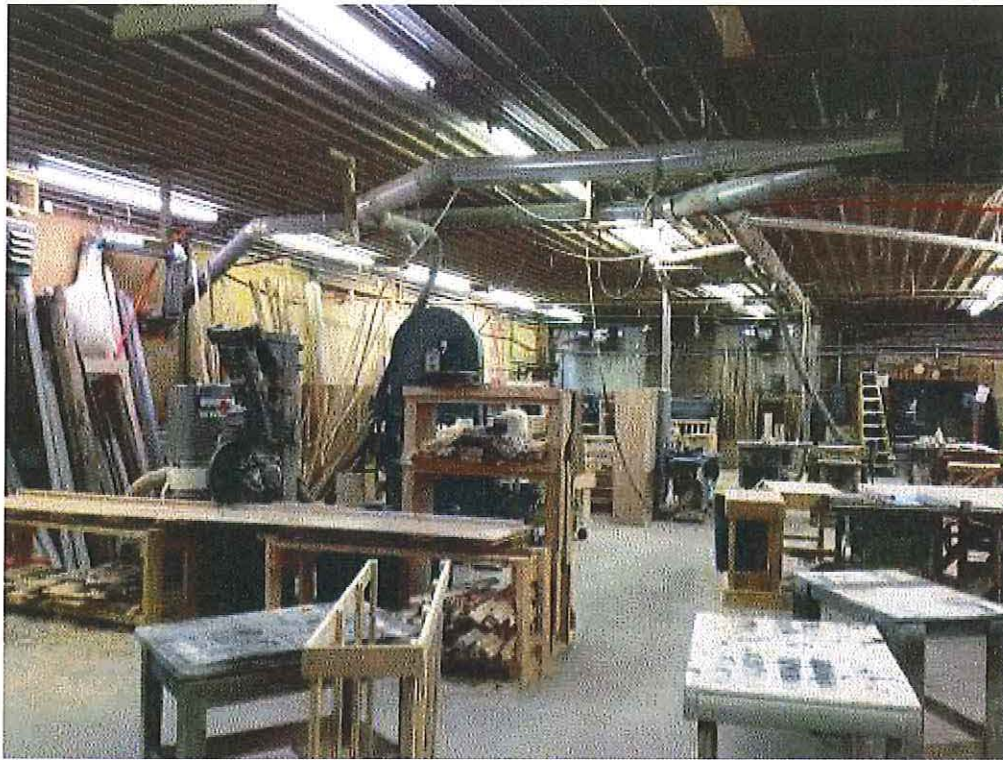
Image 4(CF2) : Wood waste collection system

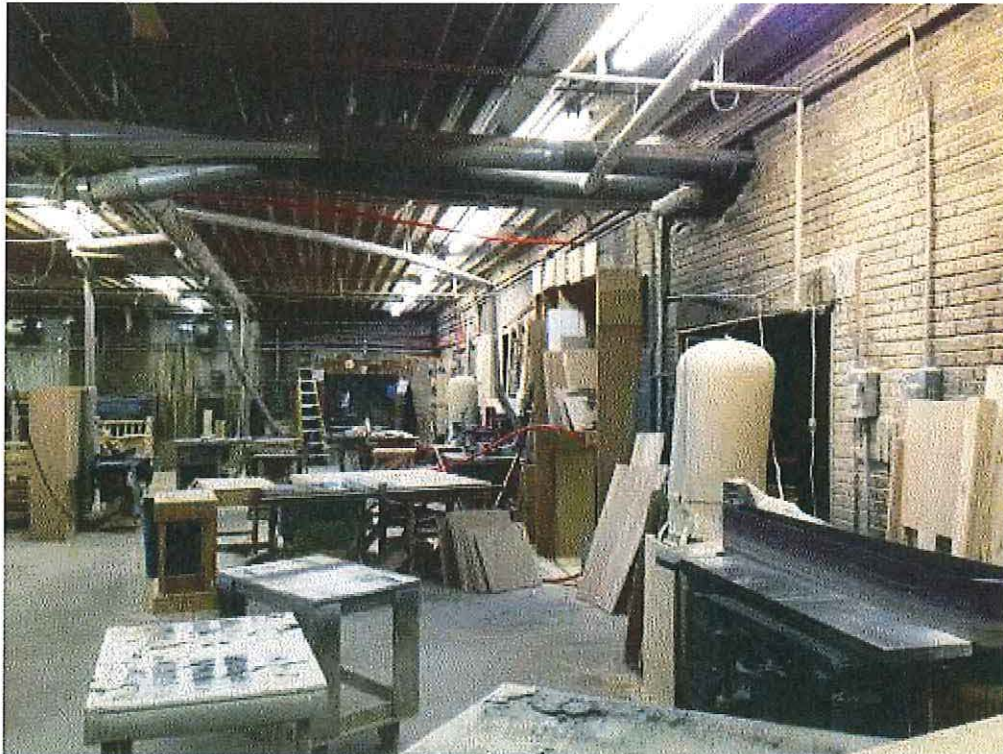
Image 5(CF3) : Wood waste collection system

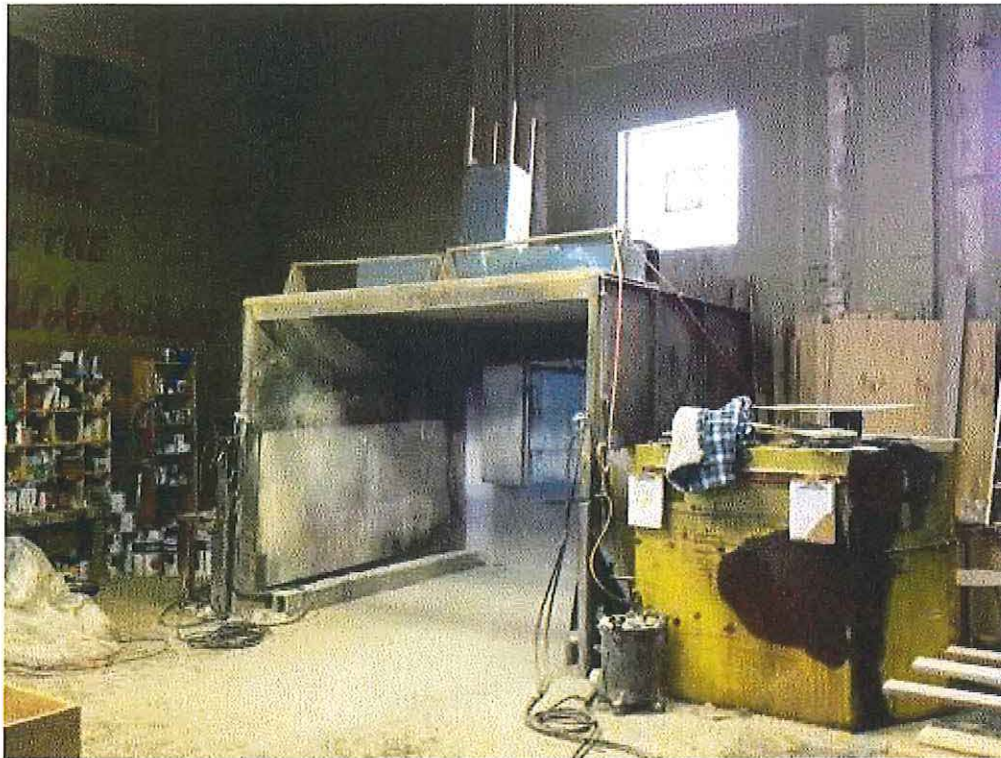
I also observed the stain spray booth, which was not in use at the time of inspection. The booth had filters in place which are maintained on a regular basis, as needed. Air from the booth exhaust is discharged into the building and not vented outside the facility.

Image 6(CF4) : Spray booth for stains & lacquers

To maintain their 287(c) exemption for the spray booth, permittee supplied AQD district staff with monthly purchase records for stain and/or solvent for 2014/15. Usages are not exceed 200 gal/month, however in October of 2015 there was an exceedance of 7.25 gallons (207.25 gallons total for October 2015). Permittee needs to be more aware of monthly usages; all other exemption requirements are being met adequately.

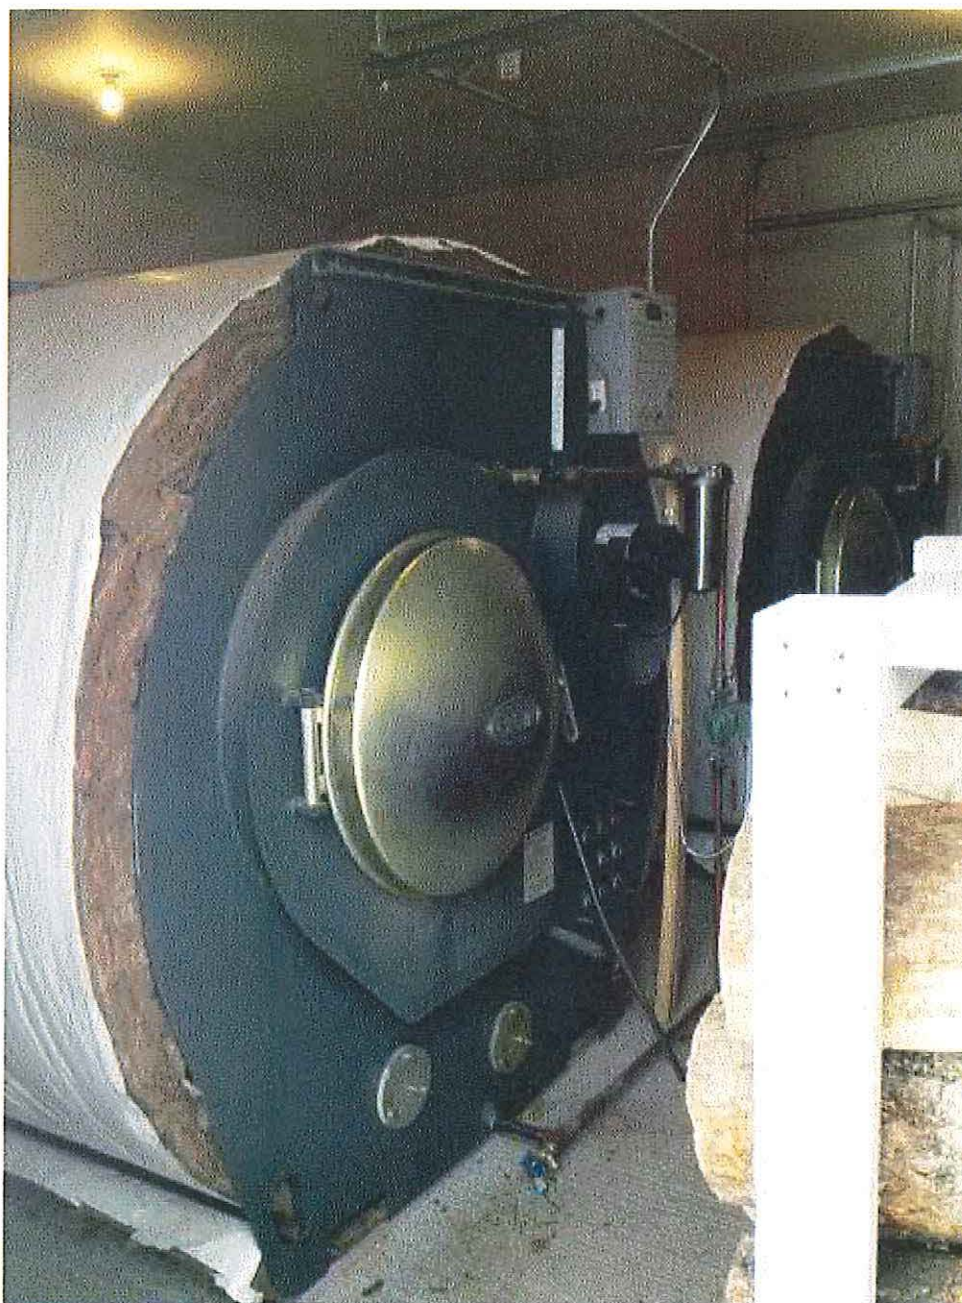
Mr. Cretens also gave me a tour of the garage housing the newly installed Garn wood-fueled hydronic heaters. The heaters were installed late 2015 and are performing very satisfactorily. These units are certified to meet EPA Phase II and New Source Performance Standard emission limits for hydronic wood heaters.

The two Garn high-efficiently gasification heaters newly installed in an adjacent outbuilding are certified to meet EPA Phase II and New Source Performance Standard emission limits for hydronic wood-fueled heaters. These units were installed in late 2015 and are performing ideally.

Image 7(CF5) : Two Garn wood-fueled hydronic heaters
