**DEPARTMENT OF ENVIRONMENTAL QUALITY
AIR QUALITY DIVISION
ACTIVITY REPORT: Scheduled Inspection**

FACILITY: Brooklyn Products Incorporated		SRN / ID: N5374
LOCATION: 171 Wamplers Lake Road, BROOKLYN		DISTRICT: Jackson
CITY: BROOKLYN		COUNTY: JACKSON
CONTACT: Lisa Bascom, Vice President		ACTIVITY DATE: 11/28/2018
STAFF: Stephanie Weems	COMPLIANCE STATUS: Non Compliance	SOURCE CLASS:
SUBJECT: Scheduled inspection of Brooklyn Products Inc.		
RESOLVED COMPLAINTS:

Minor Source: Inspection of Brooklyn Products Inc.

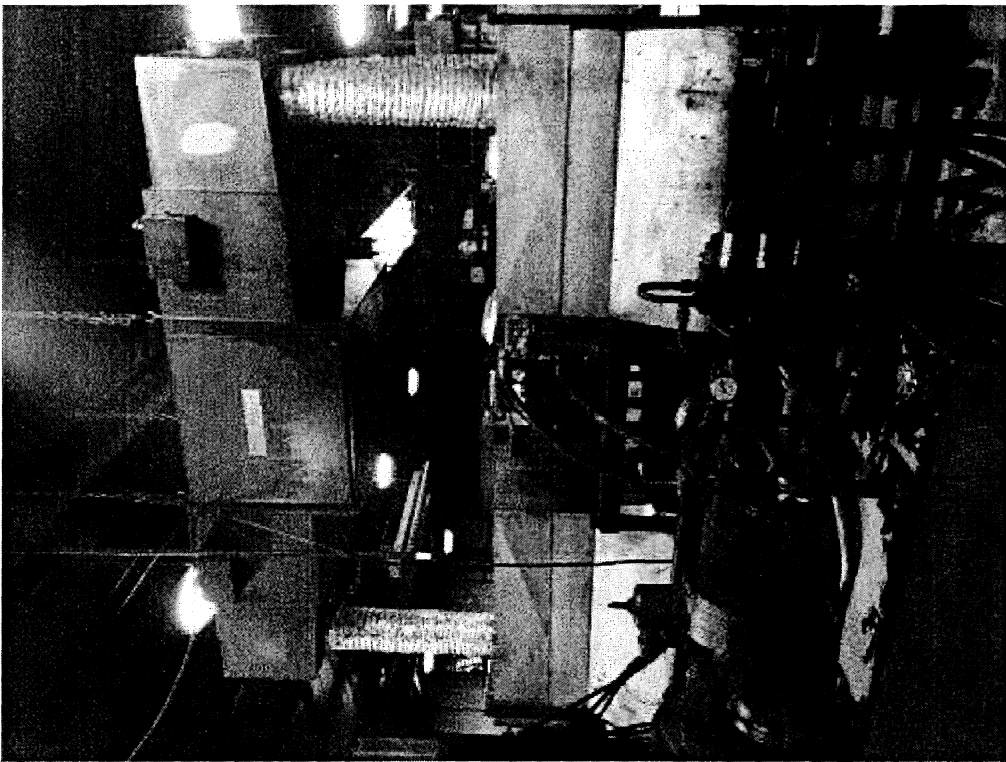
Lisa gave us a tour of the facility and explained the observed processes. A moderate, unpleasant odor of burnt foam was noticed upon first entering the facility. Lisa began by showing us the heated presses and the "smog hogs" used to capture their emissions. These "smog hogs" exhaust into the general in-plant environment. (See Images 2 &3)

Image 2(Image 2) : Back-side of "smog hog"

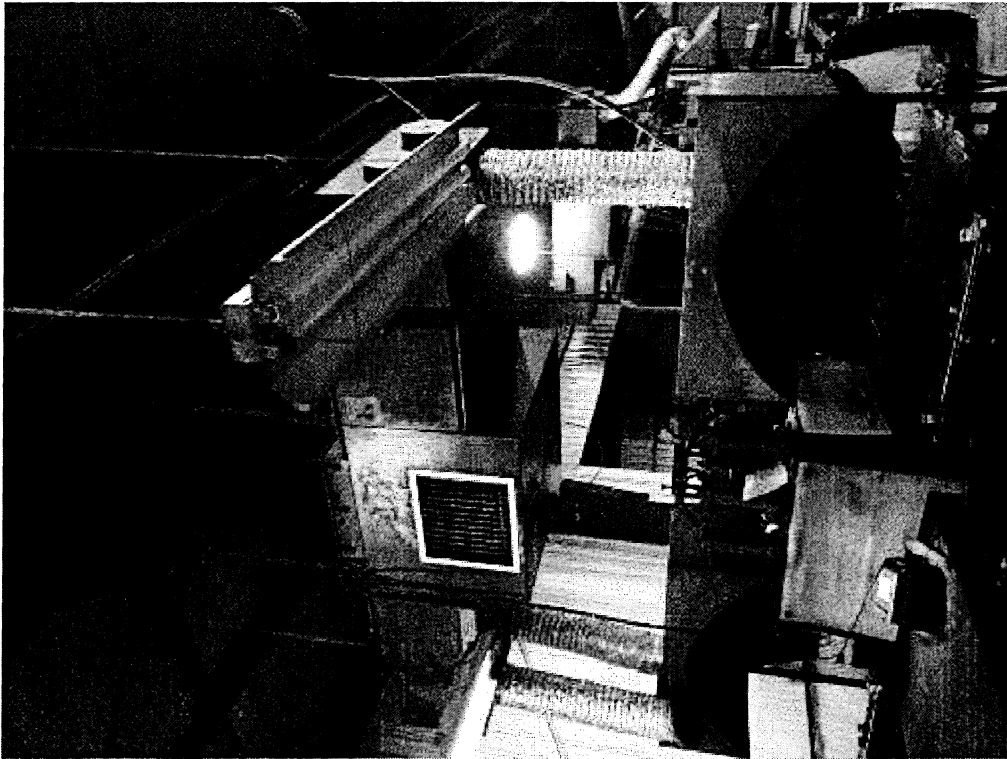
Image 3(Image 3) : Front of "smog hog"

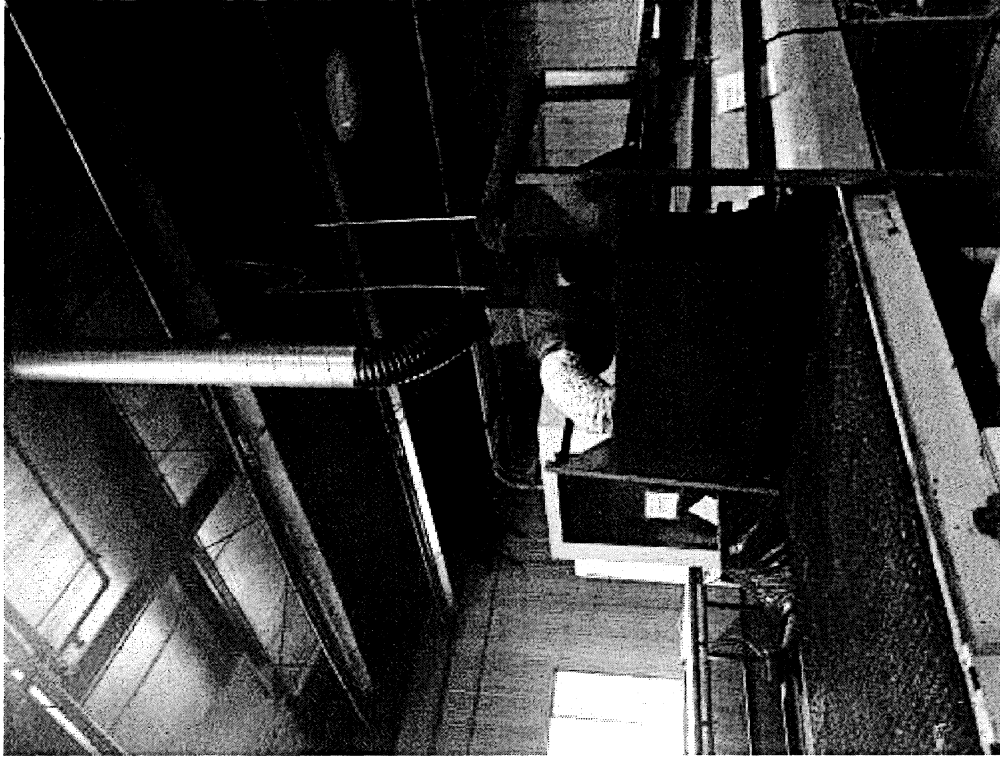
She then proceeded to show us the dryers that are used to heat the ink into their product for the silkscreen process. The smaller dryer, which Lisa states is rarely used, was not operating. The larger dryer was running, but no product was running through the dryer during the inspection. (See Images 4 &5) The dryers do exhaust outside, but the stacks were not visible from the parking lot, and the weather did not allow for a roof inspection.

Image 4(Image 4) : Small dryer

The facility is out of compliance in regards to the hot wire cutting booth and the two dryer ovens. Since information cannot be obtained and a permit exemption has not been provided for these operations, a Violation Notice (VN) will be sent to the company outlining a Rule 201 violation for not having a Permit to Install (PTI).

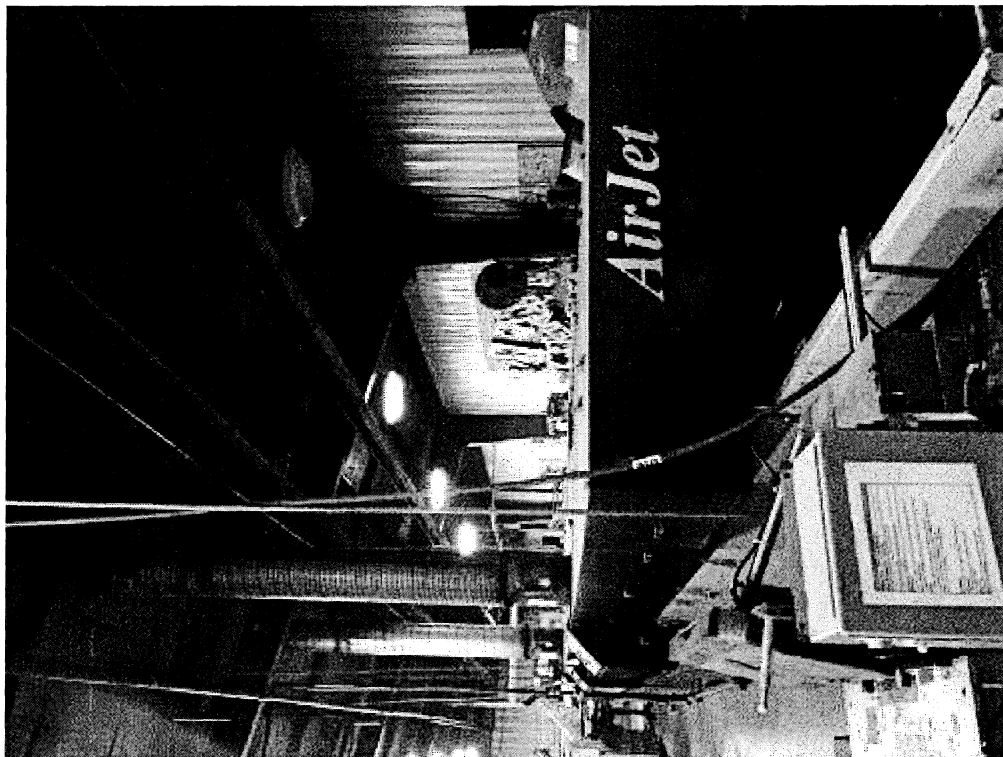
Image 5(Image 5) : Large dryer

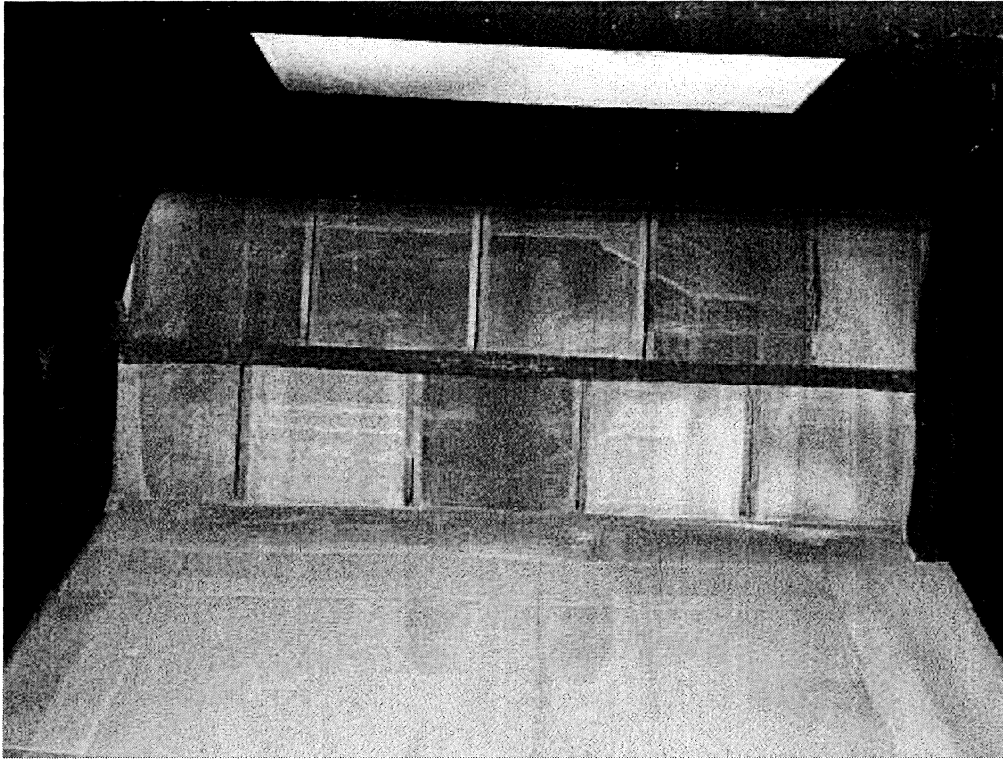
Next, Lisa showed us the adhesive spray booth and the hot melt glue device used for the firetruck product process. The inside of the spray booth is equipped with dry filters (see Image 6) and one HVLG gun. Lisa explained that they only use one type of adhesive in the booth, 3M™ Fastbond™ Foam Adhesive 100, Lavender. The spray booth is exhausted from the facility externally through an exhaust system that only services this spray booth. (See Images 7-9)

Image 6(Image 6) : Filters located inside surface coating booth

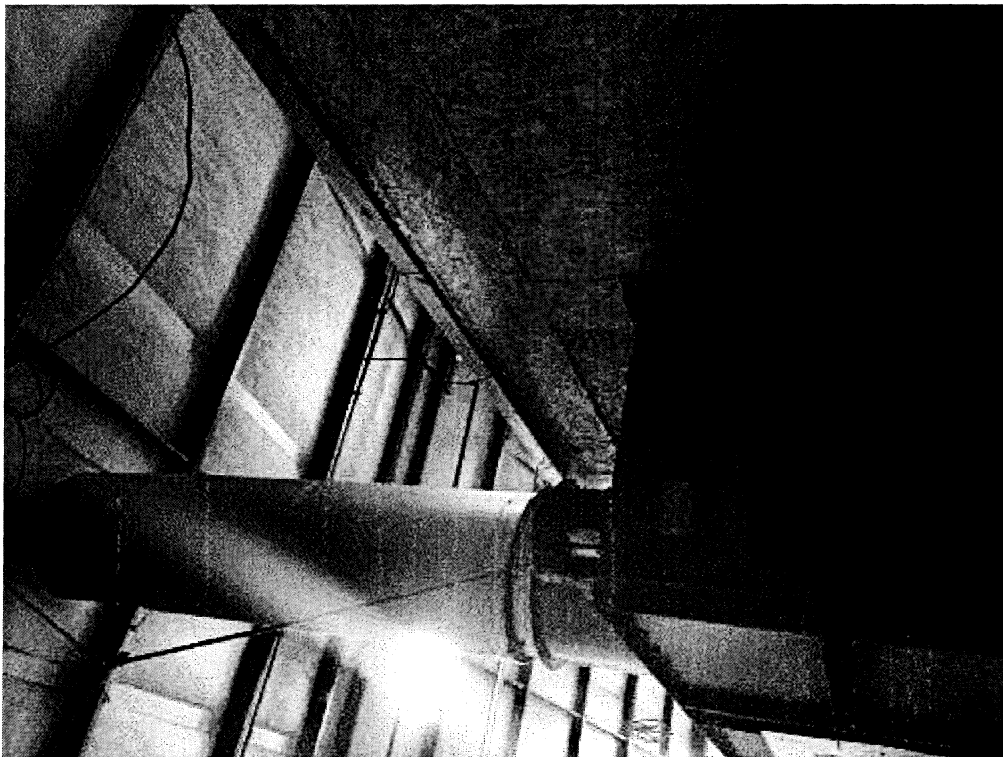
Image 7(Image 7) : Exhaust for surface coating booth

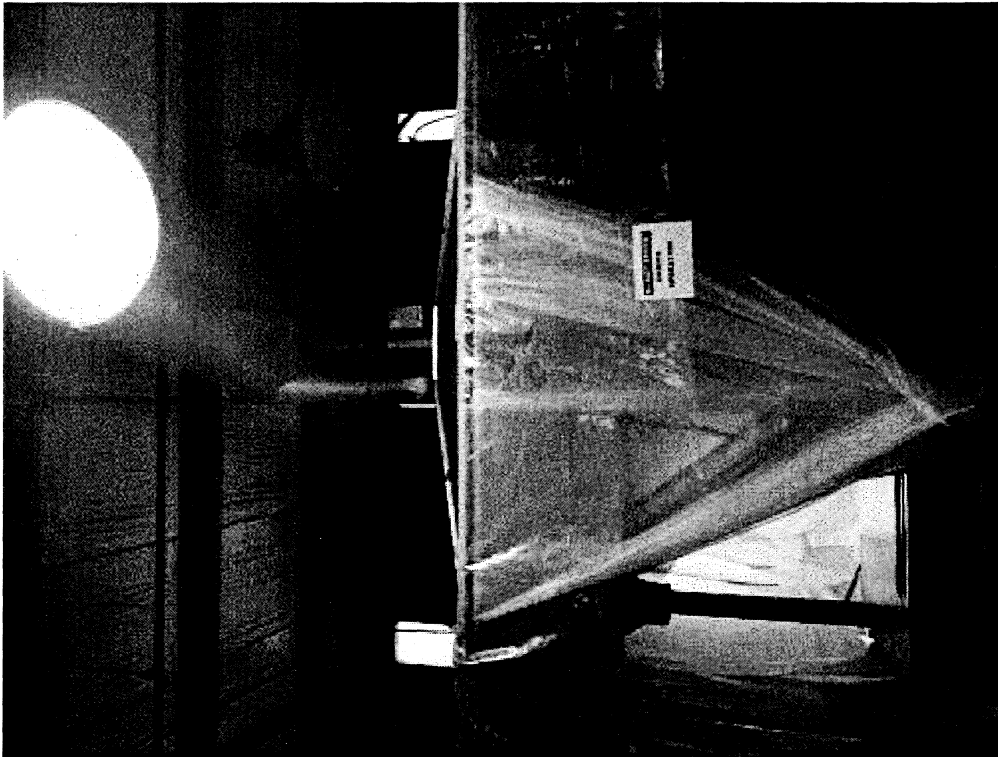
We then walked around to the west side of the facility where the hot wire booth is located. This is an enclosed booth that uses a heated set of wires to cut through the large blocks of foam. The booth was not operating during the inspection. Lisa explained to us that smoke is emitted from this process, and that it is exhausted outside. We then proceeded to exit the building through a door nearby so that we could inspect the exhaust outlet. The covered outlet was located on the side of the building. (See attached photos)

Image 8(Image 8) : Hot wire cutting booth

It appears from the information you provided the process may qualify for the exemptions R 336.1290 (Rule 290) or R 336.1291 (Rule 291). We suggest that you contact your foam supplier, and/or the cutting process manufacturer, explain to them how the foam is used and that you are looking for air permit related information in order to estimate emissions. They should be able to help you with this. From there, you may be able to calculate your emissions using the size of the foam and the amount of foam lost (burned) during the cutting process.

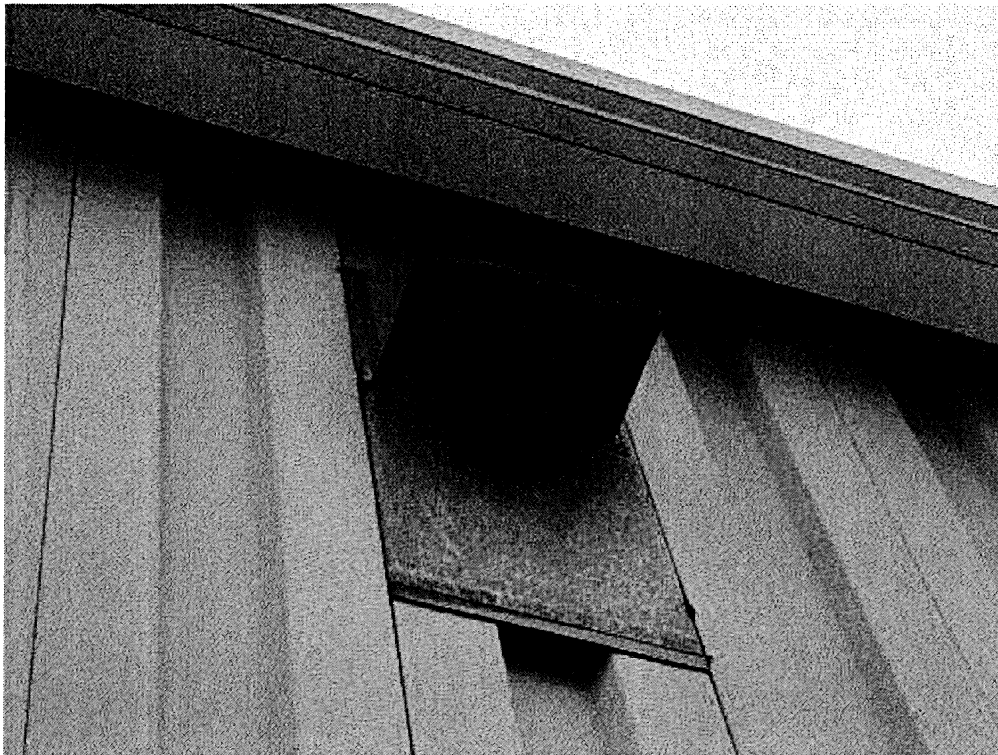
Image 9(Image 9) : Hot wire cutting booth exterior exhaust

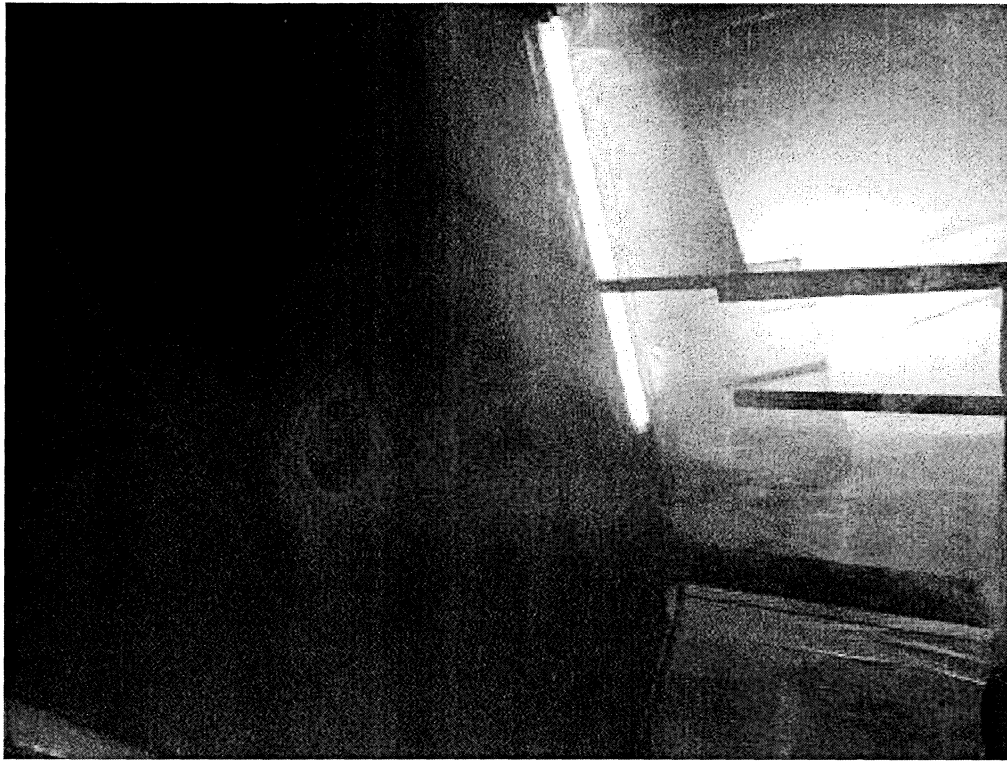
Image 10(Hot Wire Exhaust) : Photo of exhaust inside hot wire cutting booth; Provided by Lisa Bascom of Brooklyn Products

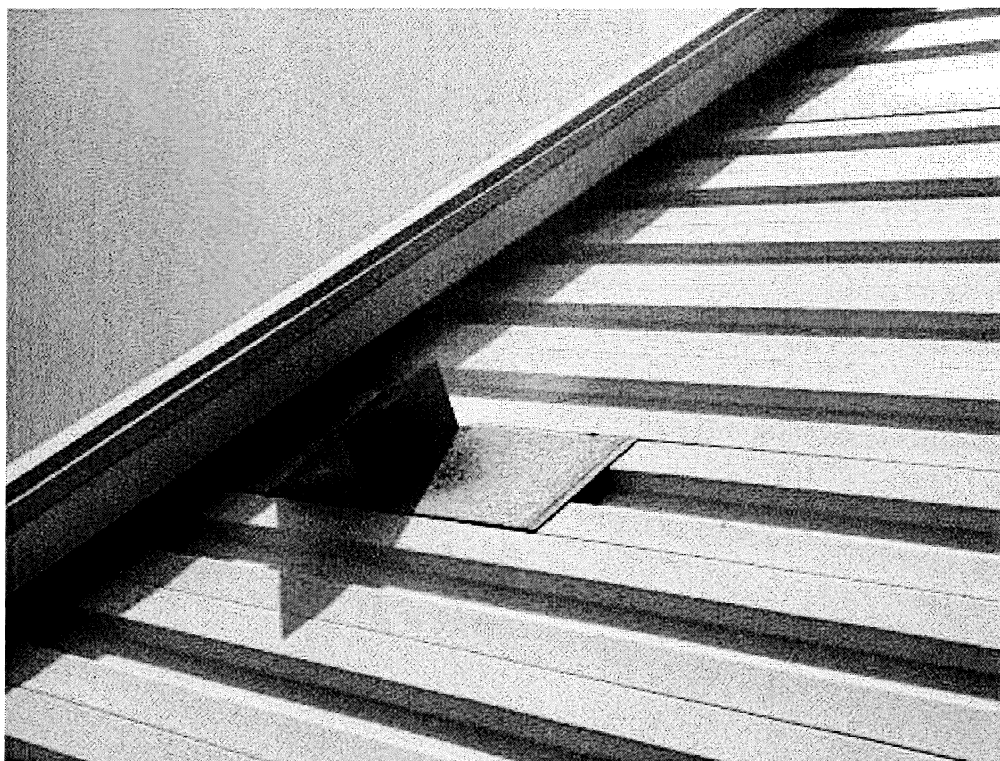
We held a brief post-inspection meeting with Lisa. The SDS and purchase records for the spray booth were requested, and she graciously supplied them. We then discussed the hot wire booth. We asked what the normal cutting time is for the machine, and Lisa stated that it was about 5 minutes. We expressed concern that, with that long of a cutting time, the smoke that is emitted may be above allowable opacity, but since it was not operating, we couldn't know for sure. We asked her to keep watch and monitor the opacity levels.

Image 12(Hot Wire Exhaust) : Exterior exhaust while hot wire cutting booth was in operation; Photo provided by Lisa Bascom of Brooklyn Products.
