**DEPARTMENT OF ENVIRONMENTAL QUALITY  
AIR QUALITY DIVISION  
ACTIVITY REPORT: On-site Inspection**

N553167060

<b>FACILITY:</b> CHAMPAGNE & MARX EXCAVATING INC		<b>SRN / ID:</b> N5531
<b>LOCATION:</b> CHAMPAGNE & MARX, MICHIGAN RD PIT, SAGINAW		<b>DISTRICT:</b> Bay City
<b>CITY:</b> SAGINAW		<b>COUNTY:</b> SAGINAW
<b>CONTACT:</b> Brad Wood , General Manager		<b>ACTIVITY DATE:</b> 04/12/2023
<b>STAFF:</b> Daniel McGeen	<b>COMPLIANCE STATUS:</b> Non Compliance	<b>SOURCE CLASS:</b> MINOR
<b>SUBJECT:</b> Inspection of concrete crusher which did not have a water spray or water line to the primary crusher.		
<b>RESOLVED COMPLAINTS:</b>

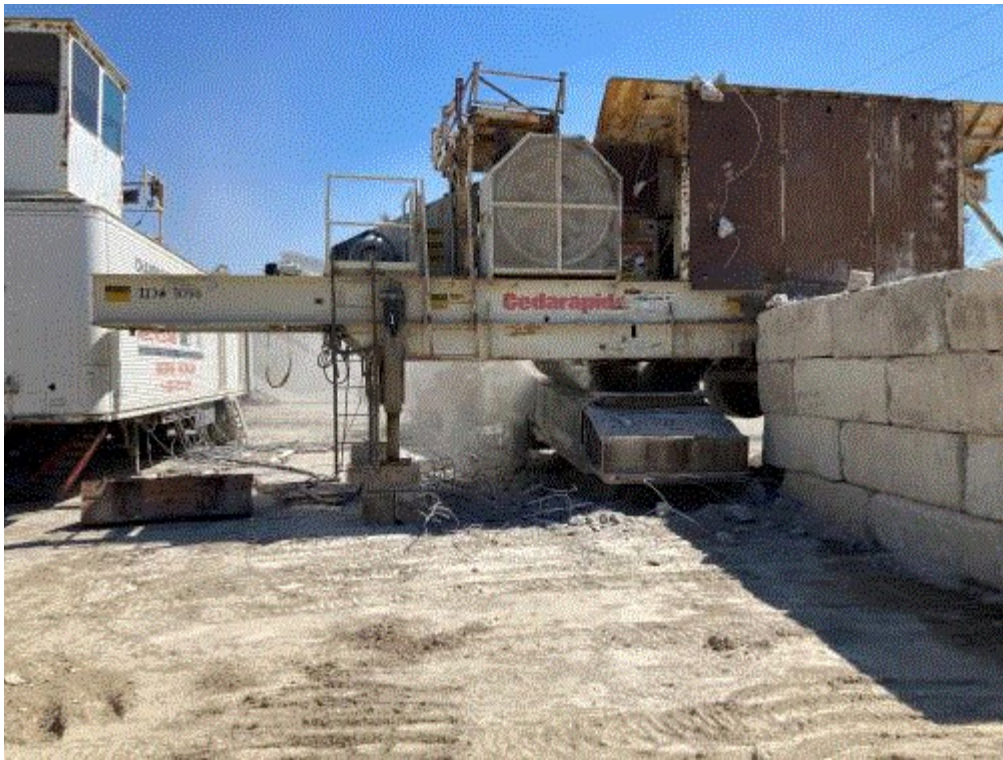
**Image 1(001)** : Fugitive dust from primary crusher.

The primary crusher, the Cedar Rapids jaw crusher, was operating. D. McGeen asked about supplying water to the crusher, and was told that it did not have a water spray system, nor a water line. This constituted a violation of General PTI No. 446-99, Special Condition (SC) 1.7, using the latest format of the crusher general PTI, available online.

Opacity from the primary crusher was excessive, per 3 photos AQD took (attached), and a video which AQD recorded.

**The VN response letter from Champagne & Marx General Manager Brad Wood was received on 4/25/2023, stating that on 4/13, a spray bar was added to the primary crusher. He noted that there were two existing spray bars, on the impactor or impact crusher, and the Meg 1 conveyor, which were reported to be in operation on 4/12.**
