DEPARTMENT OF ENVIRONMENTAL QUALITY
AIR QUALITY DIVISION
ACTIVITY REPORT: Scheduled Inspection

FACILITY: JACKSON TUMBLE FINISH		SRN / ID: N5713
LOCATION: 1801 MITCHELL ST, JACKSON		DISTRICT: Jackson
CITY: JACKSON		COUNTY: JACKSON
CONTACT: Michelle Morrison , Quality Manager		ACTIVITY DATE: 01/11/2018
STAFF: Mike Kovalchick	COMPLIANCE STATUS: Non Compliance	SOURCE CLASS:
SUBJECT: Scheduled inspection.		
RESOLVED COMPLAINTS:

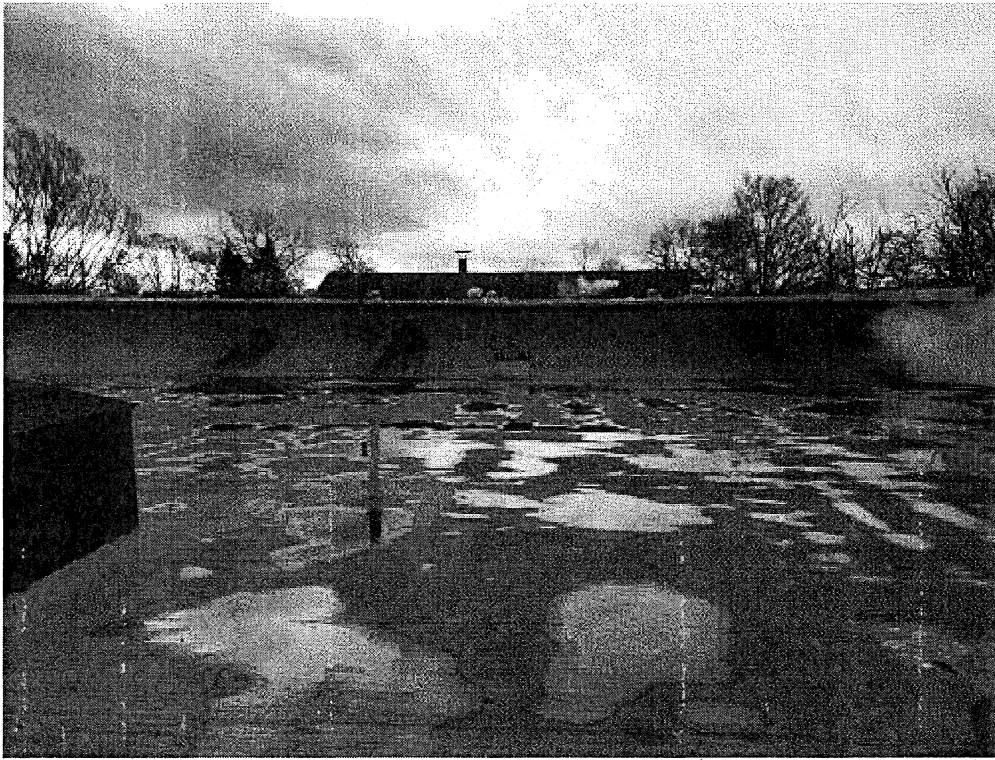
At this point, I requested access to the roof to the main building. A small mechanical lift was provided to access the roof. The roof appeared to be in excellent shape. Generally, no opacity was observed. One of the exhaust vents that vented horizontally was generating moderate odors and also appeared to contain a little smoke mixed in with the steamy emissions. (See attached photos.) I requested that we go back into the main build to observe the source of this odorous. I was brought back inside to Line 1 and was shown an alkaline cleaner tank and an oil skimmer tank. Emissions from both tanks lofted upwards to a roof fan/horizontal exhaust port that I had just witnessed on the roof. Parts were first placed in this oil skimming tank to remove the oil. The temperature was kept between 180 to 220 degrees F. The cleaner appears to be potassium hydroxide. There were too much steamy emissions coming from these 2 tanks to observe any potential smoke.

Image 1(Roof Main Building) : Roof-main building

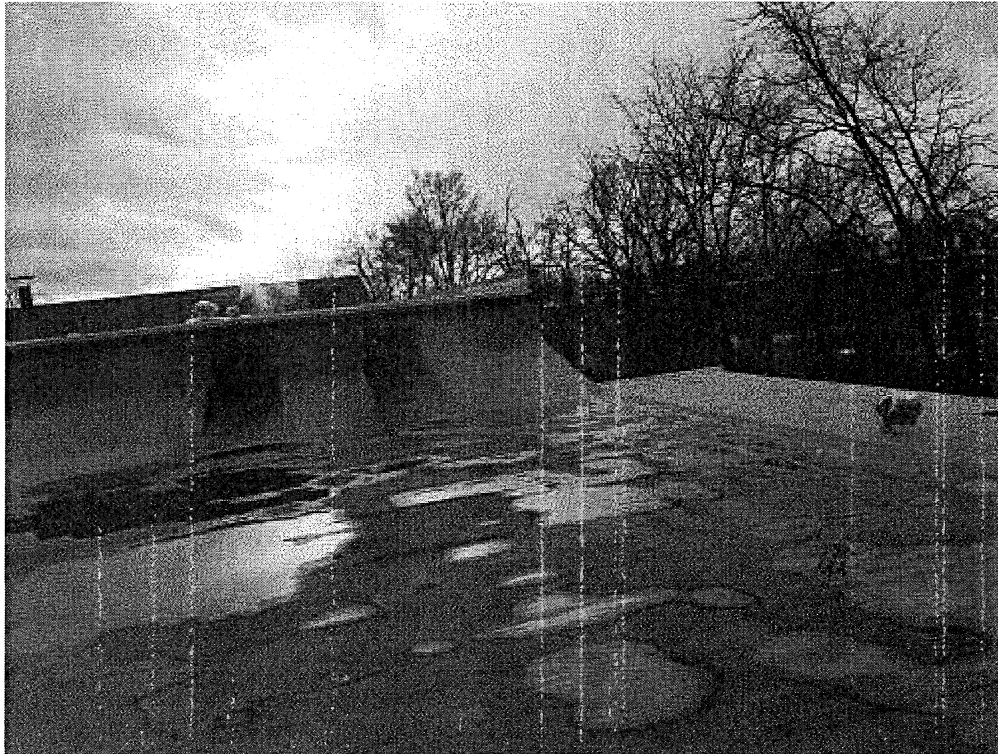
Image 2(Smoke?) : Possible smoke from line 1 cleaner tank/oil skimming tank.

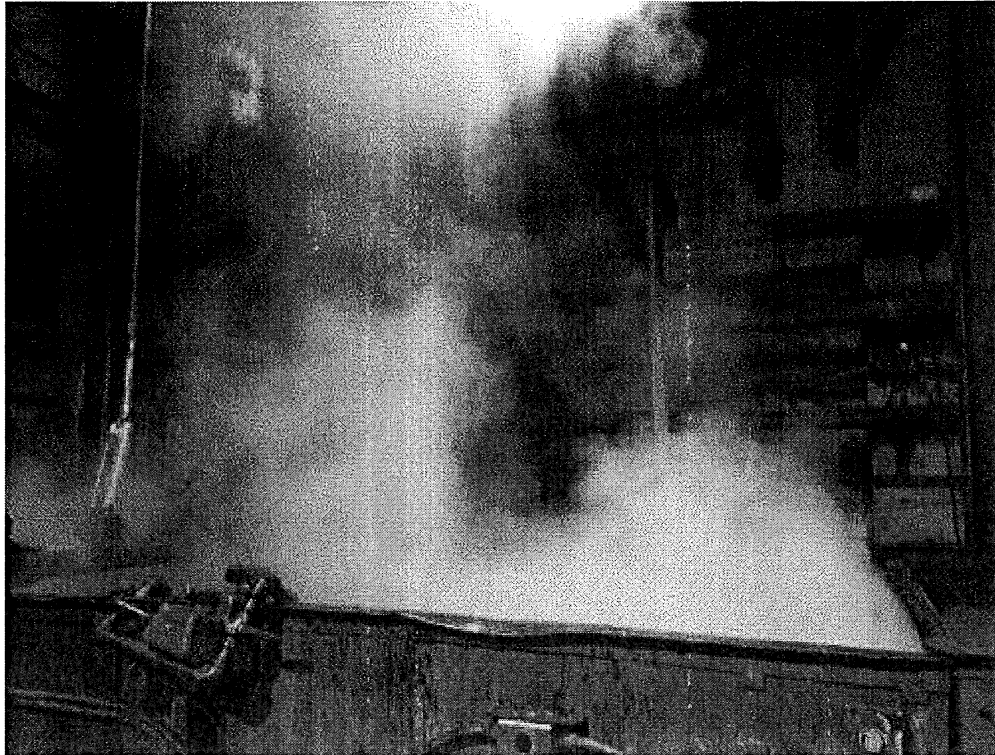
Image 3(Odororous tank) : Odorous cleaning tank and oil skim tank with emissions exiting via horizontal ceiling exhaust.

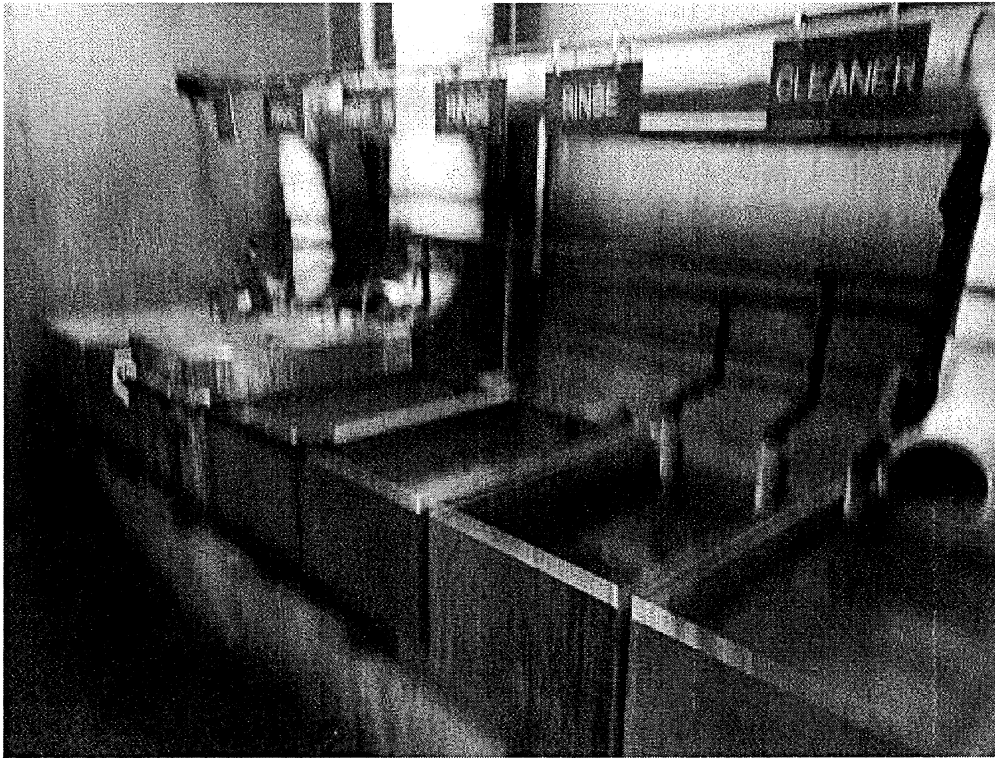
We first looked at a small washing/degreasing line at that contained a cleaning agent and an adjacent passivation tank containing some dilute citric acid. (See attached photos.)

Image 5(Washing/Degreasing) : Washing/Degreasing line.

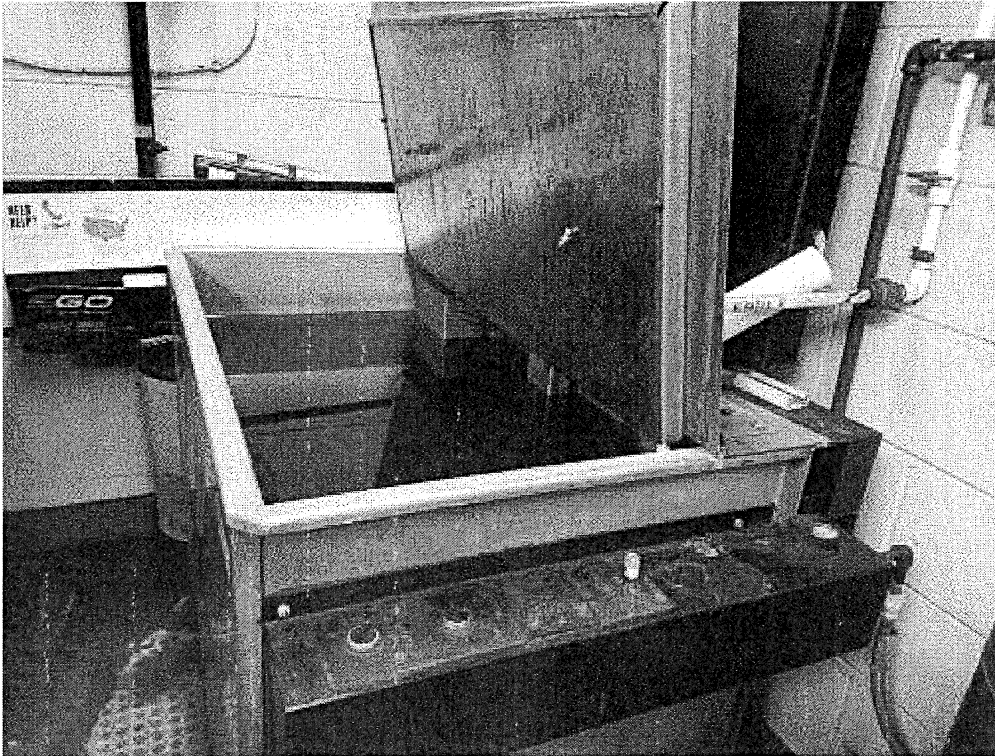
Image 6(Passivation tank) : Passivation tank using dilute citric acid.

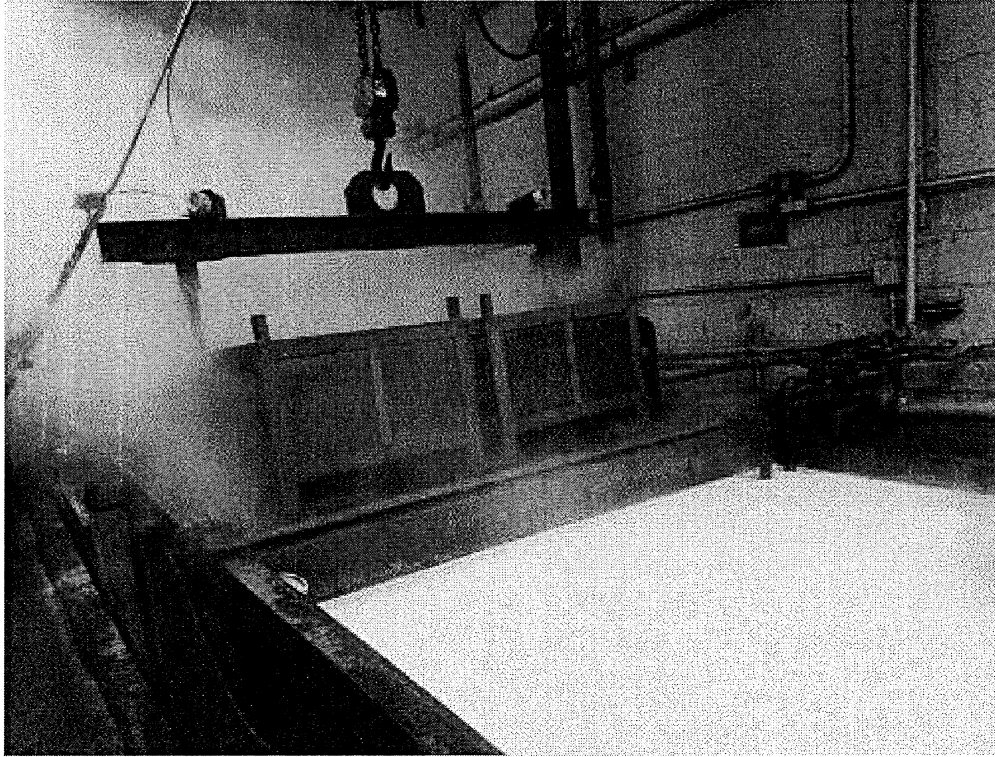
We then looked at a Line 4 zinc phosphate line. The temperature of the tanks was around 145 deg. F. There were no dedicated exhausts except some roof fans. No acid was being used. The final tank contained an aqueous oil solution. No smoke appeared to be generated when metal parts were added to this tank. (See attached photos.)

Image 7(Aqueous oil tank) : Line 4 Zinc phosphate with aqueous oil tank

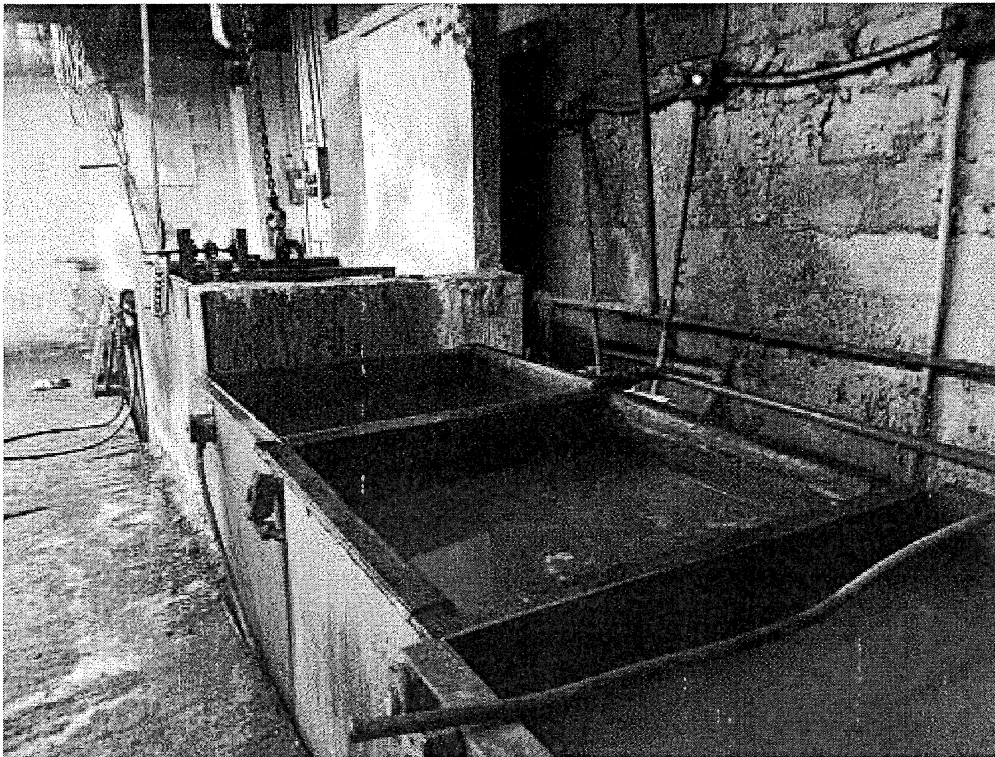
Next, we observed the black oxide line. Dilute HCL acid was being used. Two roof fans were present above the process.

Image 8(Black Oxide line) : Black oxide line.

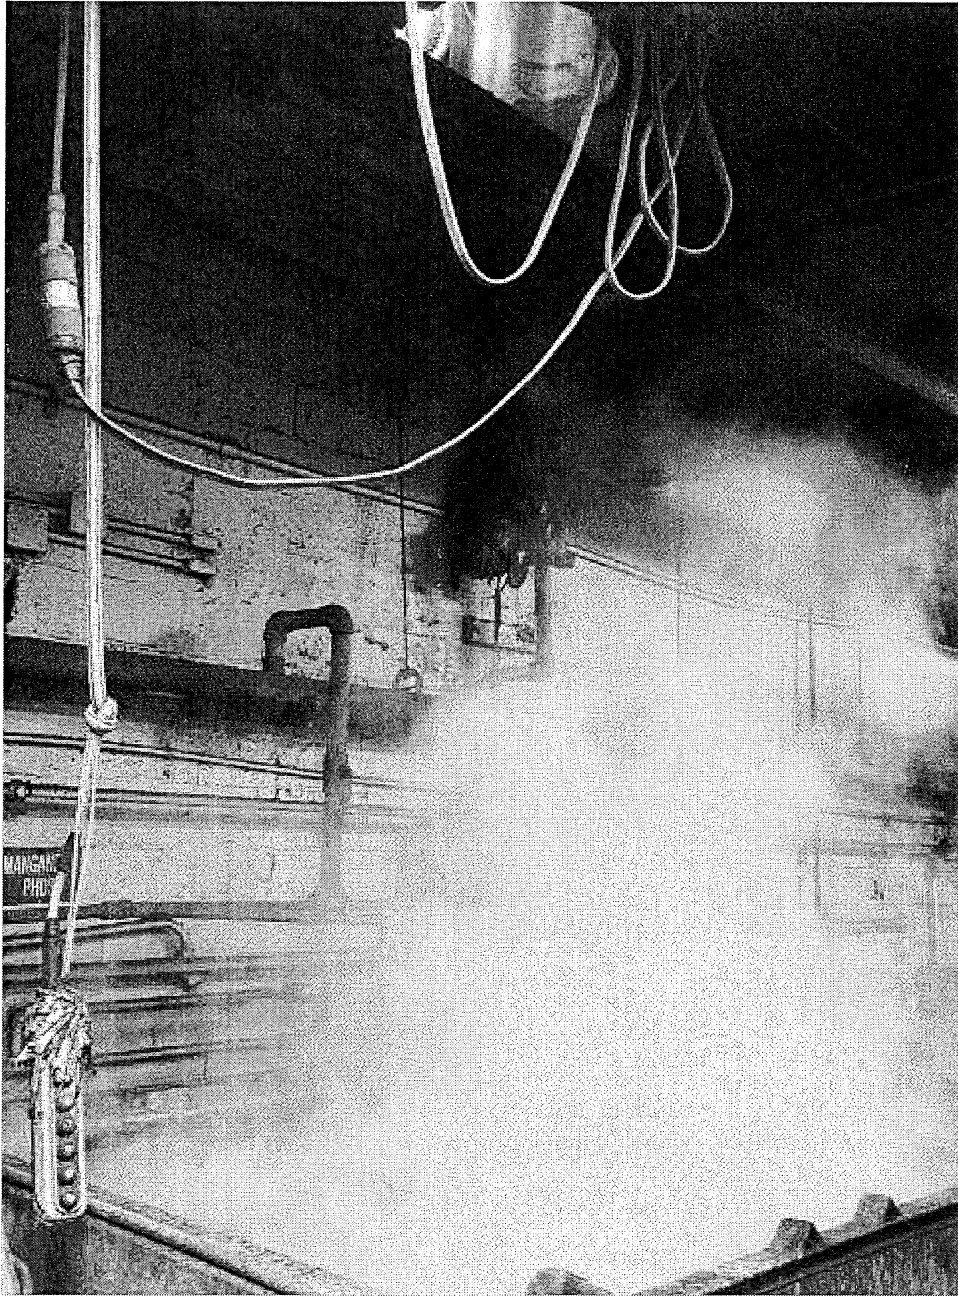
We then looked at the manganese phosphate line. This tank contains an aqueous mixture of phosphoric acid, manganese nitrate and manganese phosphate. I noted a roof fan directly above the manganese phosphate tank. This tank is being used 3 to 6 hours per day. The temperature of the tanks is around 195 deg F. The tank contains about 350 gallons of water and 50 gallons of the manganese compounds. Usage of the manganese compounds were estimated at 25 to 45 gallons per week. (The manganese compounds make about 10 to 20 % of the 25 to 45 gallons. Weight of compound is 11 pounds/gallon which works out to a maximum estimate of 200 to 400 pounds of manganese compounds per month. ITSL 0.3 (**ug/m3**) Prior to the manganese phosphate tank, there was an alkaline cleaner tank. (See attached photos of this line.)

I was told during the inspection that approximately 25 to 45 gallons of manganese compounds are used per week in the manganese phosphate tank. This amounts to approximately 200 to 400 pounds of manganese compounds potentially emitted per month if we assume all these compounds are emitted. (The Company does not maintain actual estimated emission calculations for possible Rule 290 considerations.) With the ITSL of manganese compounds being 0.3 $\mu\text{g}/\text{m}^3$ emissions can be no more than 20 pounds per month. Hence, Rule 290 does not apply and thus emissions of manganese compounds require a PTI permit.

Image 9(Manganese tank) : Manganese phosphate tank with ceiling exhaust fan.

The Company is in compliance except for the manganese phosphate tank which is not in compliance with the 6W MACT and Rule 201-No Permit to Install (PTI). A Violation Notice (VN) will be sent to the Company and they will have 21 days to respond.

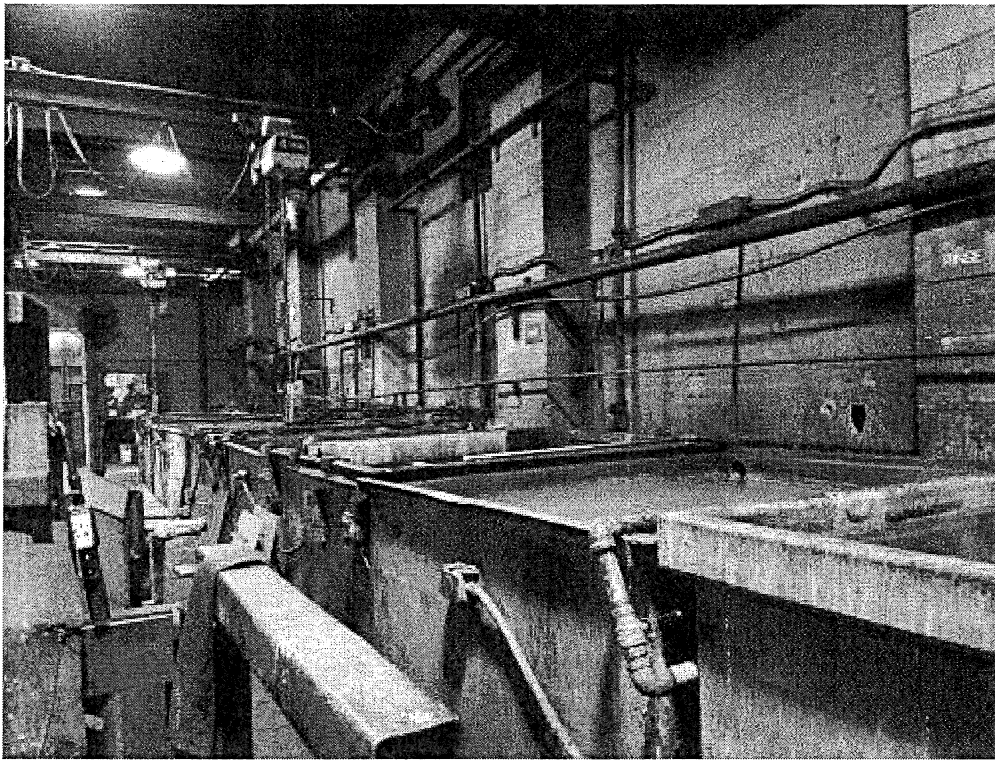
Next, we observed the Line 2 zinc phosphate line. There was also an aqueous oil tank in this line. Acid concentrate (HCL) in one of the tanks was estimated at 5%. I did not observe any dedicated exhausts but with ceiling exhaust fans nearby. Line 1 was directly adjacent to Line 2 with a similar setup. No dedicated exhausts other than roof exhaust fans directly above the process.

Image 10(Line 2 Zinc Phosphat) : Line 2 Zinc phosphate line.

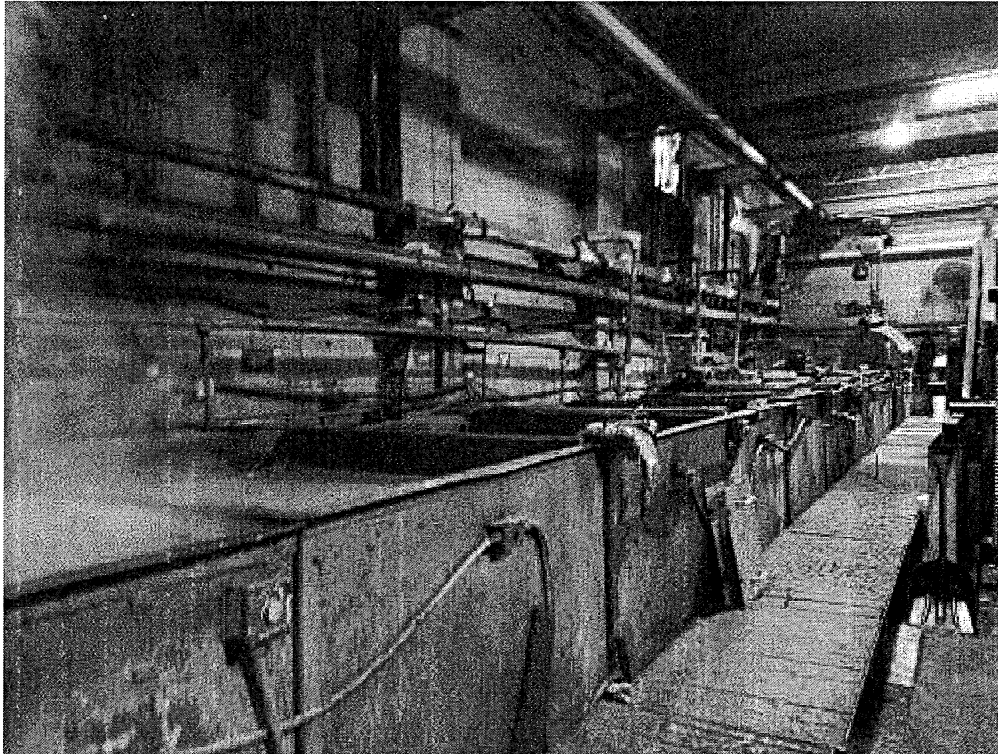
Image 11(Line 1 Zinc Phosphat) : Line 1 Zinc Phosphate line

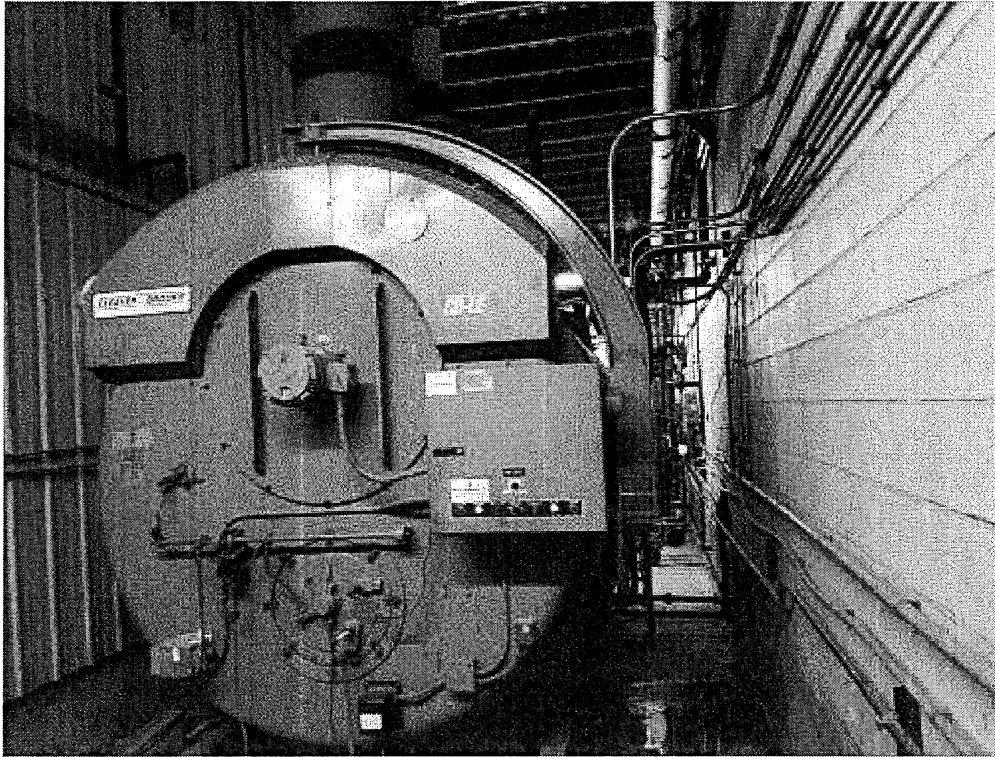
We then looked at the Line 3 phosphate line. No findings. Near that area was a 10 Million BTU natural gas fired boiler. (See attached photos.)

Image 12(Boiler) : Natural gas boiler

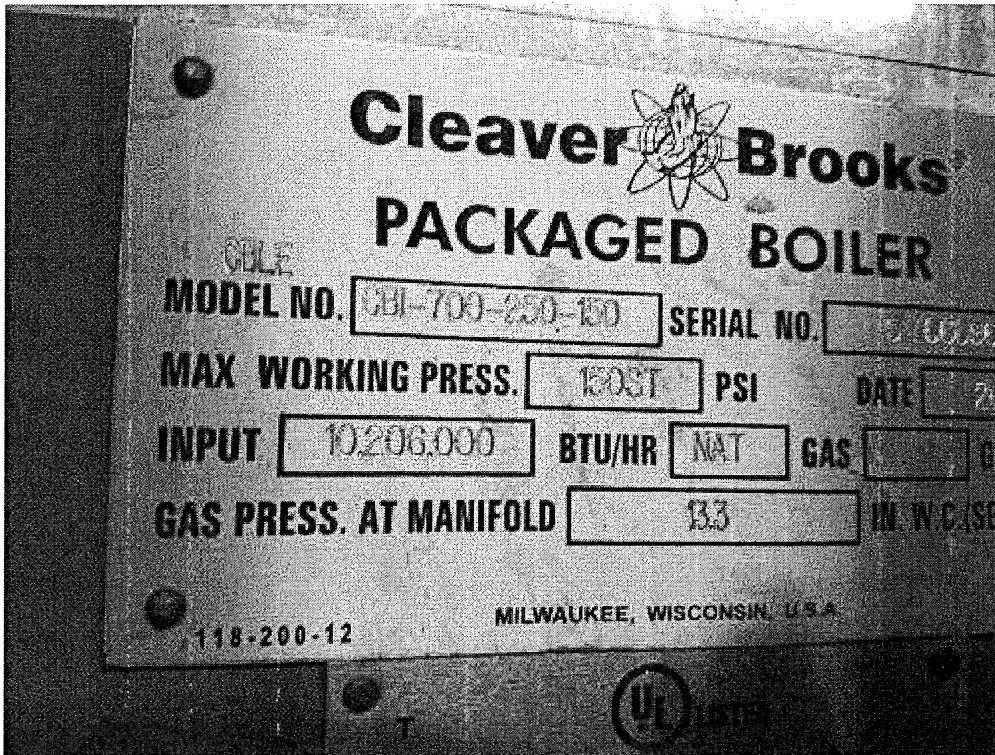
Image 13(Boiler plate) : Boiler plate showing 10 million BTU rating

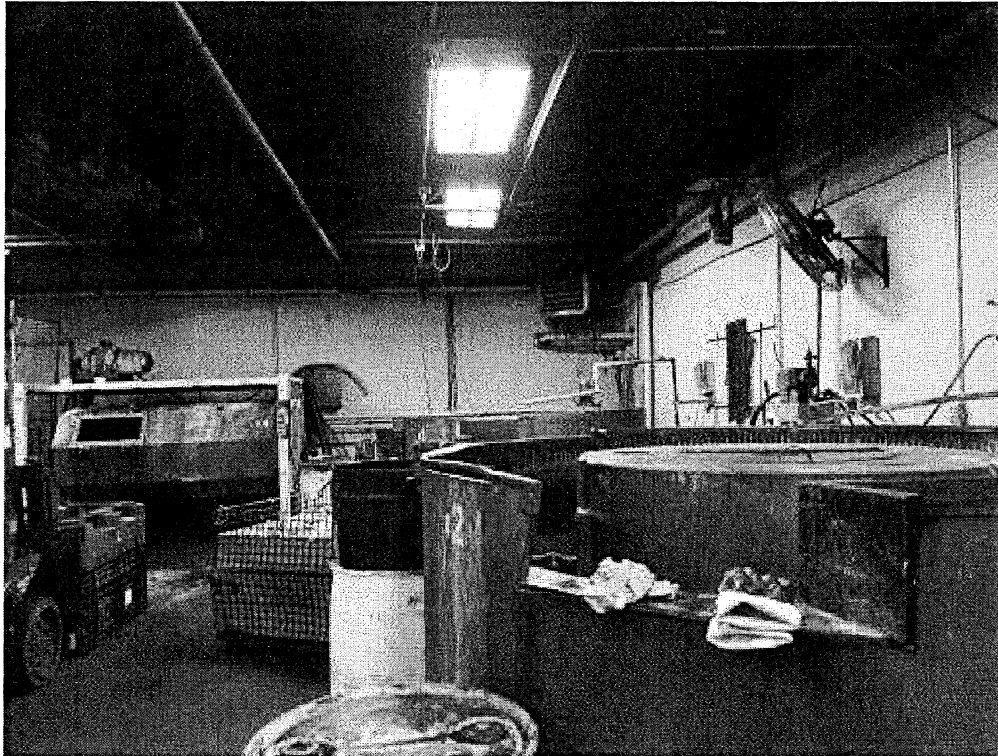
We stopped briefly to look at a room containing 5 tumble machines. No dust was observed and there was no exhaust from the room.

Image 14(Tumbler machines) : Tumbler machines

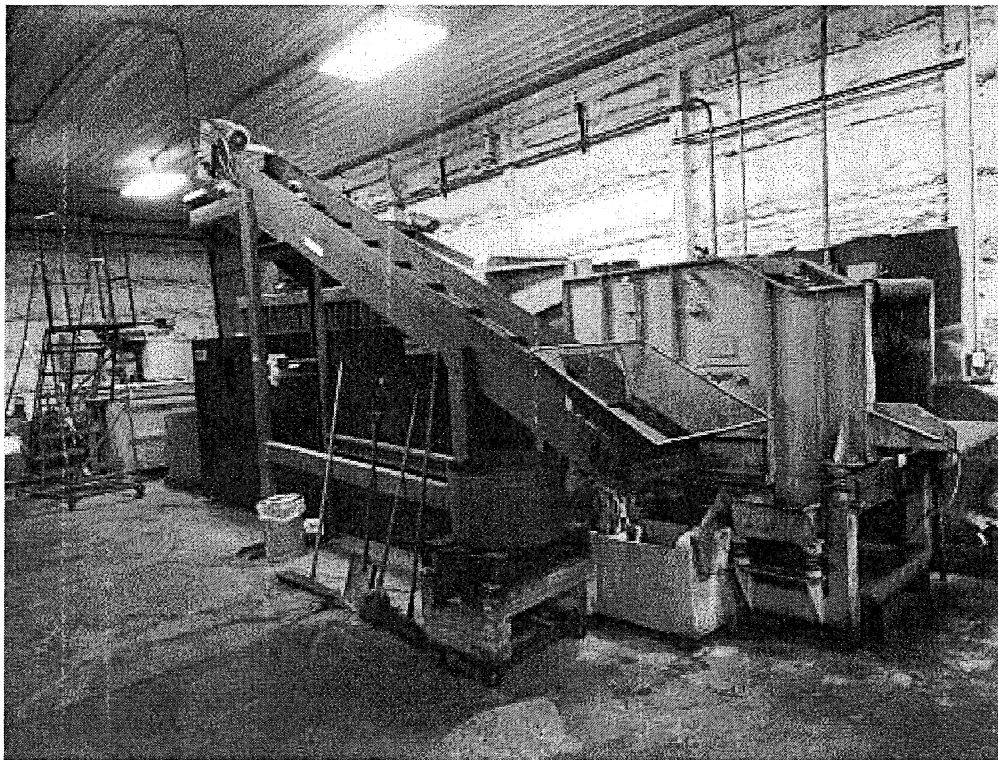
Image 15(Deburring machine) : Deburring machine.

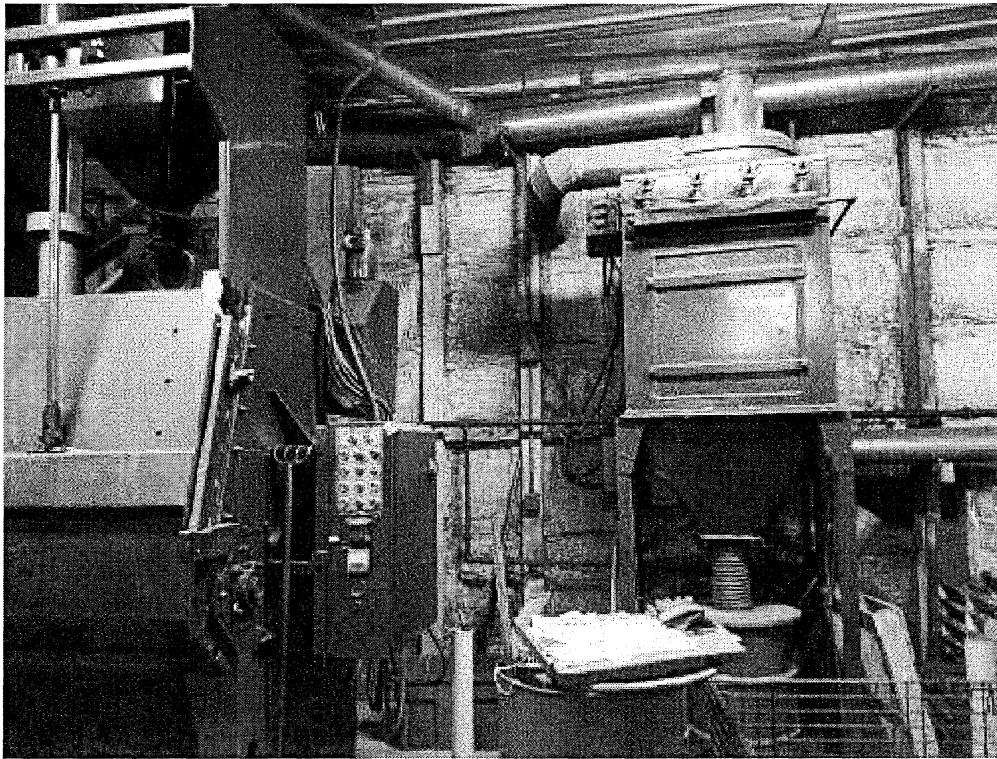
We exited the building then walking across a dirt road to the West building that contained deburring and shot blast. Nothing was operating. The 2 shot blast machines were each controlled by a baghouse that exhausted

Image 16(Shot blast) : 1 of 2 shot blast machines with baghouse.

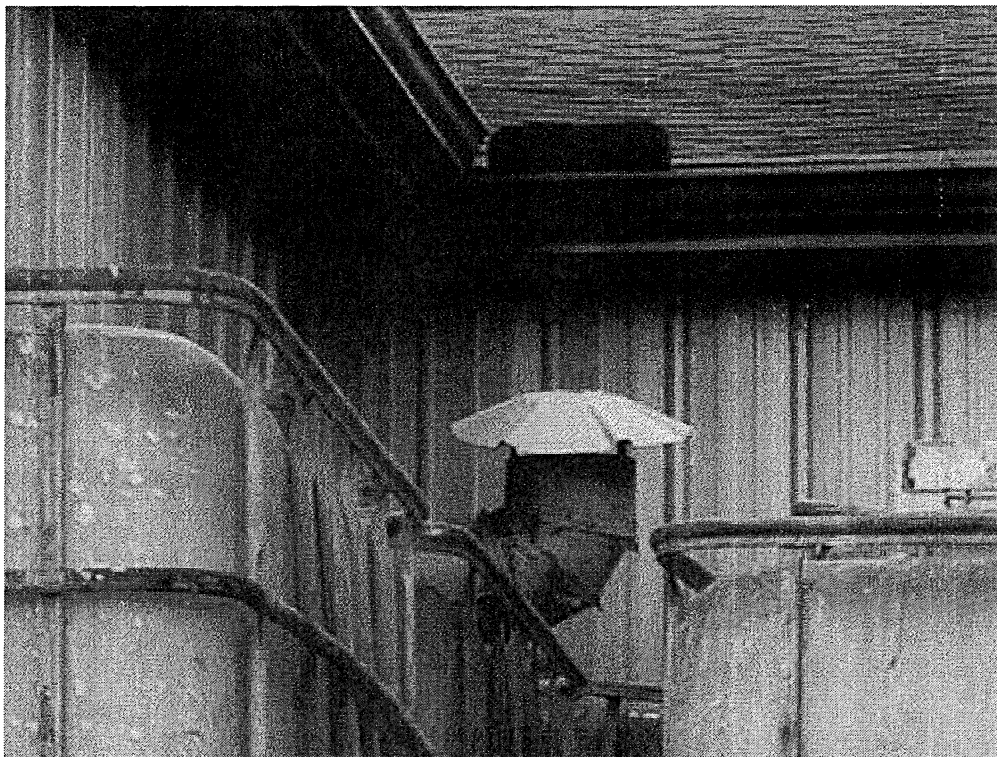
Image 17(Exhaust stack) : Exhaust stack for 1st shot blast baghouse.

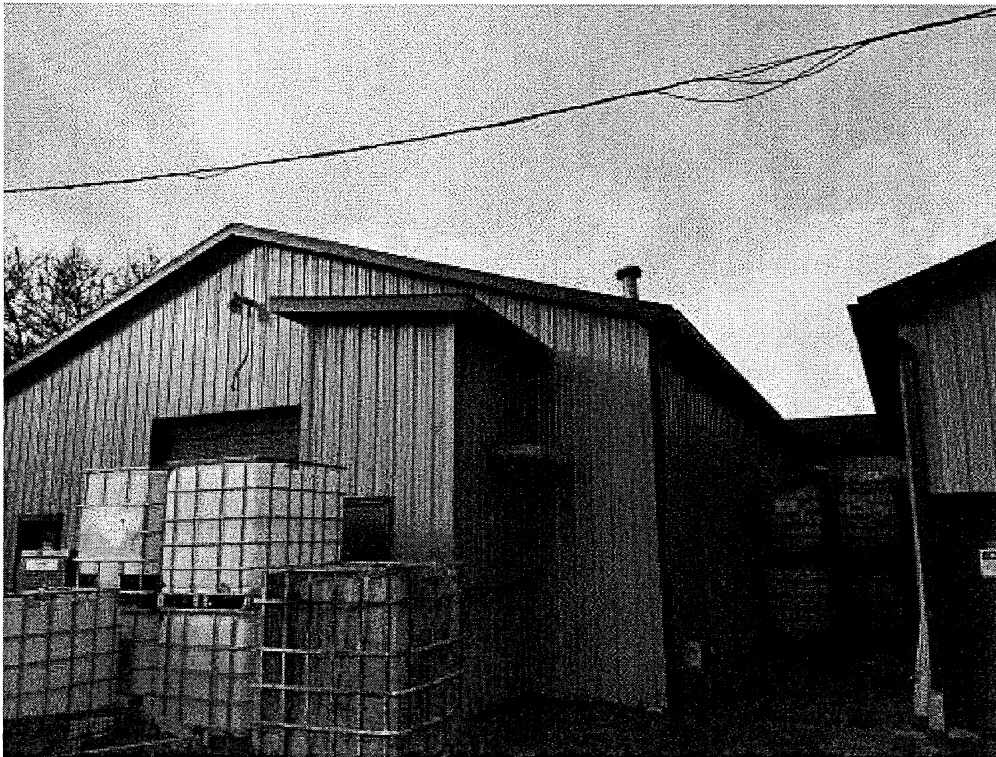
Image 18(Exhaust shotblast) : Small roof stack from 2 shotblast baghouse. 2nd baghouse located in small building in front of the main building.
