DEPARTMENT OF ENVIRONMENTAL QUALITY  
AIR QUALITY DIVISION  
ACTIVITY REPORT: Scheduled Inspection

FACILITY: Kinder Morgan Cochin, LLC		SRN / ID: N5916
LOCATION: 10743 Stone Quarry Road, RIGA		DISTRICT: Jackson
CITY: RIGA		COUNTY: LENAWEE
CONTACT: Danny Cochran , Area Manager		ACTIVITY DATE: 02/09/2017
STAFF: Mike Kovalchick	COMPLIANCE STATUS: Compliance	SOURCE CLASS: MINOR
SUBJECT: Compliance inspection. No findings.		
RESOLVED COMPLAINTS:

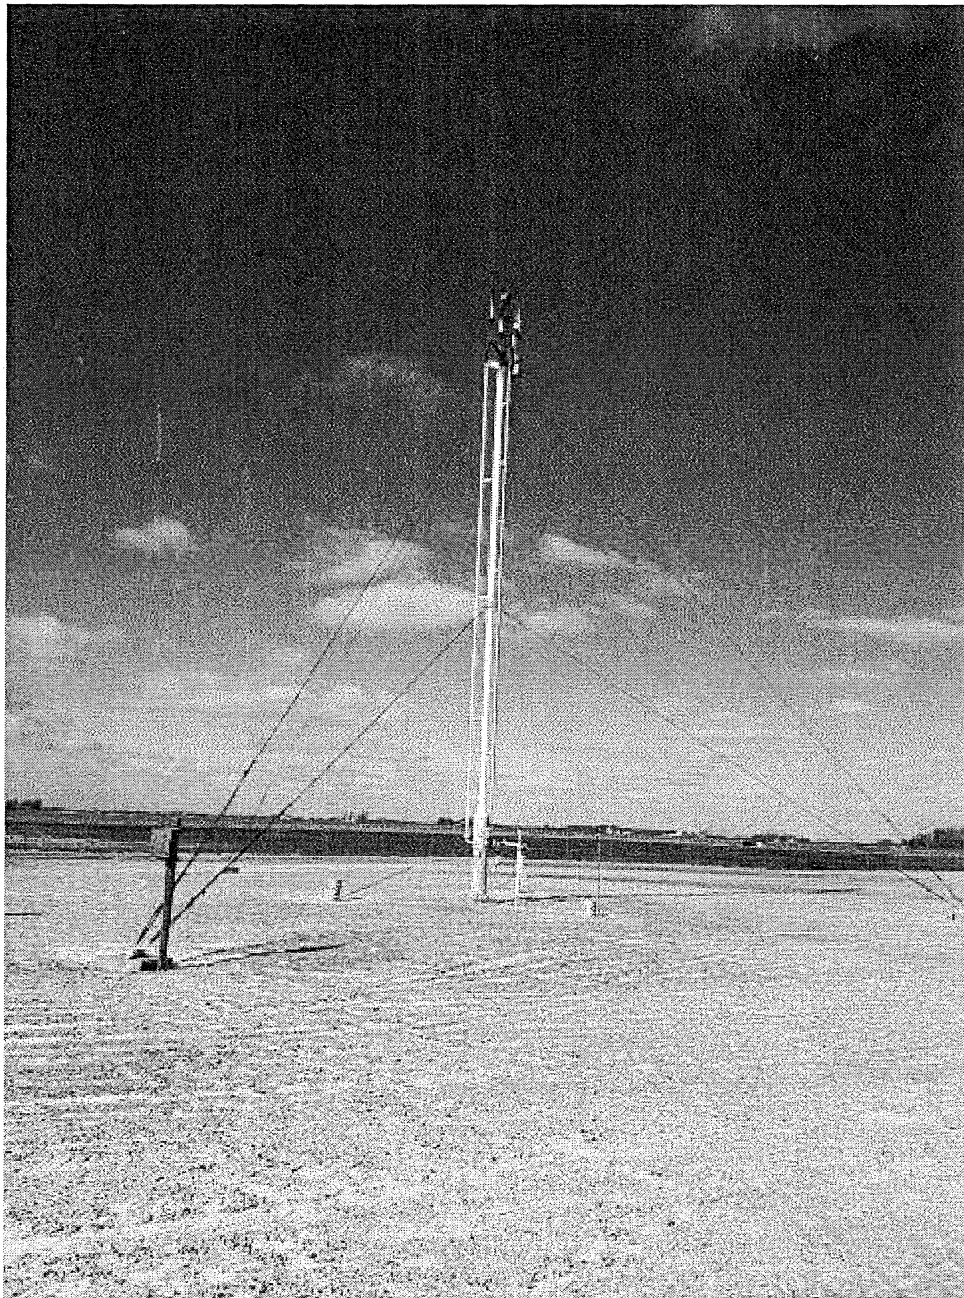
The pump station is equipped with a John Zink Flare model Linear Relief Gas Oxidizer. It has been there since at least 2007. Although the flare is designed to allow for daily use, it is used infrequently. The flare is 51 feet tall and consists of three separate burner heads. Product that is sent to the flare is first sent to a flash tank. The flash tank provides a decrease in working pressure. The decrease in pressure allows the product to flash, or become a vapor. From the flash drum the product is piped to the flare. The flare is equipped with an in-line differential pressure switch. When the pressure switch detects a differential pressure above the set-point, an igniter is activated at the top of the flare. The pressure switch eliminates the need to run a continuous pilot flame, thus allowing flaring only when necessary.

**Image 3(Flare) :** Flare
