DEPARTMENT OF ENVIRONMENTAL QUALITY
AIR QUALITY DIVISION
ACTIVITY REPORT: Scheduled Inspection

FACILITY: FAST TRACK VENTURES ACQUISITIONS		SRN / ID: N8051
LOCATION: 45310 VAN DYKE AVE, UTICA		DISTRICT: Southeast Michigan
CITY: UTICA		COUNTY: MACOMB
CONTACT: Tom Sampson , Project Manager		ACTIVITY DATE: 12/15/2015
STAFF: Robert Elmouchi	COMPLIANCE STATUS: Non Compliance	SOURCE CLASS: MINOR
SUBJECT: Scheduled inspection.		
RESOLVED COMPLAINTS:

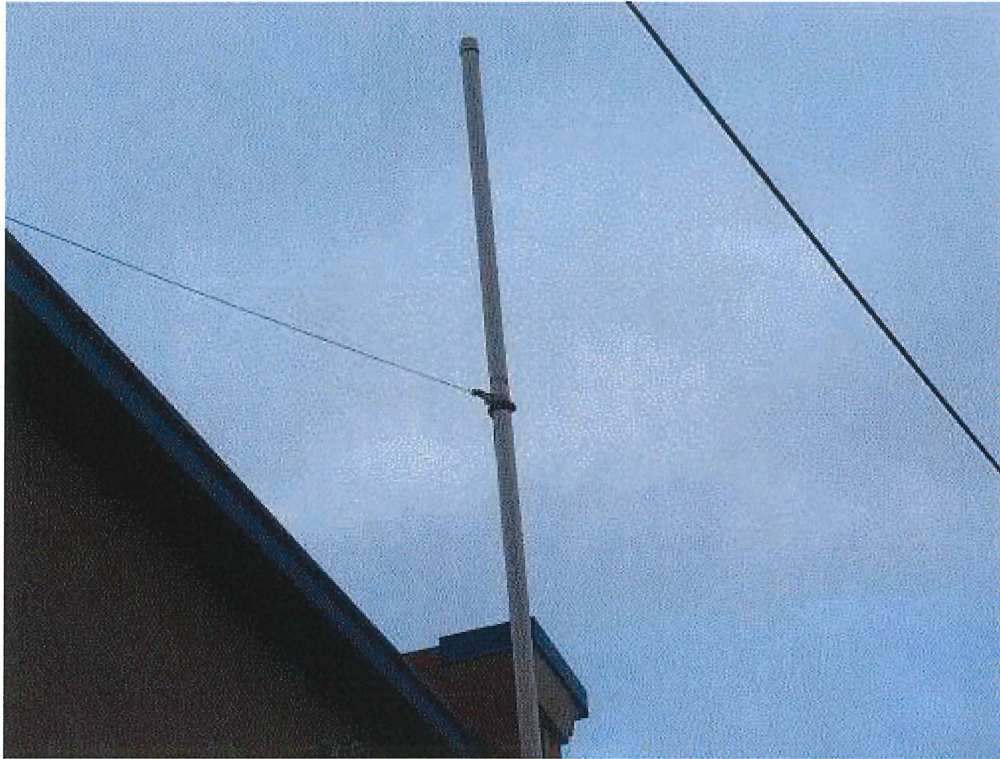
The SVE was not operating on the day of the inspection and I was informed by Mr. Cargill that the SVE had not been operated since 2012. The records provided supported Mr. Cargill's statement and indicate that the SVE was last operated during May of 2012. I observed that the SVE system exhaust discharge stack was damaged. The upper portion of the stack, which is made of white plastic pipe, was laying on the ground. Mr. Cargill and I assumed that the upper portion of the exhaust stack may have fallen during a wind storm. I have no supporting evidence that the stack was damaged when the SVE was last operated on May 2, 2012, which was approximately 3 ½ years before the inspection. Mr. Cargill and I discussed the actions needed to restore the SVE to a permit compliant condition before resuming operation of the emission unit. Mr. Cargill stated that the exhaust stack would have to be repaired and he would need to check the integrity of the wells.

Image 1(20151215 094340 Van) : View of remaining portion of broken exhaust stack. Remaining portion of stack does not meet permit height requirements.

Fast Track Ventures Acquisitions, LLC has not maintained compliance with the monitoring frequency specified in special condition 1.5. This noncompliance shall be cited in a violation notice. Exhaust stack height concerns shall also be noted in the violation notice.

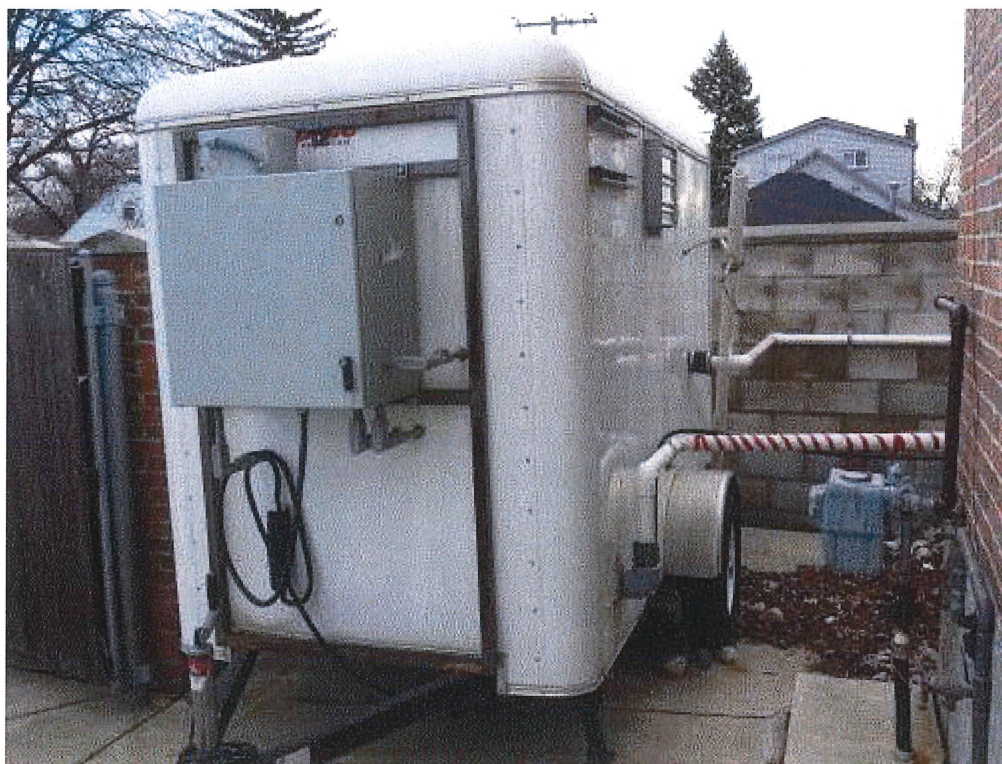
Image 2(20151215 093330 Van) : Exterior view of SVE trailer.
