# DEPARTMENT OF ENVIRONMENTAL QUALITY AIR QUALITY DIVISION ACTIVITY REPORT: On-site Inspection

FACILITY: Great Lakes Cremation Service, Inc.		SRN / ID: N8339
LOCATION: 29547 Costello Dr, NEW HUDSON		DISTRICT: Warren
CITY: NEW HUDSON		COUNTY: OAKLAND
CONTACT: Gil Pietrandrea , Facility Manager		<b>ACTIVITY DATE:</b> 03/18/2022
STAFF: Robert Elmouchi	COMPLIANCE STATUS: Non Compliance	SOURCE CLASS: MINOR
SUBJECT: Ongoing complaint investigations and unannounced on-site inspection.		
RESOLVED COMPLAINTS: C-22-00496

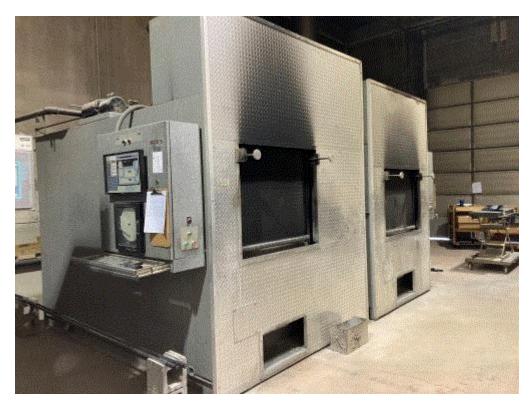
Both Mr. Pietrandrea and Ms. Hall were forthcoming with information. They stated that the facility is pending a thorough cleaning, in which dust will be blown off the tops of each machine and the exterior surfaces of each machine will be cleaned. I've attached a photo of the current state of EUCREMATORY4 and EUCREMATORY5 as reference.

<u>Image 1(IMG 0293.JPG)</u>: Cremation units EUCREMATORY5 and EUCREMATORY3 (left to right). This photo was taken to document the soot deposits on the exterior of each machine. All cremation units had similar soot deposits.
