FCA US LLC

WARREN TRUCK ASSEMBLY PLANT: EU-COLOR-TWO AND EU-TUTONE THERMAL OXIDIZER (TO) HYDROCARBON DESTRUCTION EFFICIENCY TESTING

April 11, 2018

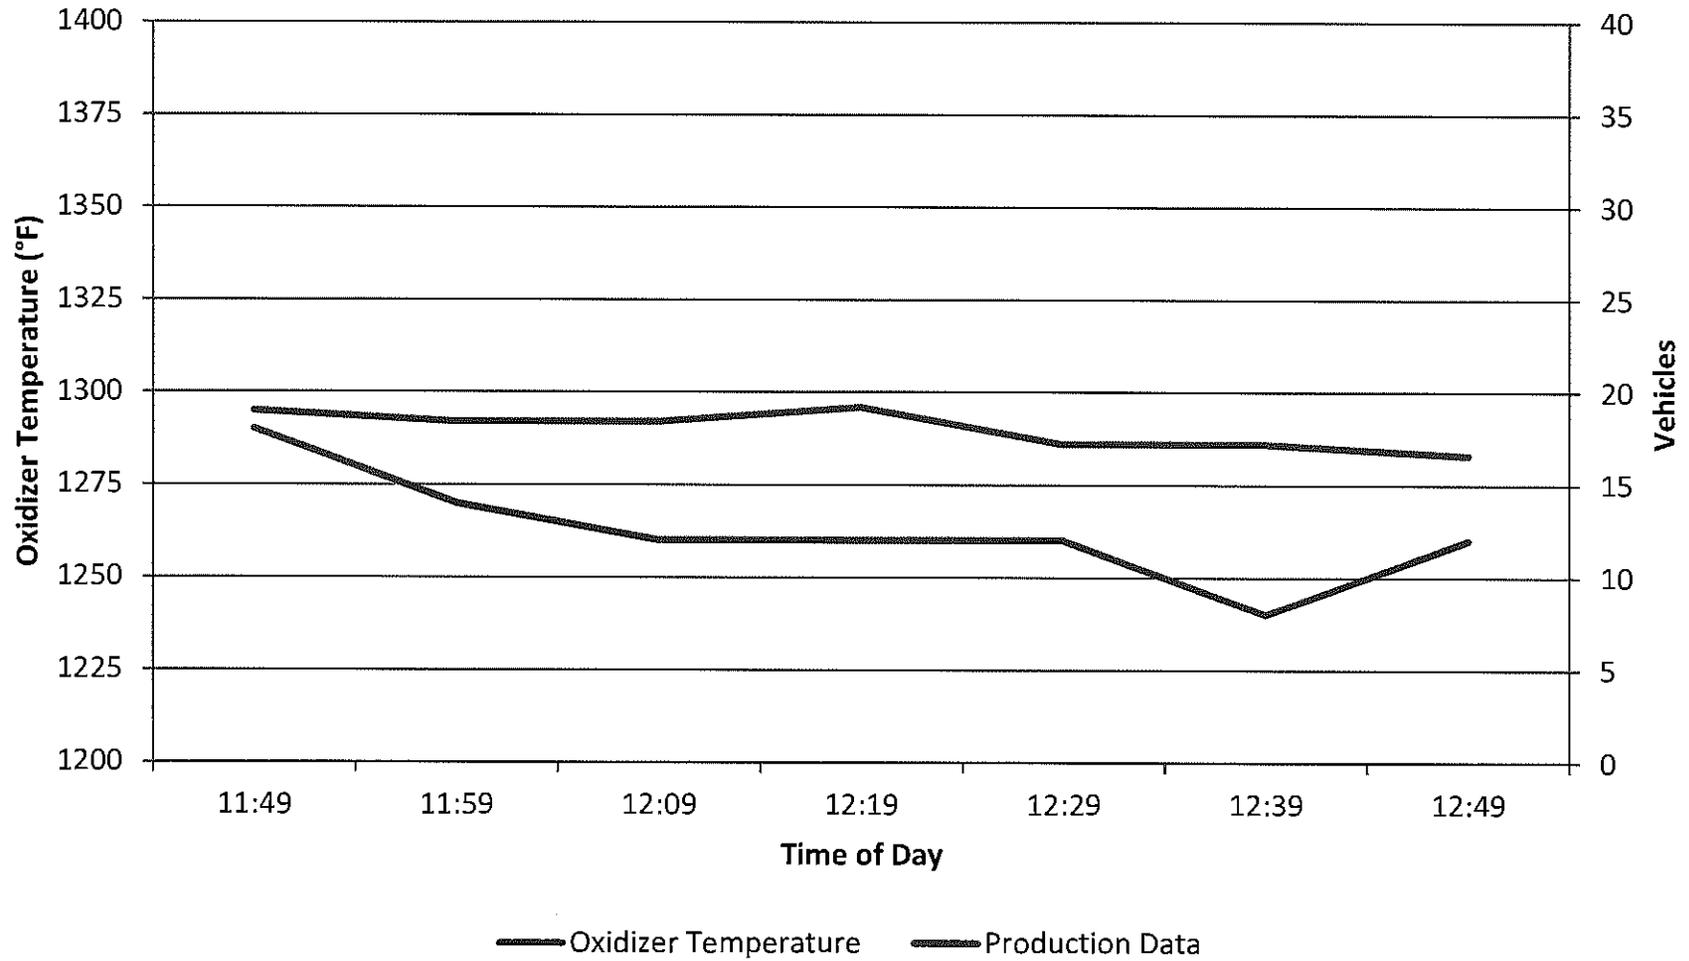
**Figure 14: Tutone Process Data - Test 4
February 15, 2018**
