DEPARTMENT OF ENVIRONMENTAL QUALITY
AIR QUALITY DIVISION
ACTIVITY REPORT: On-site Inspection

FACILITY: MPLX Terminals LLC - Lansing Terminal		SRN / ID: B5215
LOCATION: 6300 W GRAND RIVER, LANSING		DISTRICT: Lansing
CITY: LANSING		COUNTY: CLINTON
CONTACT: Faith Taylor , Environmental Professional		ACTIVITY DATE: 03/03/2022
STAFF: Michelle Luplow	COMPLIANCE STATUS: Compliance	SOURCE CLASS: SM OPT OUT
SUBJECT: Scheduled, onsite, partial compliance evaluation inspection to determine compliance with PTI 302-05D.		
RESOLVED COMPLAINTS:

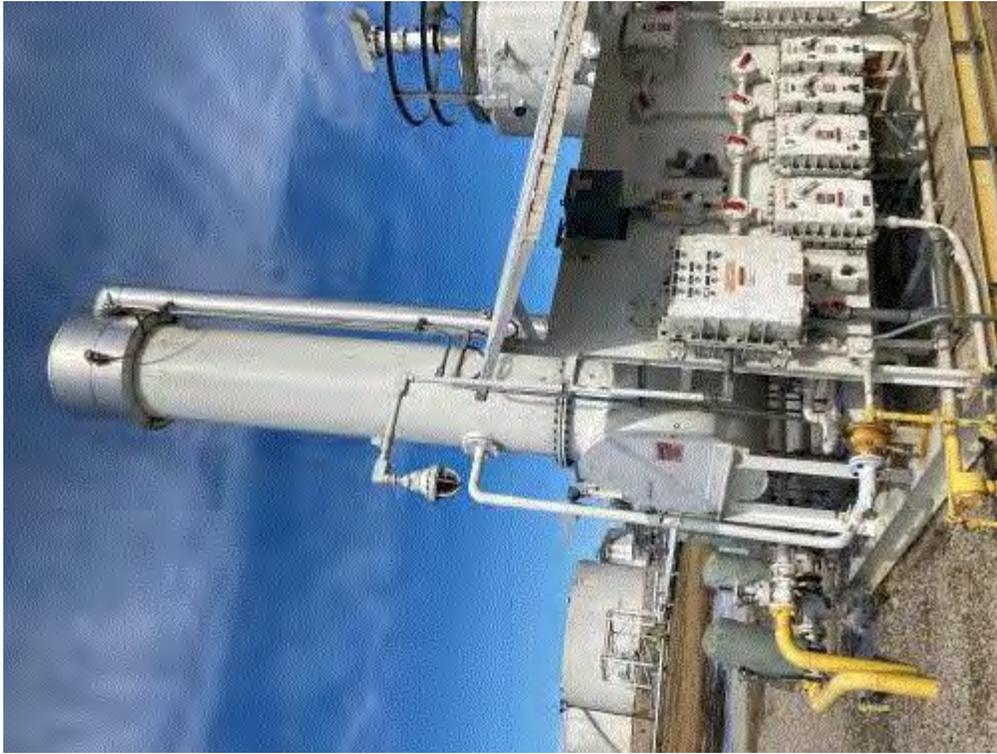
Image 1(VRU stack) : Stack for VOC emissions from VRU carbon bed system.

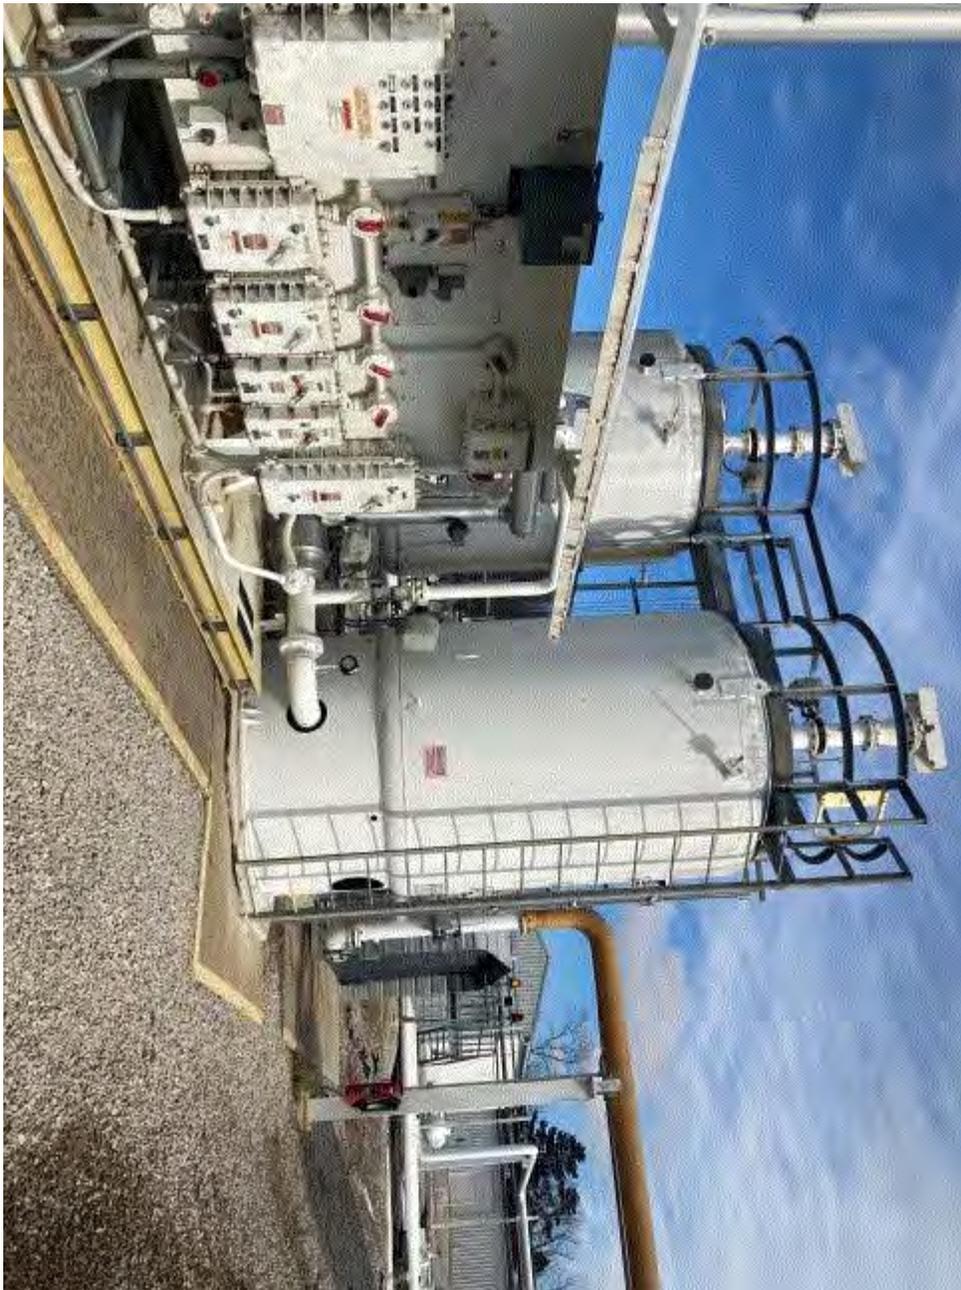
Image 2(VRU carbon beds) : Vertical structures house the carbon adsorption beds for VRU

K. Snyder said that both the CEM and annual carbon bed sampling are used to determine when carbon beds should be changed out on the VRU. The carbon beds are sampled once per year (as required by GDGACT) using a long grain probe – 1 sample core taken at random per carbon bed. The samples are then sent to John Zink for analysis. Each sample is given an overall grade by John Zink (A – F). K. Snyder said they watch for trends in the carbon beds (e.g. a “B” rated bed, gradually declined to a C or D carbon bed over the course of several years). When a decline in the bed is noted, MPLX looks into scheduling replacement, unless the CEM indicates that there are no excessive VOC emissions.

K. Snyder said MPLX conducts semi-annual preventative maintenance to look for “dusting” from the carbon beds: fine carbon in the glycol or VRU, as this is an indicator that the carbon beds are degrading. He said they also check for back pressure in the system and look for high pressure via the pressure transmitter on the vapor line. High pressure would indicate mechanical damage of the carbon bed.

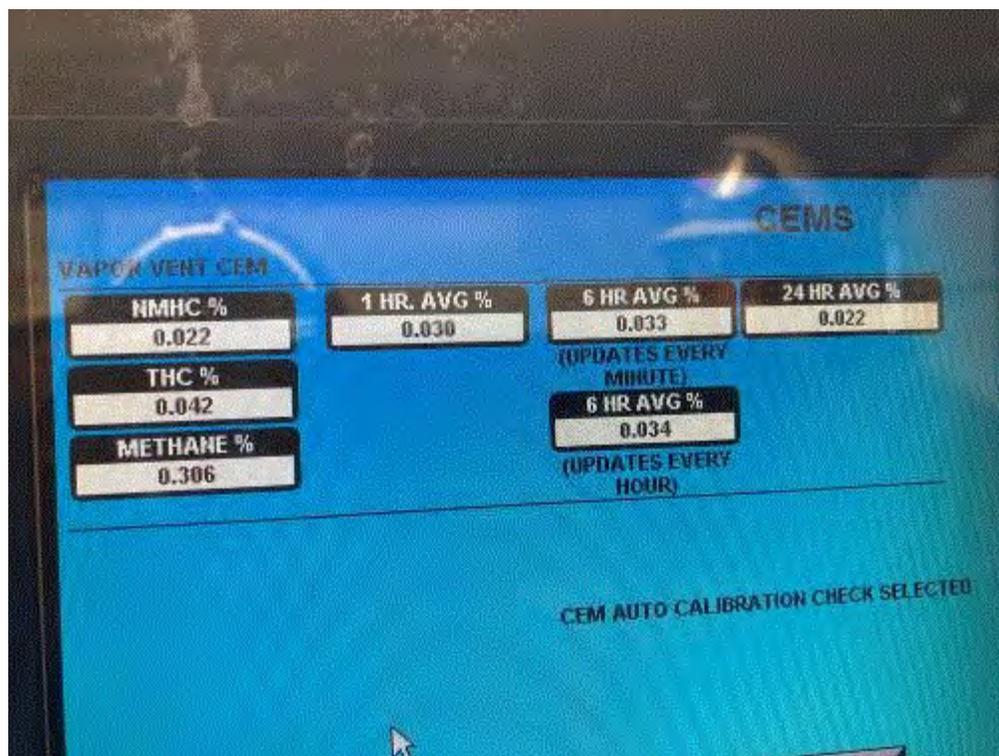
Image 3(CEM Data) : Instantaneous CEM data monitor readout for NMHC, THC, and Methane.

A. Lebrun said that EURACK will shut down if the CEM reads an NMHC of 0.06% (much lower than the emission limit of 31 mg/L or 1.30%). A. LeBrun explained that they have an alarm that will sound if the NMHC 6-hour average reaches 1.47% (35 mg/L). I informed them that the permit limit is 31 mg/L and recommended that they

readjust the alarm to something below the permitted limit of 31 mg/L. A. LeBrun and F. Taylor were amenable to this recommendation.

K. Snyder said that if the CEM detects emissions at 45% of the permit limit, loading from the rack is discontinued until MPLX can determine the cause for the increase in emissions. They will not begin loading again until the CEM detects NMHC below 45% of the permit limit.

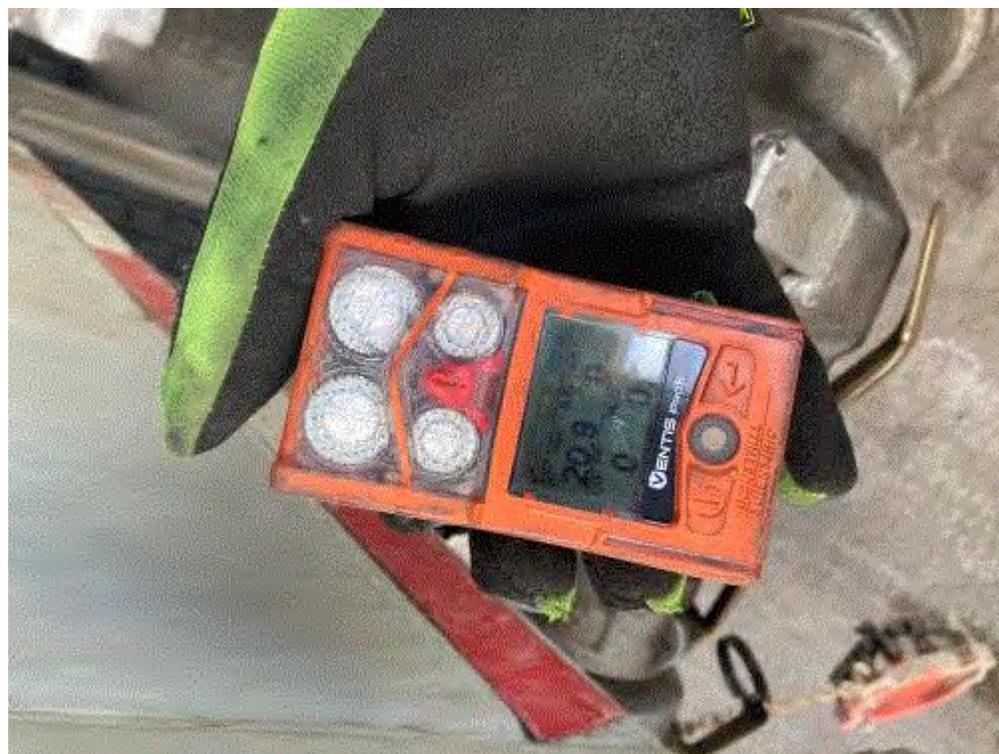
Image 4(LEL Meter) : Meter used to check for leaks. Reading was "0" during inspection.

Personnel onsite check for the sight, sound and smell of VOCs while trucks are loading, as well as conduct random checks using the portable PID monitor. During the inspection B. Keller used the portable PID meter to detect the % LEL at the vapor return line from the truck being loaded, as the LEL will indicate whether there is a vapor leak. The LEL meter read 0, i.e. there were no vapors leaking from the collection line. Each truck driver is also trained in MPLX's procedures for loading trucks, including attaching the vapor recovery hose correctly.

Rule 627 also requires that there shall be no gas detector reading greater than or equal to 100% of the LEL at a distance of 1 inch from the location of the potential leak in the vapor collection system using the method in Rule 2005, which is used to confirm leak-tightness of the gasoline delivery vessel tanks during loading, but also for determining leak-tightness on the VRU. B. Keller said their PID monitors will go off at 10% of the LEL, but that MPLX wants to see 0% LEL on all leak-tightness checks.
