**DEPARTMENT OF ENVIRONMENTAL QUALITY
AIR QUALITY DIVISION
ACTIVITY REPORT: On-site Inspection**

FACILITY: Hound Resources - Wexford 10 Facility		SRN / ID: B5588
LOCATION: 7 Mile Rd., BUCKLEY		DISTRICT: Cadillac
CITY: BUCKLEY		COUNTY: WEXFORD
CONTACT: Julie Johnston , Vice President		ACTIVITY DATE: 07/24/2024
STAFF: Tammie Puite	COMPLIANCE STATUS: Non Compliance	SOURCE CLASS: SM OPT OUT
SUBJECT: Complete a Full Compliance Evaluation and Inspection for the Wexford 10 Facility.		
RESOLVED COMPLAINTS:

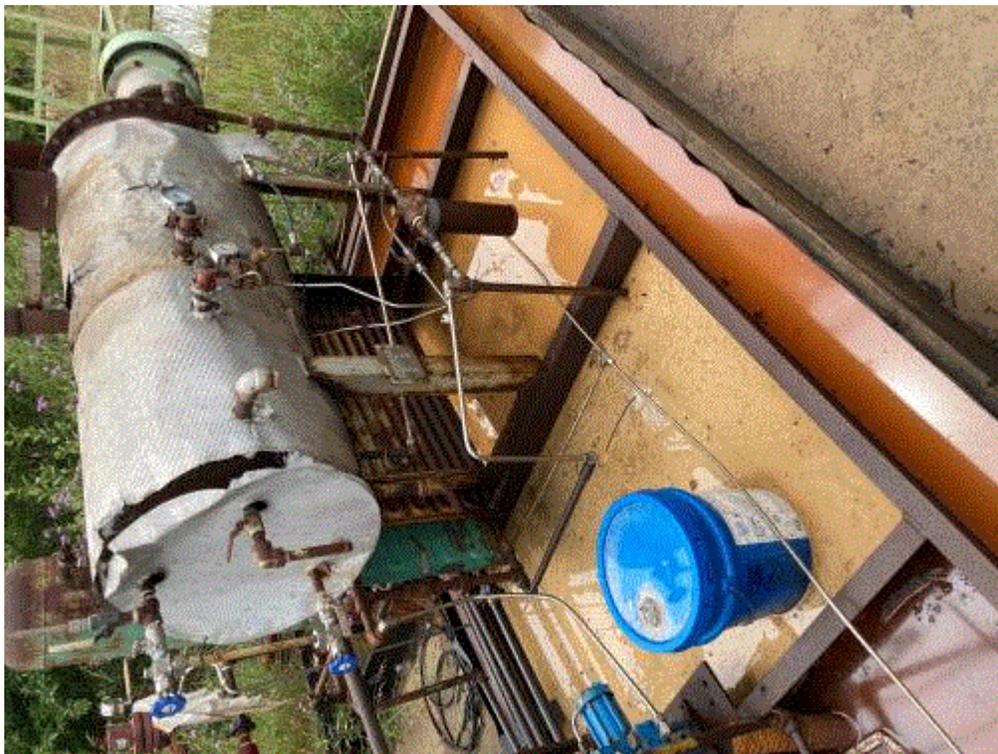
Image 1(EUDEHY) : Showing Leak

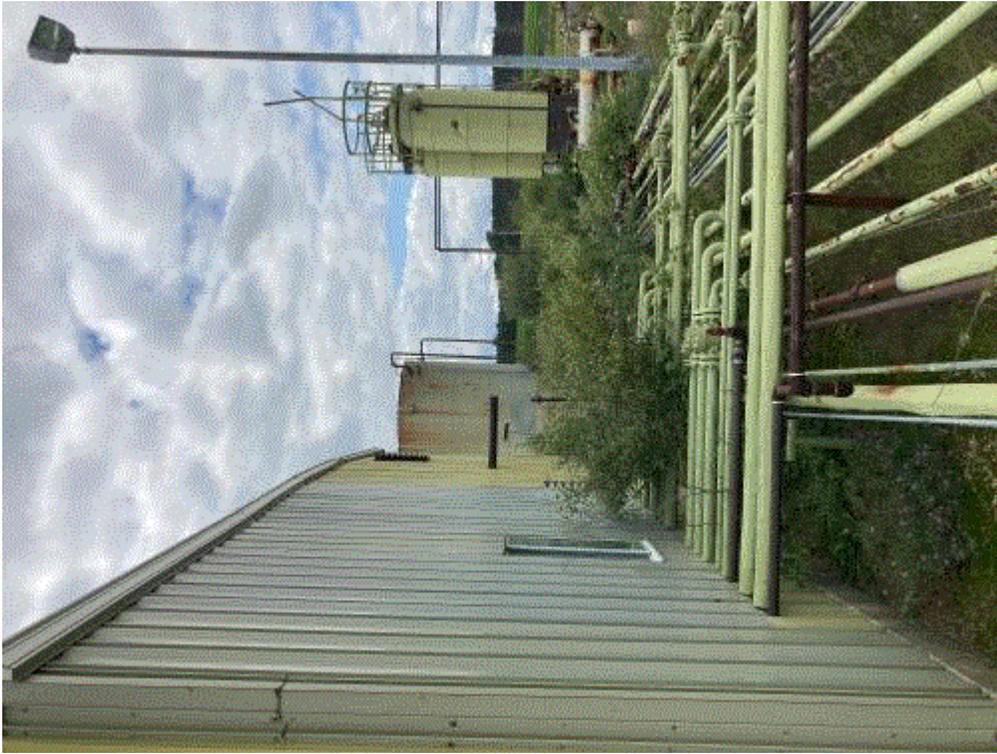
GC 1, GC 6, GC 12 & R 336.1278a (1) - There are two engines on site a 12 Cylinder Waukesha that is not in operation and a running engine on a Skid labeled BATB 28, 6 cylinder inline, running at 1130 RPM, with suction pressure of 20, and a PSI of 42. PTI 140-22 says that a CAT 3306NA 145 hp engine was in operation at the time of the PTI issuance. A records request was sent, requesting information to prove the operating engine onsite is truly exempt. Hound Resources says that the engine is a Caterpillar G3306NA, 145 HP, 4-stroke, rich burn, installed in 2014. Our records indicate that this engine was installed in 2016, replacing an electric compressor motor. There is evidence that an engine previously vented up through the roof, however, the current engine vents directly out through the wall of the building. I was unable to determine if the engine onsite is still the CAT G3306NA due to not finding a serial number or nameplate on the current operating engine. The CAT G3306 NA meets exemption requirements, and I assume that the current engine on site, if not the same, does as well, as the operation panel stated that it was operating at a low enough RPM to meet exemption. On August 1, 2024, the 4 gas meter alarmed when trying to view the sponges/seperators outside of the compressor engine building and downwind of the stack of the compressor engine, CO at 55 PPM, thus not allowing me to do a full analysis of the separators. Under GC 12, it would be better if the engine vented vertically upward, instead of horizontal.

Image 2(Engine Stack) : Shows Stack Venting out Wall

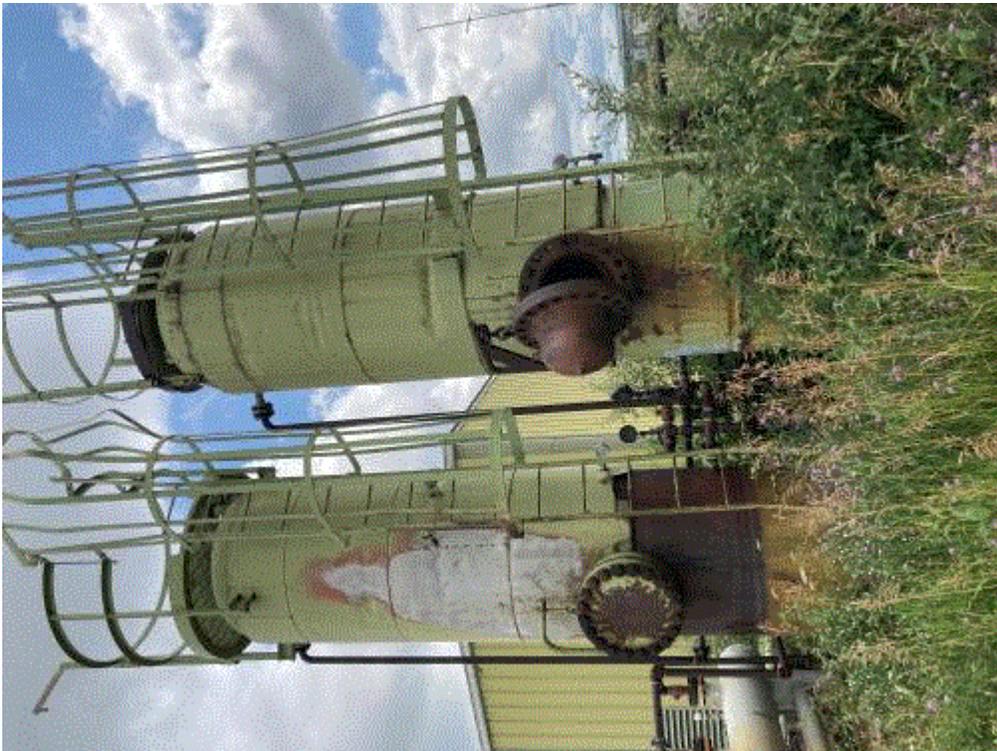
Two Iron Sponges or separators are located on site. Only 1 is in operation, but the system does have pressure, at 140 PSI. There is an oil leak for the sponge that is working.

Image 3(Sponges) : Shows that one of them is not operating.

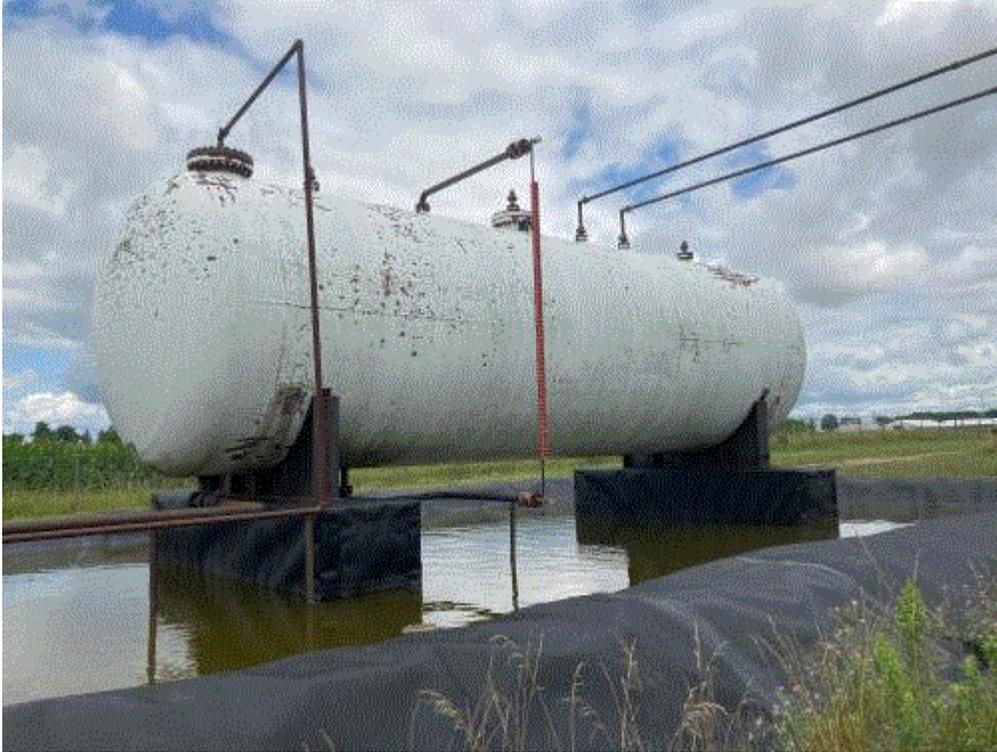
NGL Tank 30,000 gallon – secondary containment was ½ full of water. It appears that the loadout for this tank has not been used, due to the amount of overgrown vegetation, and no tire tracks. Hound Resources reported that 128.42 (gallons?) were hauled away in June of 2023.

Image 4(NGL Tank) : Shows Secondary containment 1/2 full of water.

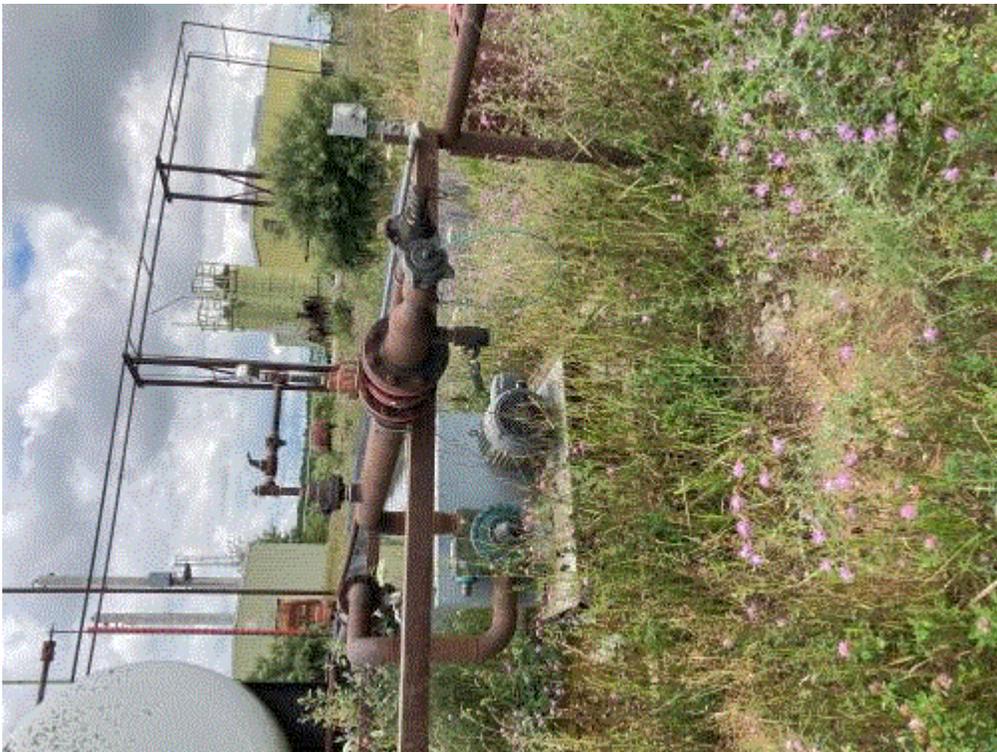
Image 5(NGI Tank Loadout) : NGL Loadout with excessive vegetation.

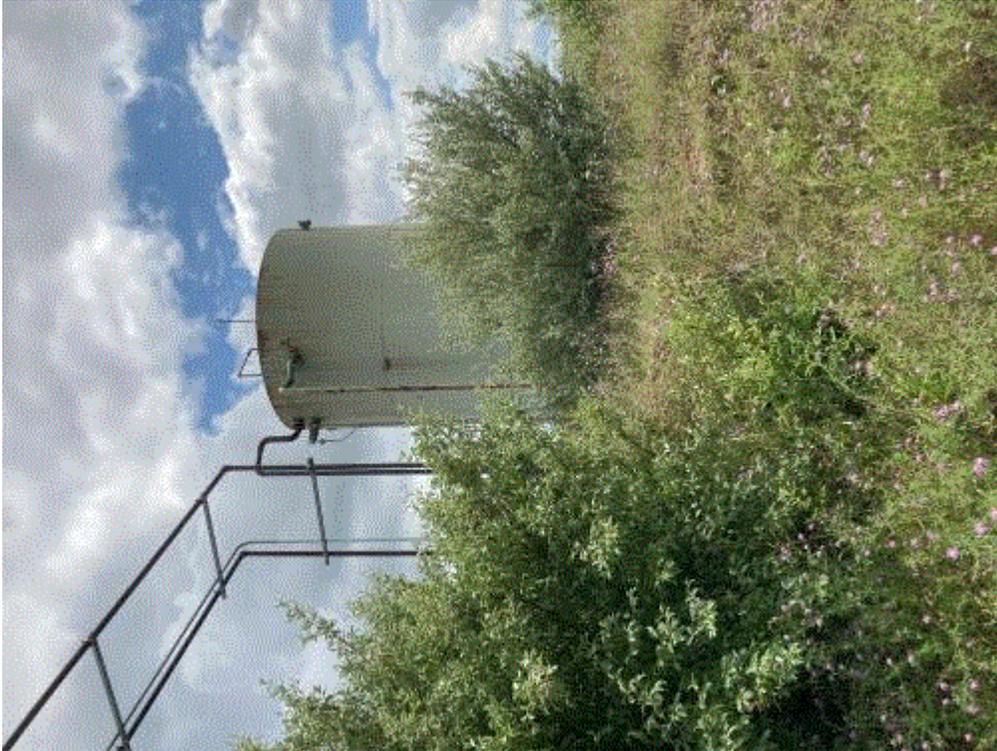
400 BBL Stock Tank – Vegetation was so overgrown that I was unable to see much about this tank. It does appear to still be in use, due to active pipes going to the tank. Hound Resources reported that 114 (Barrels?) were trucked out in September of 2023.

Image 6(400 BBL Tank) : Overgrown Vegetation limiting Access to Tank.

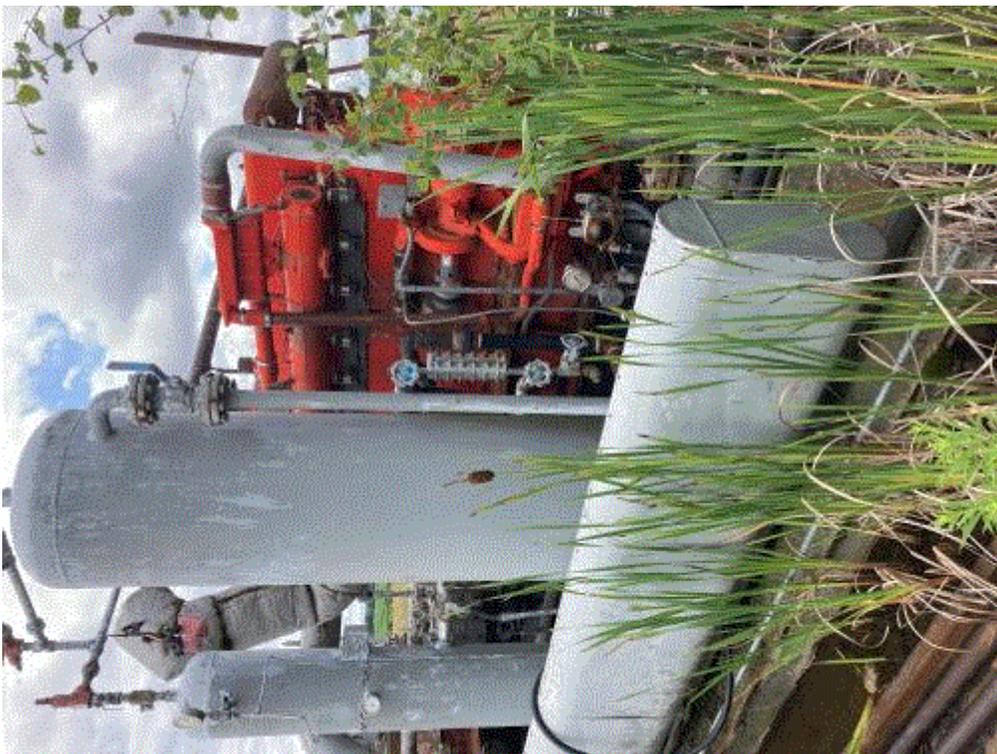
Refrigeration Skid – Was not in operation, but it is pressurized. It appears that there is flow through this process. A 6 cylinder Wakesha engine powers this unit. This engine was determined to meet exemptions February 20, 2016, when it was operating.

Image 7(Refrigeration Skid) : 6 Cylinder Waukesha Engine

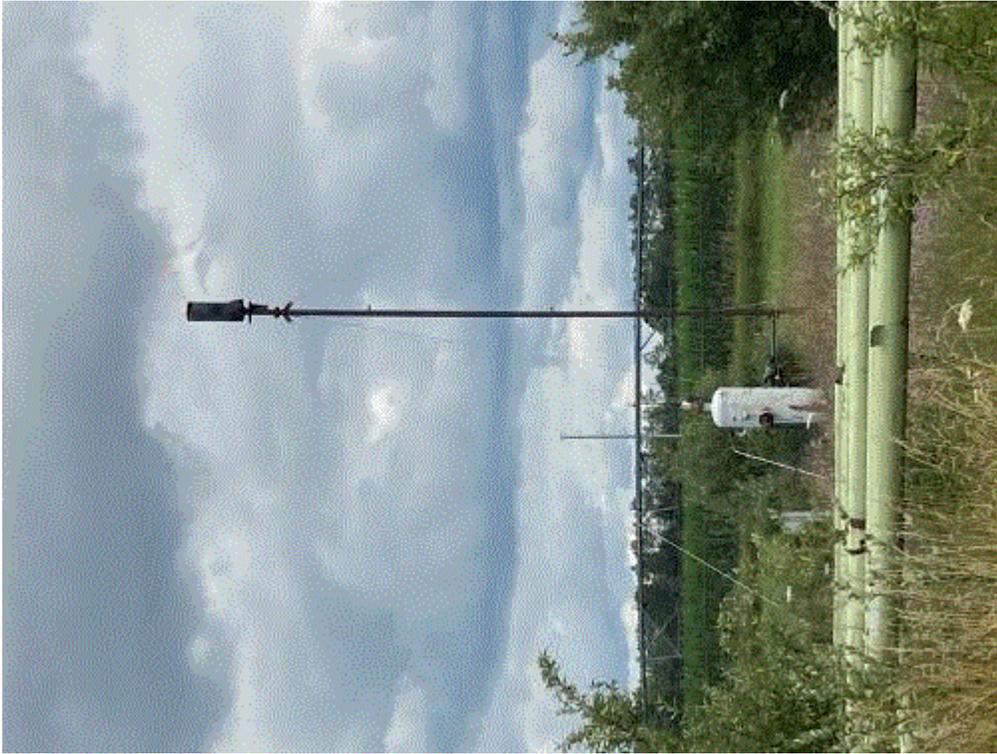
- **FLARE – IV. 1-3.** A records request to determine if the sulfur dioxide emissions from the flare meet the exemption of less than 1 pound per hour. As built diagram of the flare was requested. There are multiple flares on site, and a diagram would help determine the exact equipment that records are provided for and which one pertains to the issued PTI. There was a flare onsite that was operating, but it was not maintained in accordance with industry standards. VI.4 – A request was made for 12-month rolling time period when the flare pilot was extinguished. OGMD, did inform me that they have had odor complaints that pertain to this facility, which leads me to believe that there are periods where the flare pilot does extinguish. Hound Resources reports that there were, "No recorded instances of Flare not burning during audit periods." Hound Resources reported that SO₂ emission are .000014 lb/hr that feed to the flare from the 400 BBL Tank. No calculations were provided, nor any Lab Analysis for verification. I was unable to reproduce this number doing my own calculations from the data provided, and this number is not for the full amount of emissions going to the flare. At this time I am unable to make a compliance determination to determine if the flare is meeting the exemption requirements. As built diagrams were not provided, but field checks with a range finder demonstrate that the flare is built and operating as permitted.

Image 8(EUFLARE) : Operating Flare

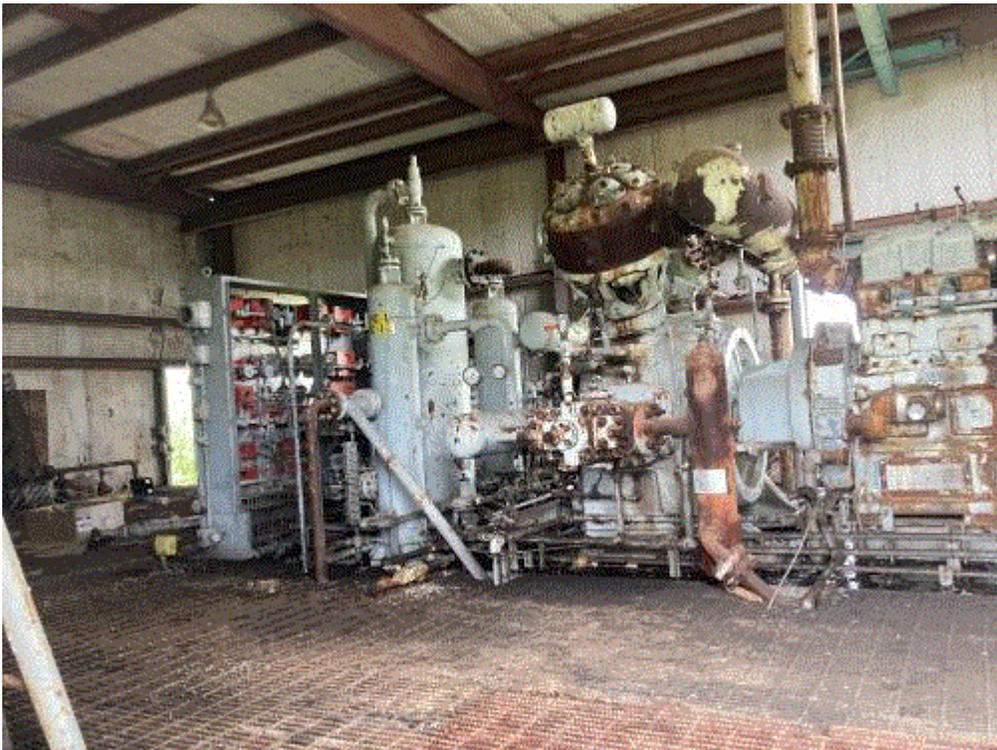
Image 9(Old Compressor Eng) : 12 Cylinder Waukesha Engine - Not in Operation.

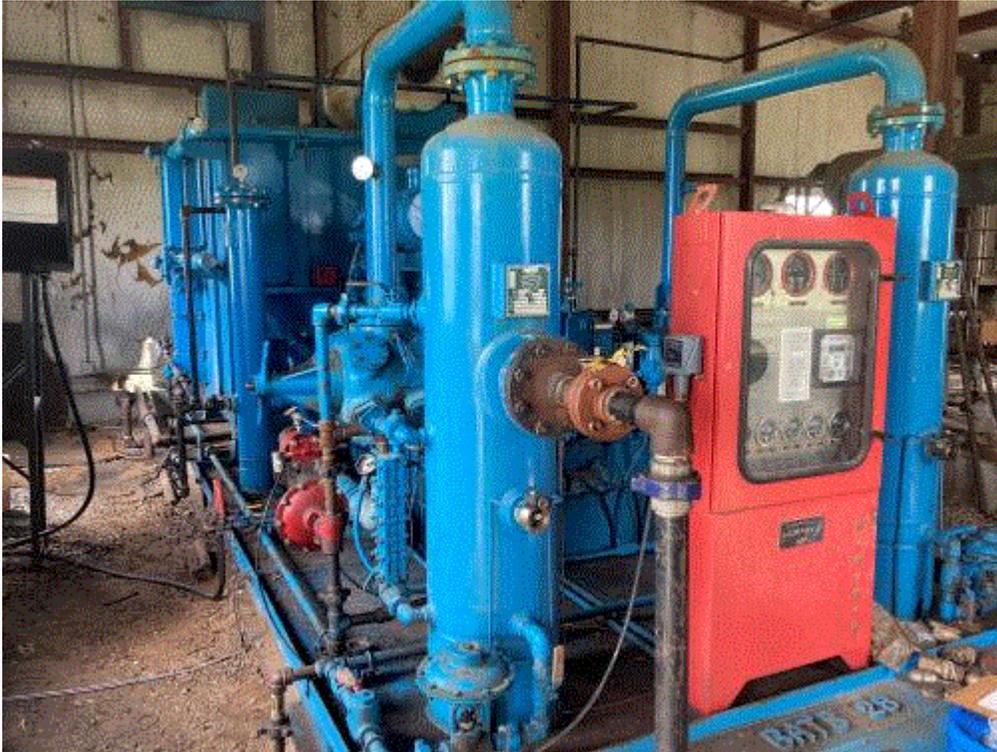
Image 10(BATB28) : Operating Engine

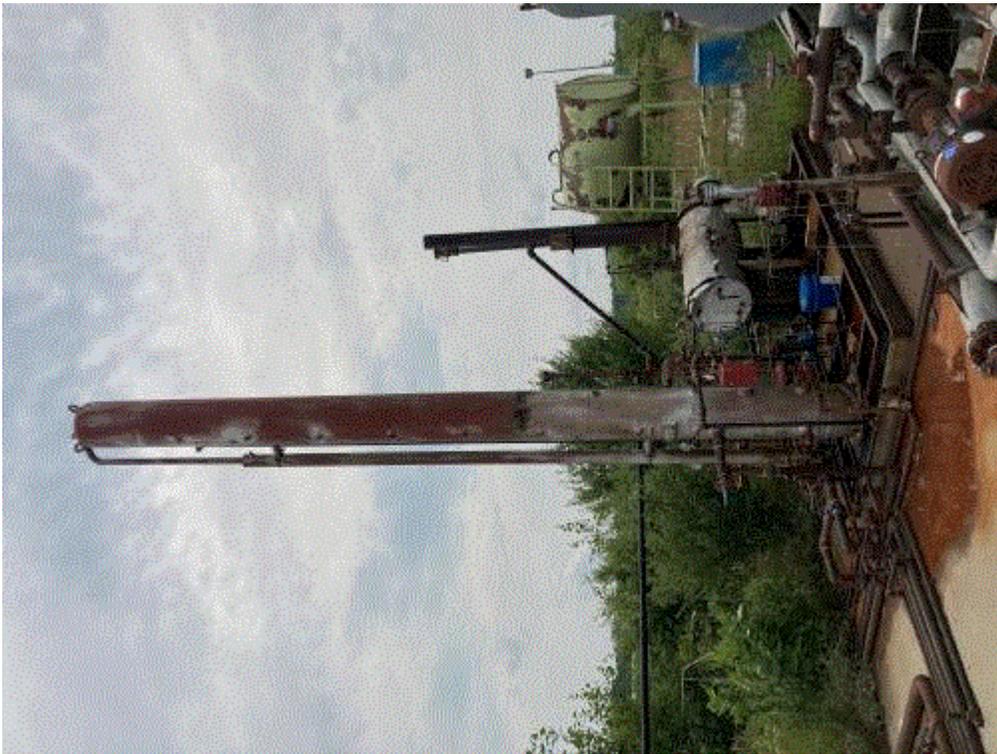
Image 11(EUDEHY) : Operating Dehy

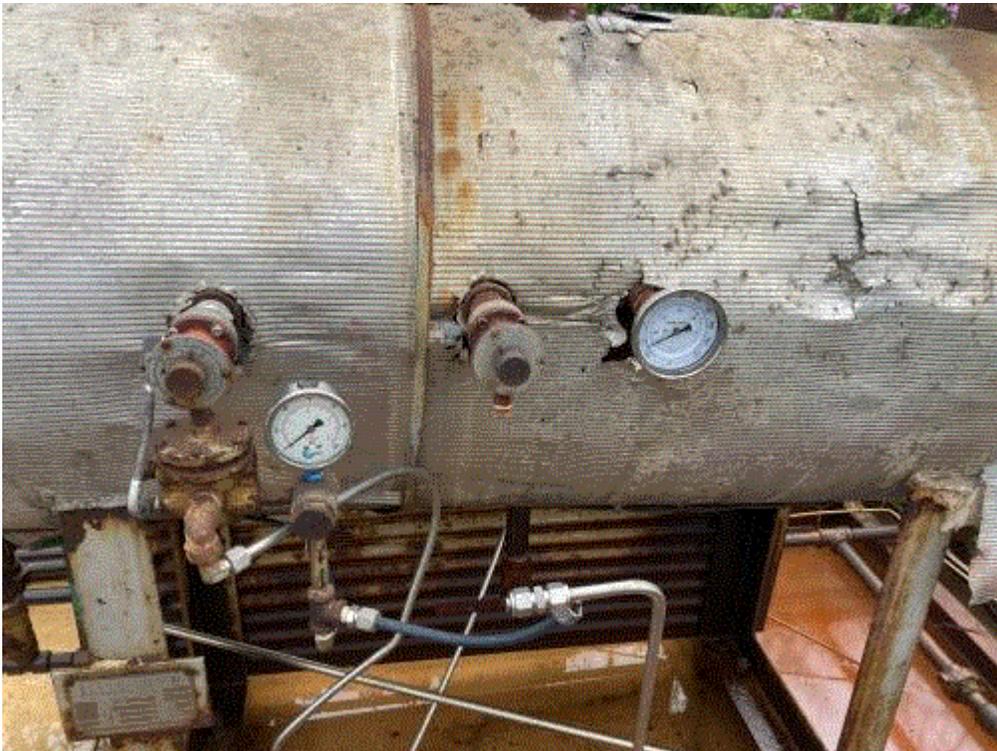
- **EUDEHY –** It is believed that there are at least 3 different Dehys on site, and an Amine Plant/ Sulfanol Process, two sponges, and a refrigeration unit. Two dehy's were not operational. The one that matched up with previously submitted company diagrams as the "operating dehy" was partially operating, the heater for recycling the Glycol was not in operation, the dehy unit was in disrepair and leaking. There was no burner operating that is associated with any of the dehys. V.1 – A wet gas analysis was requested. III.1 – Records were requested to demonstrate that the dehy is not exceeding the minimum of 0.13 GPM recirculation rate. A request for a site diagram showing what equipment is supposed to be operating that pertains to the permit was made. During the permitting process, the company provided documentation to show that the EUDEHY met the criteria for exemption but felt that having a PTI best suited the company's needs, a wet gas analysis was provided for the permitting process and issuance of PTI 140-22. Hound Resources responded with a site diagram that showed that the leaking dehy is the permitted unit. That the sponges are an active part of the process, and the refrigeration unit and Amine Plant/ Sulfanol Plant are not operating. Hound Resources records showed that the Dehy is recirculating at 0.41 gpm, which is violation of the permitted limits of 0.13 gpm. A wet gas analysis was not submitted with the records request. This equipment is not being maintained or operated per industry standards.

Image 12(EUDEHY) : Showing Reboiler not working

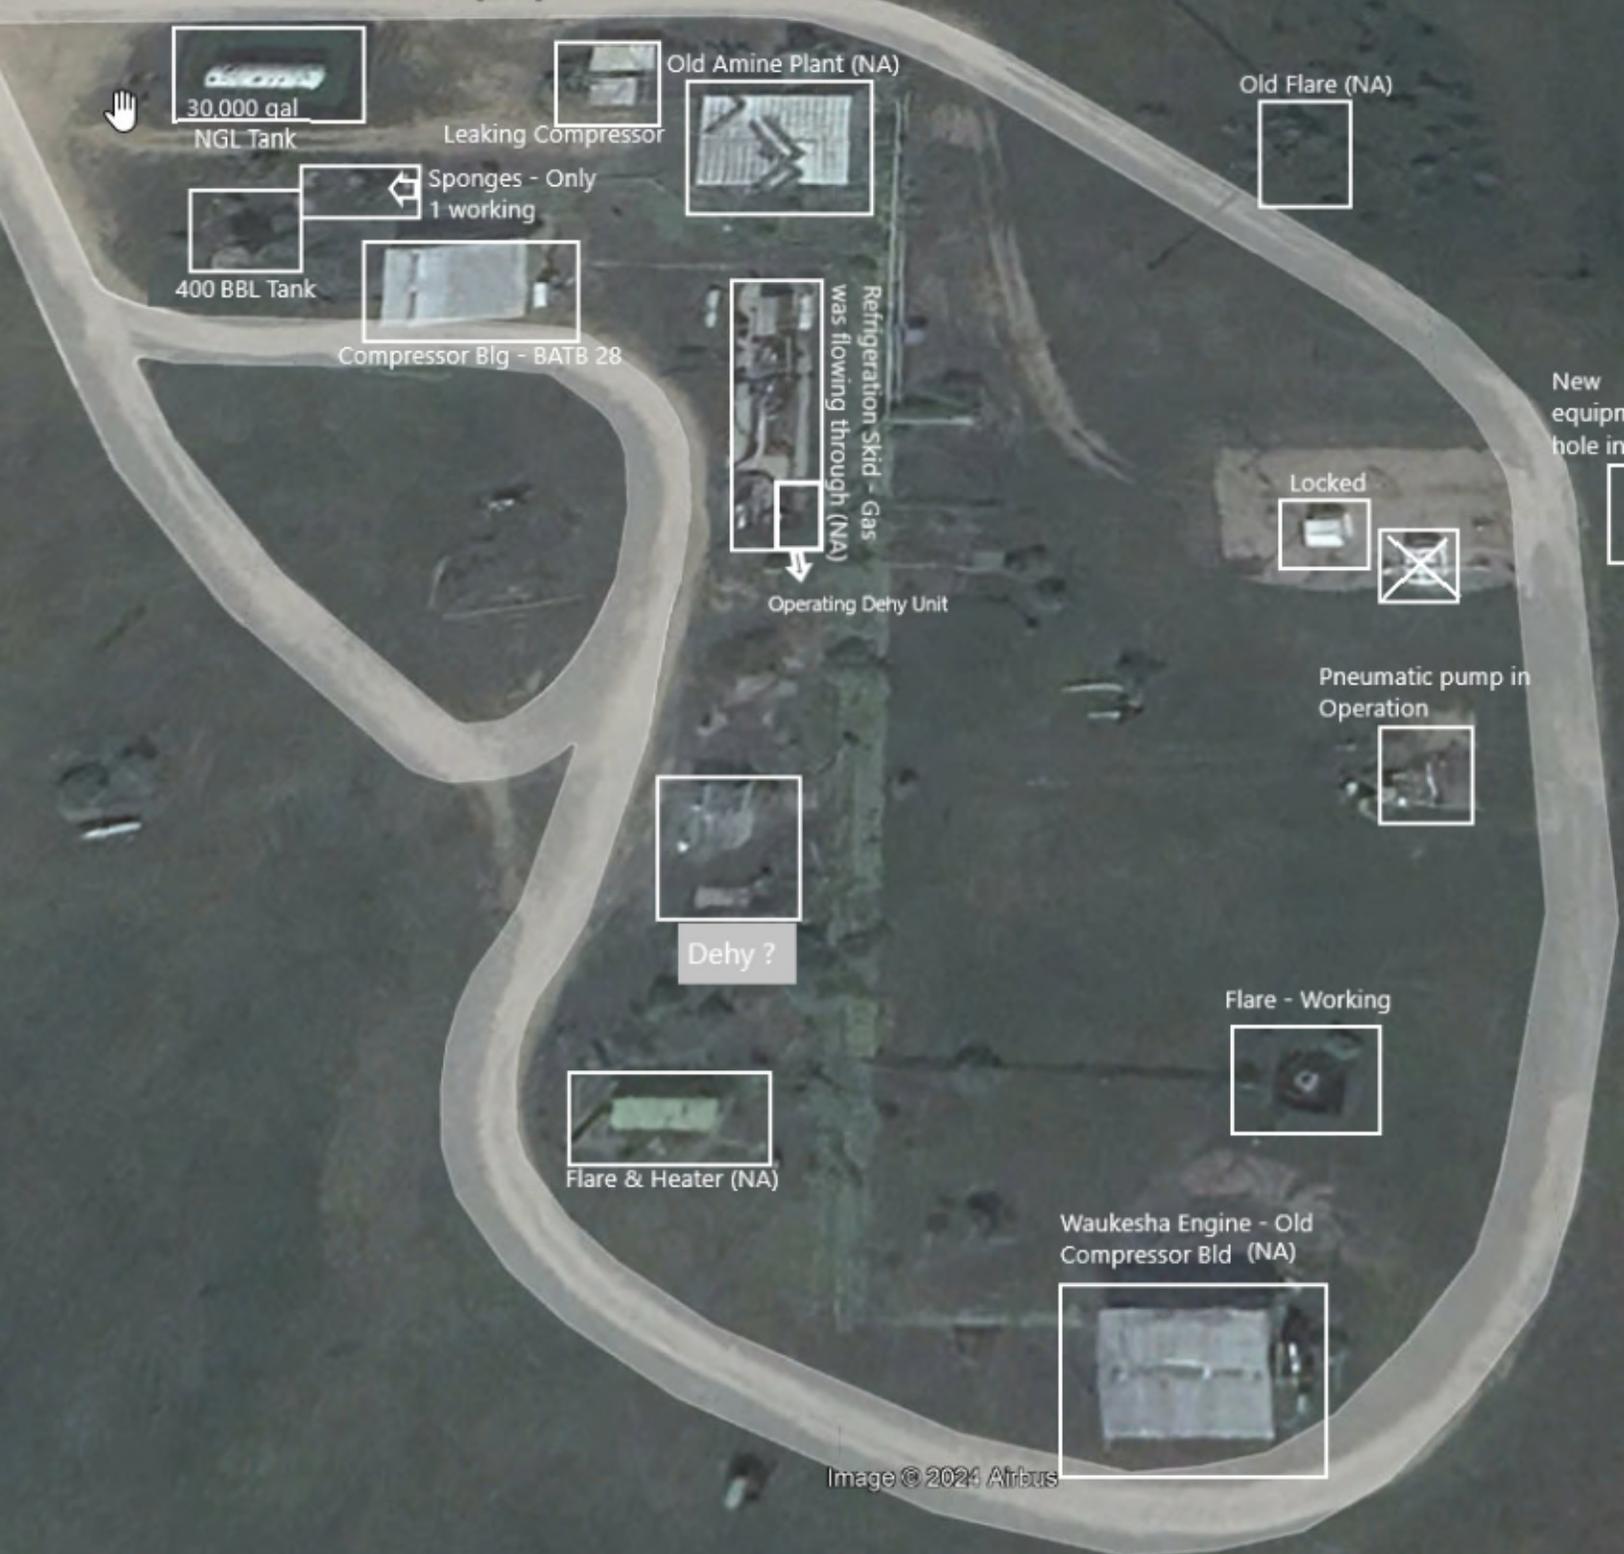
30,000 gal
NGL Tank

Leaking Compressor

Old Amine Plant (NA)

Old Flare (NA)

Sponges - Only
1 working

Compressor Bldg - BATB 28

Refrigeration Skid - Gas
was flowing through (NA)

Operating Dehy Unit

Flare - Working

Waukesha Engine - Old
Compressor Bld (NA)

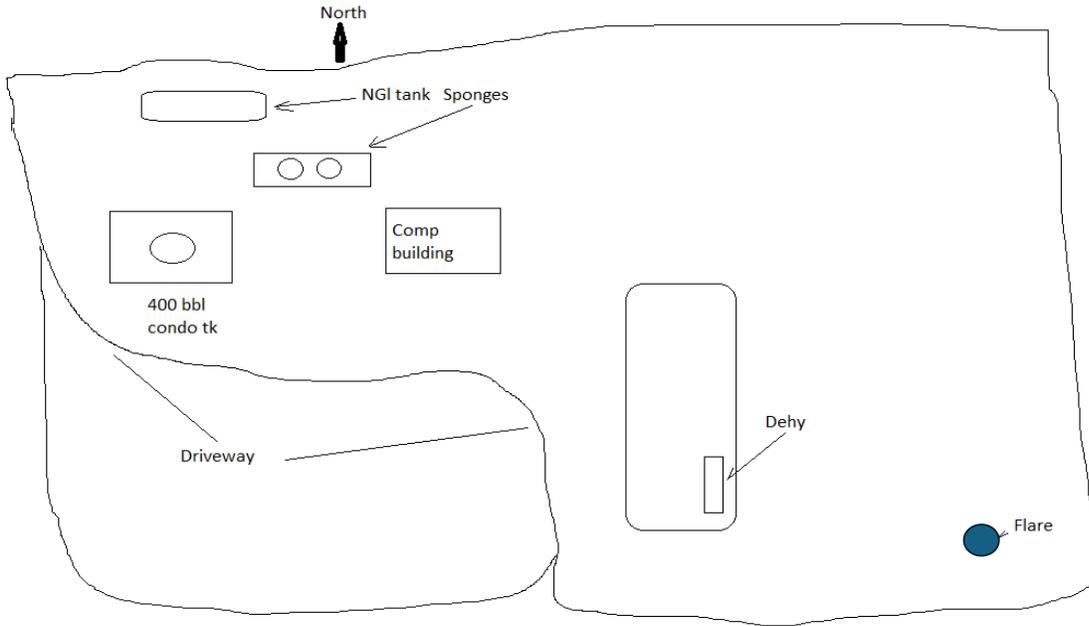
EUDEHY/SVFLARE

Dimensions remain the same as the previously reported and information supplied

Flare is 3 inches in diameter and 36 feet tall

Location is showed in diagram

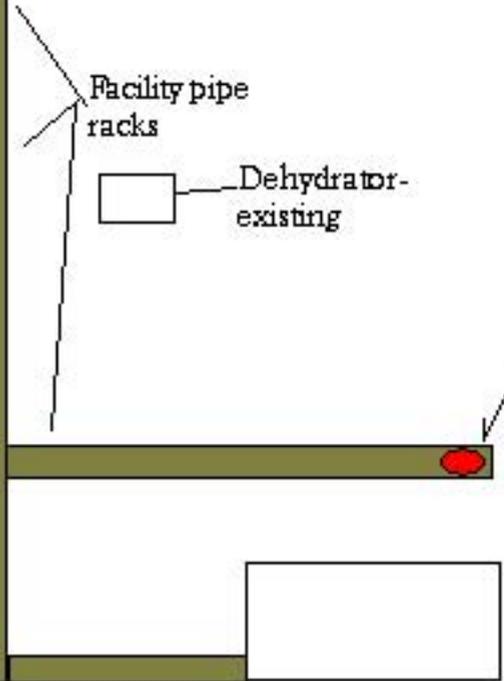
Sour production gas from wells

1st stage compression

Sulfa Treat Sponges

2nd stage compression

Dehy&Ref skid

FLARE

Old amine plant, amine heater, and big flare are not used or even connected to the process anymore.
