**DEPARTMENT OF ENVIRONMENTAL QUALITY
AIR QUALITY DIVISION
ACTIVITY REPORT: On-site Inspection**

FACILITY: GMI - HMA Plant 19		SRN / ID: B7068
LOCATION: 2675 TREAT RD, ADRIAN		DISTRICT: Jackson
CITY: ADRIAN		COUNTY: LENAWEE
CONTACT: David Benecke , Environmental Manager		ACTIVITY DATE: 07/11/2024
STAFF: Brian Merle	COMPLIANCE STATUS: Non Compliance	SOURCE CLASS: SM OPT OUT
SUBJECT: Announced scheduled compliance inspection.		
RESOLVED COMPLAINTS:

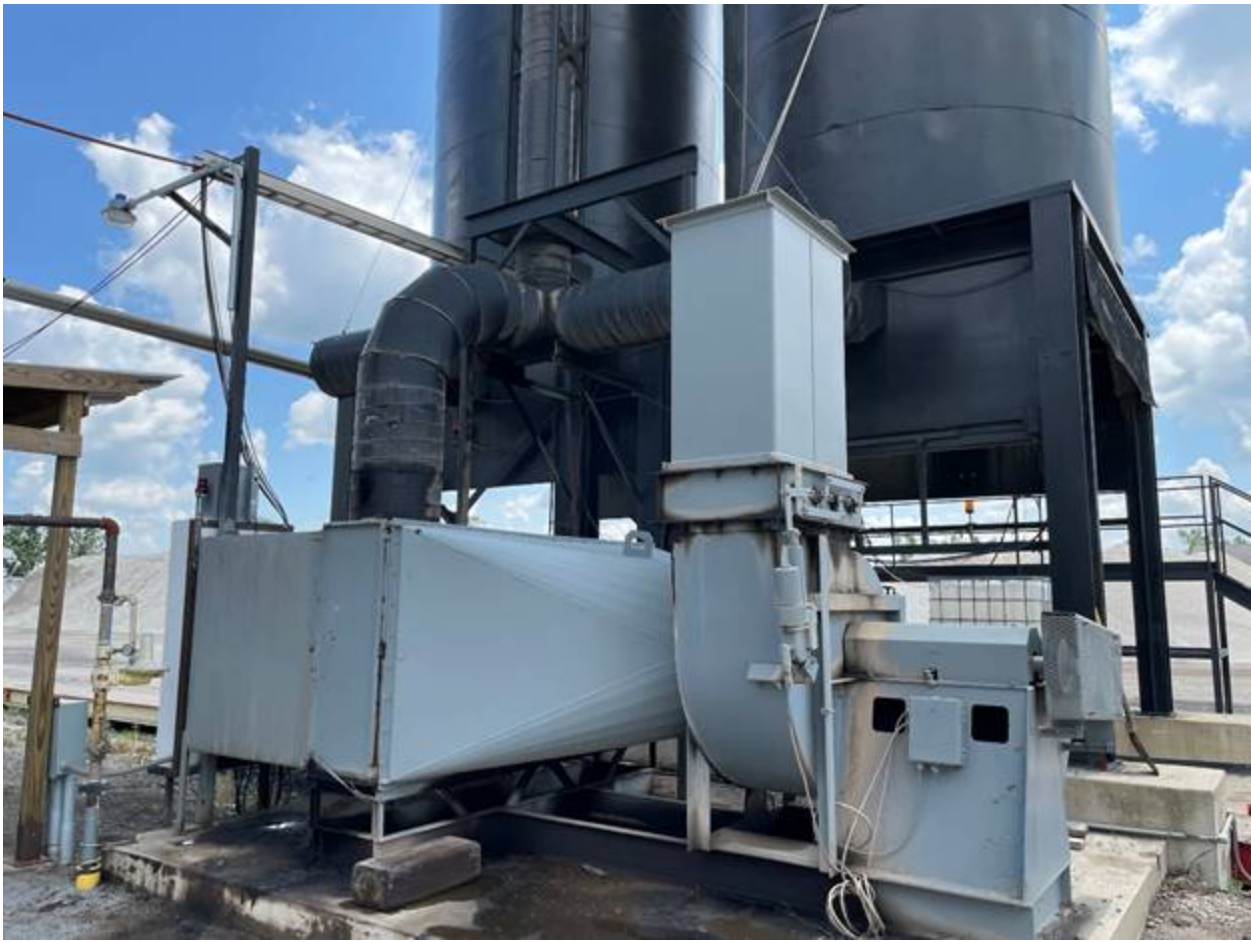
SC III.2 I was able to observe the load-out area controlled by the Blue Smoke collection system (Image 5). They are in compliance with this condition.

Image 5: Blue Smoke collection system with storage tanks.

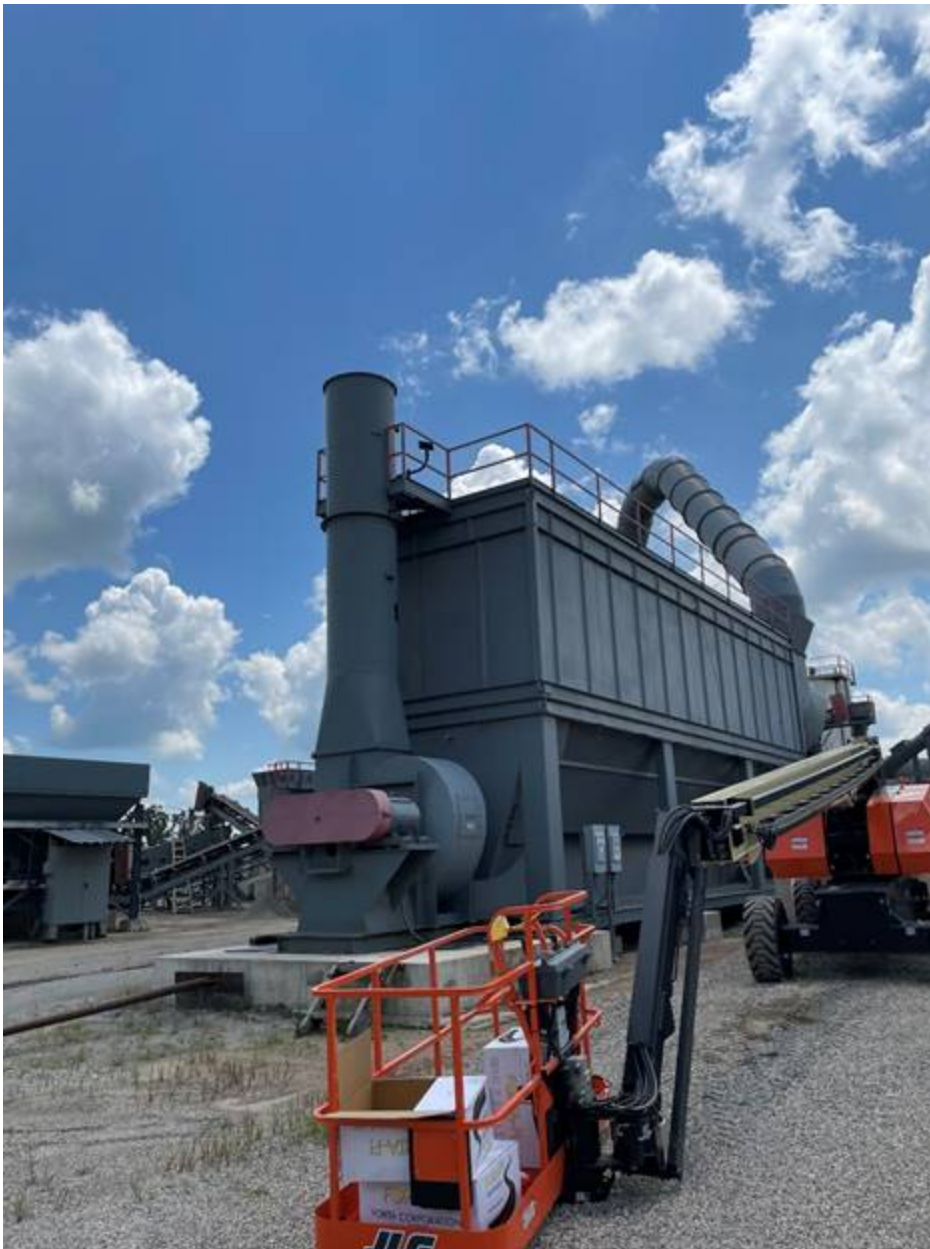
Dave took me out to the plant yard and explained the entire process. Aggregate is loaded from the yard into hoppers (seen in back left of Image 6). This is then transferred by conveyor into the rotary drum (Image 7) where it is heated with the binder to produce asphalt. I asked Dave about their current production, and he said they typically operate at 50-60 tph, but they process is capable of reaching 300 tph. The permit is currently permitted for 225 tph, but they were planning on submitting a modification to increase this limit. The new baghouse was observed to be in good working order (Image 6). We then went over to the asphalt storage tanks, where the material is transferred by conveyor from the drum into the asphalt storage tanks (Image 5, behind Blue Smoke collection system). This is also where the Blue Smoke collection system is located (Image 5). The facility also has a sign posted for drivers to remember their tarps as required in the Fugitive Dust Control Plan (Image 8). Dave explained that any particulate collected by the baghouse is kept in a storage pile at the facility or put back into the process. Overall, the yard and process equipment appeared to be well maintained and clean. No emissions or fugitive dust were observed from the process.

Image 6: Baghouse with aggregate hoppers to the back left.

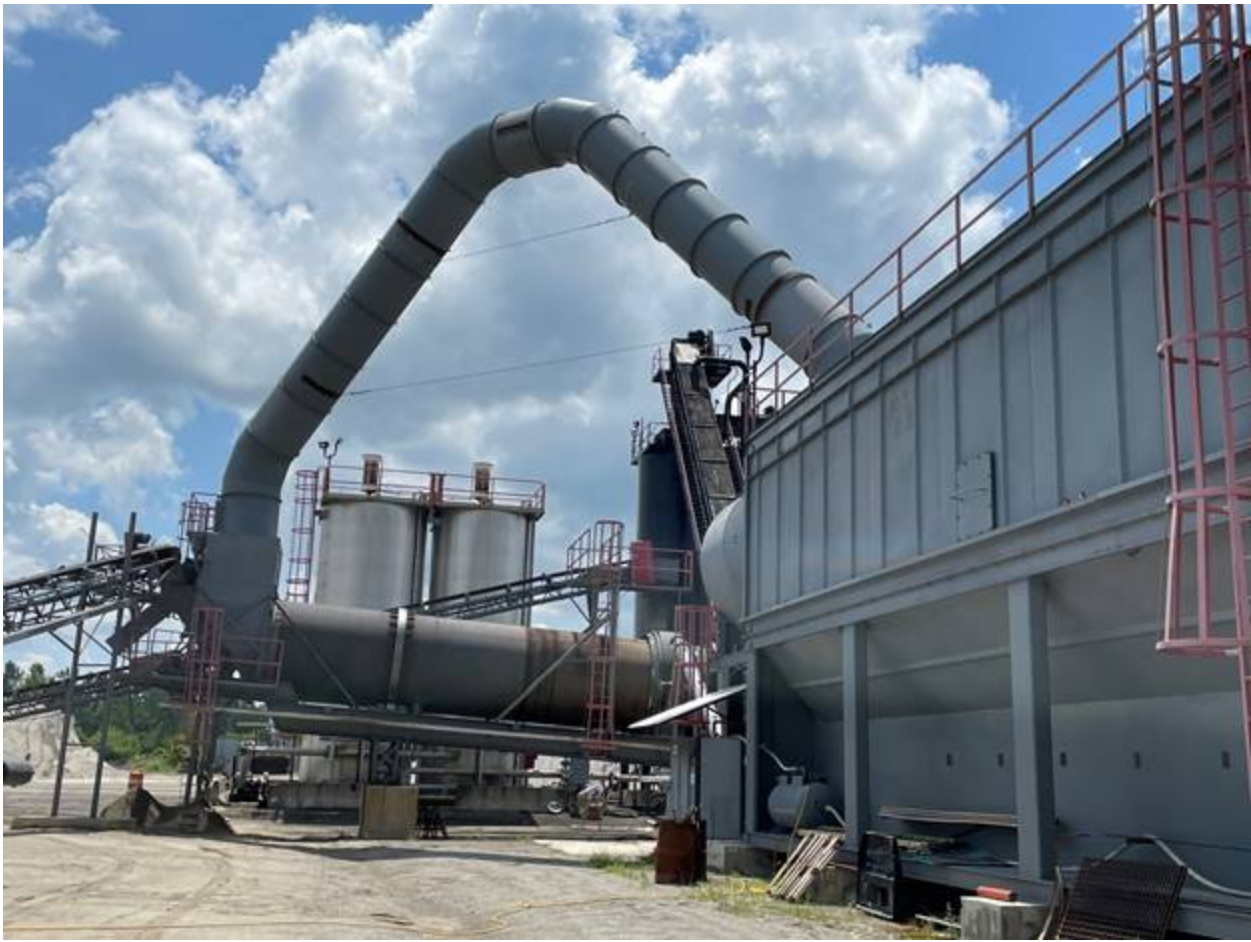
Image 7: Rotary drum. Aggregate is fed from the left, and exits the drum to the right and is conveyed up into the storage tanks.

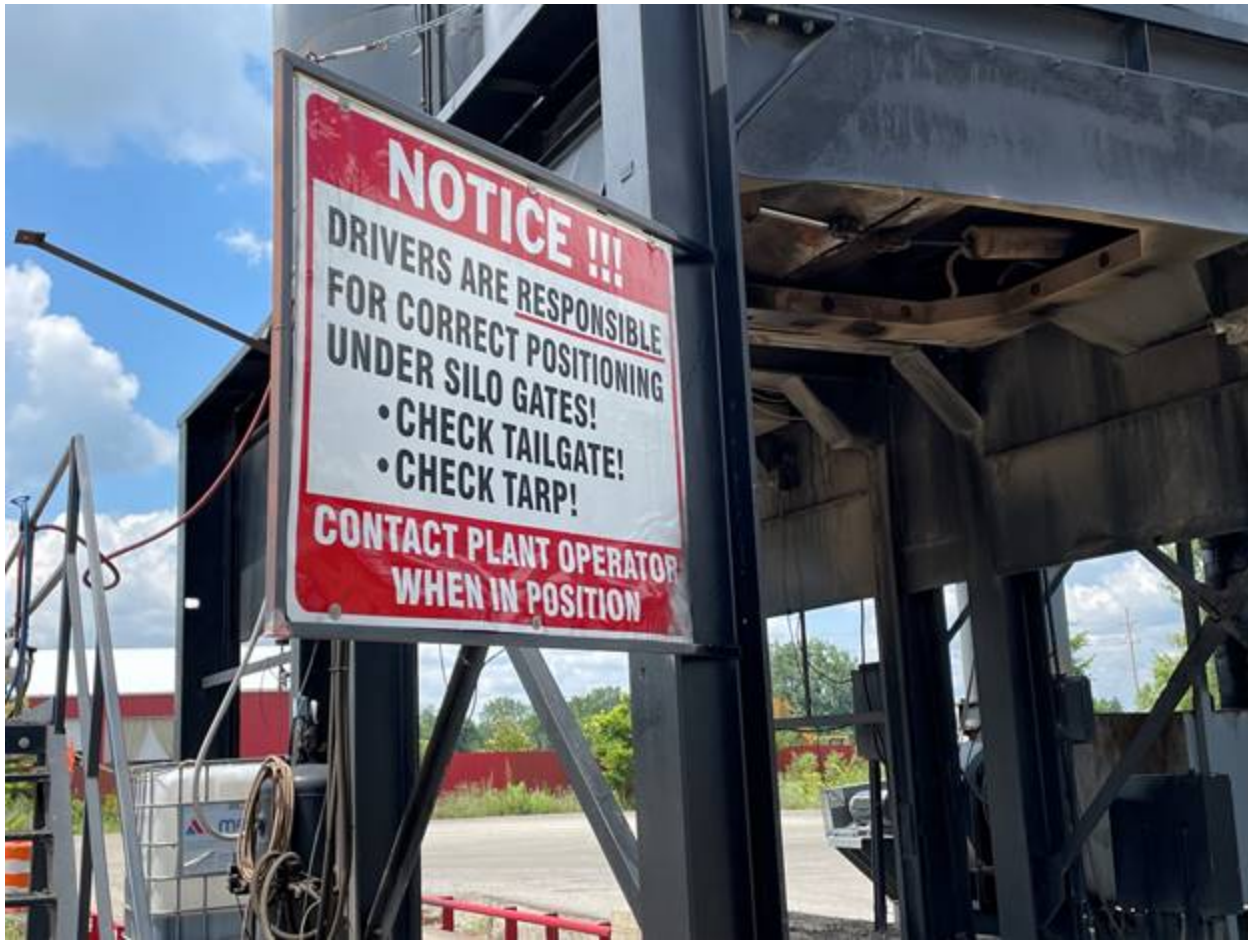
Image 8: Tarp sign at facility.

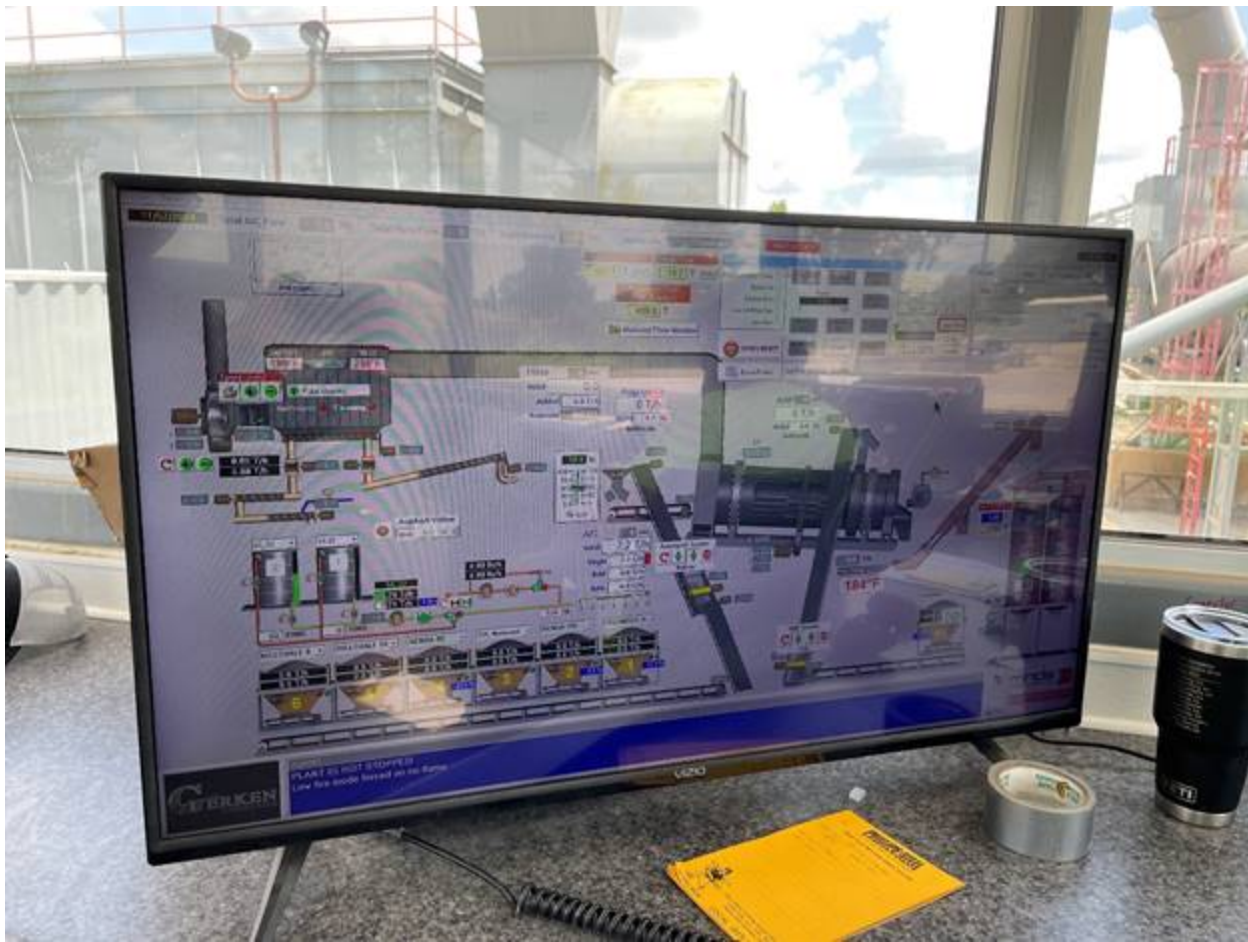
We returned to the office, where I was able to take a look at the process monitoring parameters (Image 9). I thanked Dave for his time and left at 1:50 PM.

Image 9: Production diagram.

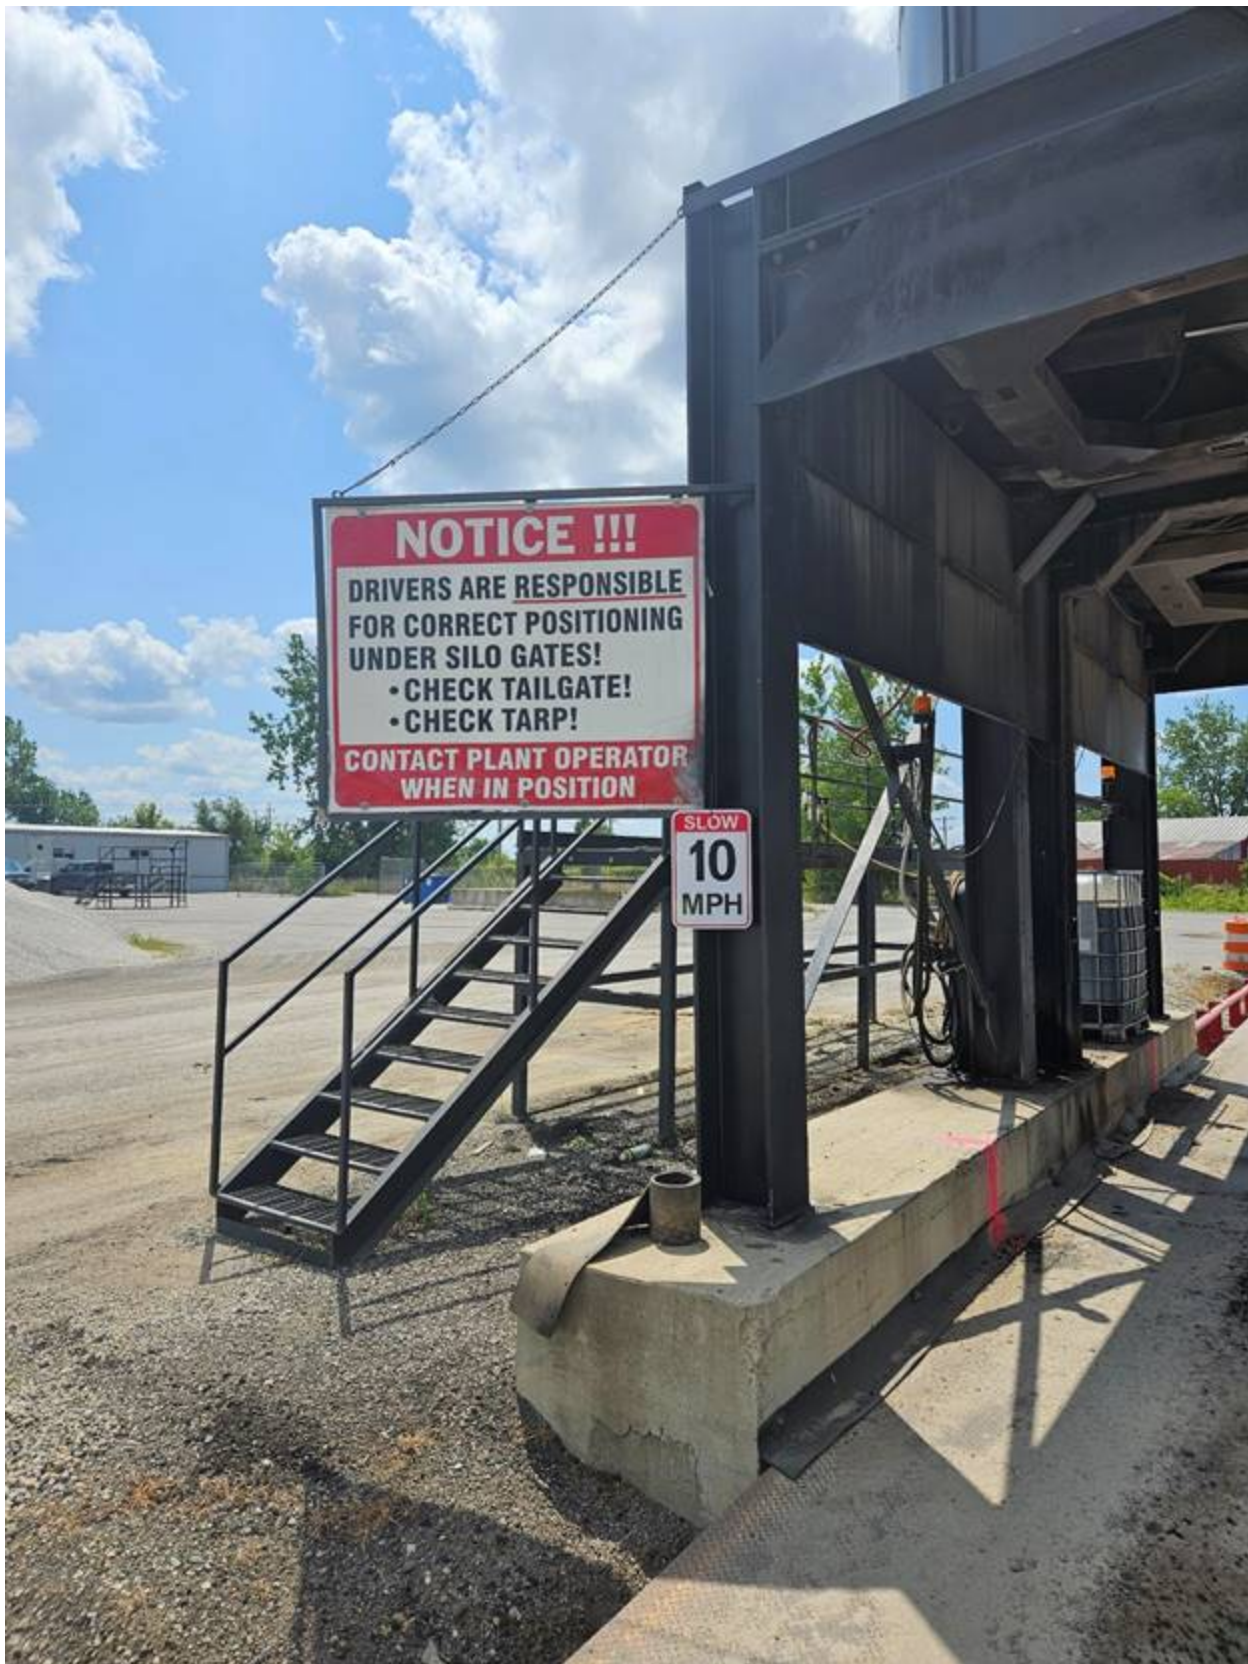
SC III.1 The facility has implemented the Fugitive Dust control Plan specified in Appendix A. They maintain records of duct control activities at the plant, which I reviewed on site. The company has a sweeper that travels between their different properties and is brought to the facility as needed. The aggregate they receive is washed stone and rarely needs attention for fugitive dust. All roadways for HMA haul vehicles were paved and watered weekly and as needed. The facility does not currently have a sign indicating the speed limit of 10 mph as specified in 1.b of the Fugitive Dust Control Plan. The facility committed to installing a sign during my inspection.

Image 10: Speed limit sign posted following my inspection.

the daily average tons per hour below the permit limit (Attachment 1). This replaced the data provided in Image 3. He also provided updated monthly and 12-month rolling emission calculations for June 2024 as well as production data for the same month (Attachments 2 and 3). These updated calculations replace Images 2 and 4. He also provided proof that the facility added speed limit signs to the yard (Images 10 and 11) as well as proof of the blacklight inspection (Images 12 and 13).

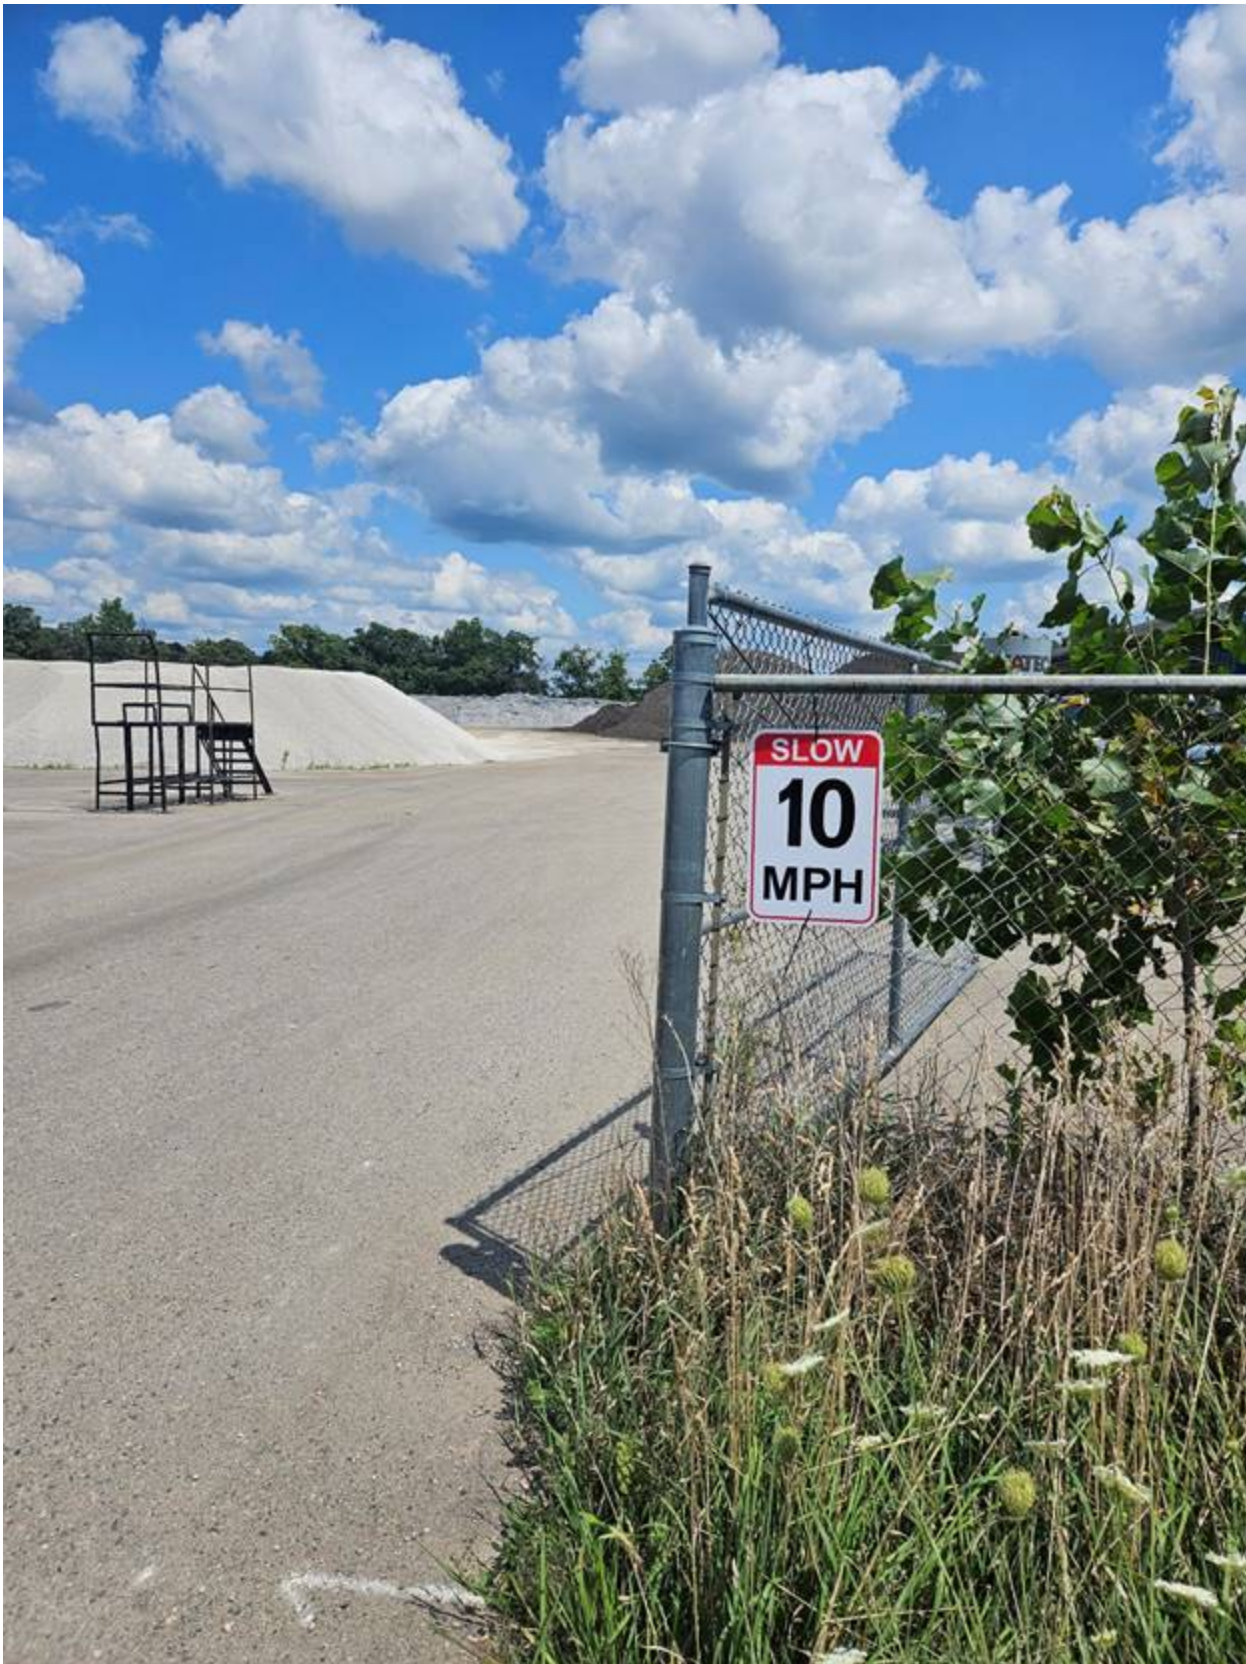
Image 11: Speed limit sign posted at entrance following my inspection.
