FINAL REPORT

FCA US LLC

STERLING HEIGHTS ASSEMBLY PLANT: SOUTH PAINT SHOP

RWDI #1804652

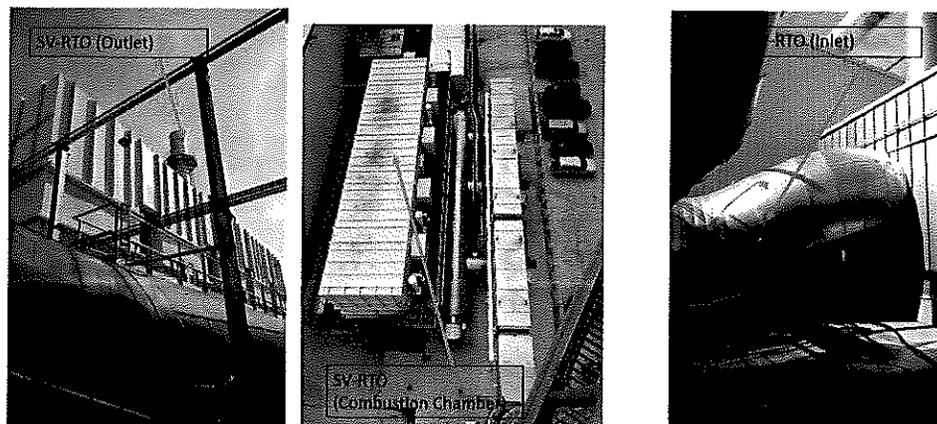
Figure 2.2.1: Summary of RTO Sampling Locations

SV-RTO (Inlet and Outlet Locations)

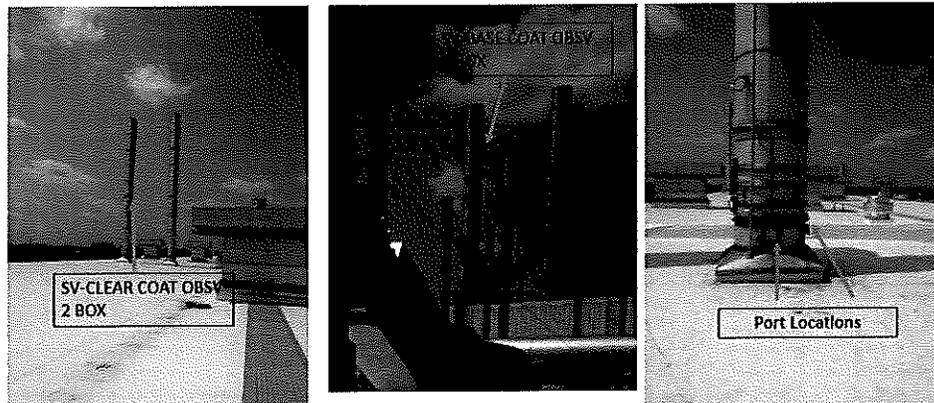
Figure 2.2.2: Summary of Basecoat and Clearcoat Observation Zone Exhausts

SV-BASE COAT OBSV 2 BOX & SV-CLEAR COAT OBSV 2 BOX

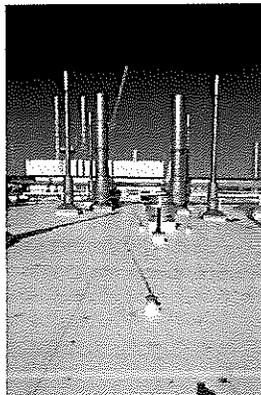
Figure 2.2.3: Summary of Powdercoat Cure Oven Exhaust

SV-POWDERCOAT CURE OVEN 2 BOX

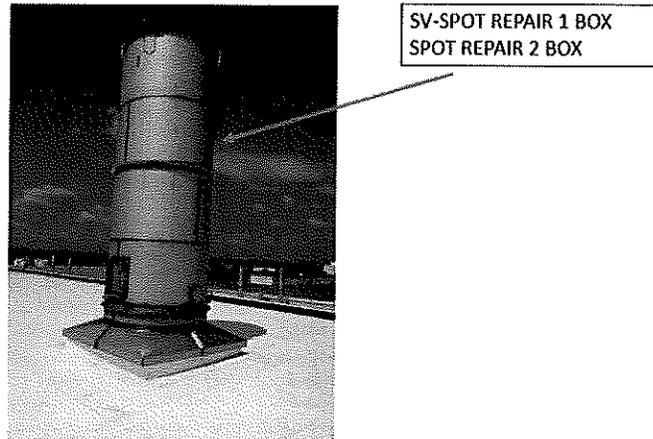
Figure 2.2.4: Summary of Repair (Spot Repair) Exhausts

FG-REPAIR BOX
