DEPARTMENT OF ENVIRONMENTAL QUALITY
AIR QUALITY DIVISION
ACTIVITY REPORT: On-site Inspection

FACILITY: Arbor Hills Landfill, Inc.		SRN / ID: N2688
LOCATION: 10690 W. SIX MILE RD, NORTHVILLE		DISTRICT: Jackson
CITY: NORTHVILLE		COUNTY: WASHTENAW
CONTACT: Suparna Chakladar , Vice-President		ACTIVITY DATE: 10/08/2021
STAFF: Mike Kovalchick	COMPLIANCE STATUS: Unknown	SOURCE CLASS: MAJOR
SUBJECT: Methane/H2S ambient air inspection. Significant methane and H2S concentrations detected on the roof of the treatment and turbine buildings.		
RESOLVED COMPLAINTS:

Major / ROP Source. Inspection of Arbor Hills Energy LLC portion (Section 3) of the Arbor Hills Landfill (Green for Life Environmental) and Arbor Hills Energy Stationary Source.

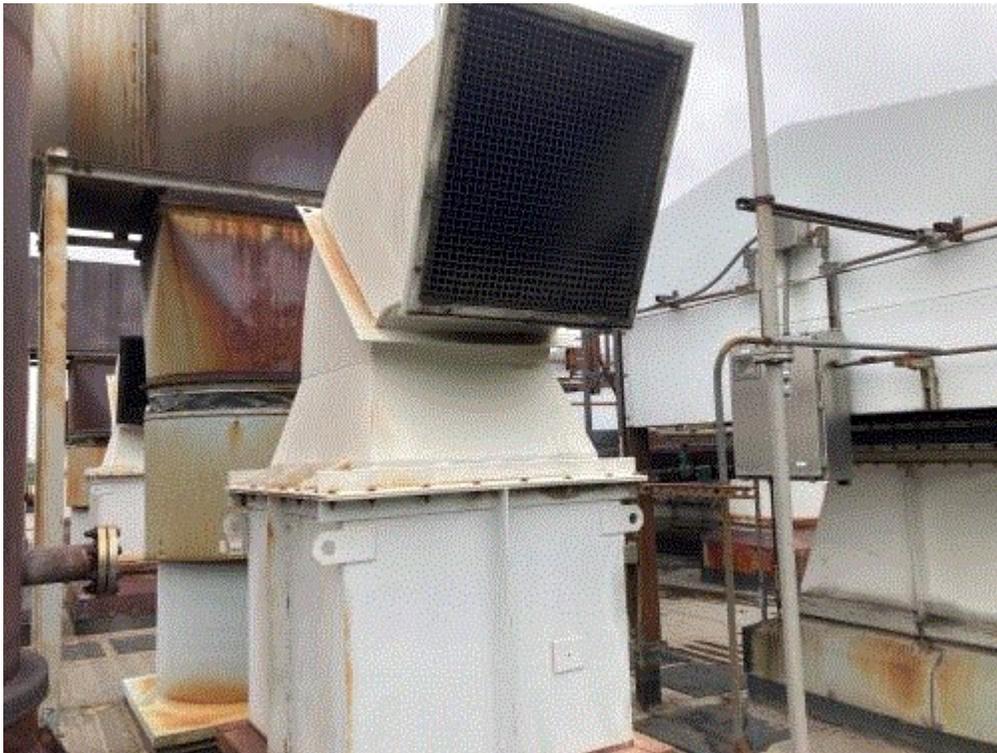
Next, we surveyed the roof of the turbine building. Some elevated methane readings were also encountered but at much lower levels/extent than the treatment building. The main source appeared to be vents associated with air that is used to cool “the package” that includes the turbines themselves which are then vented back out to the roof. (See attached photo.) One vent appears to be associated with each turbine. The vent associated with Turbine 2 had the highest readings that were in excess of 500 ppm and relatively high volumes of exhausted air. These are new sources of gas emissions that had not been previously documented. No readings higher than 0.15 ppm H₂S were encountered on the roof of the turbine building.”

One vent appears to be associated with each turbine. The amount of scfm coming from the forced air vents is unknown but thought to be significant based on the size of the vent and the amount of flow velocity observed coming out of the vents. A maximum concentration of 1500 ppm methane was measured coming from Turbine 2 cooling vent with elevated valves coming from at least one other vent. H₂S was measured at 0.15 ppm. The exact source of how landfill gas is getting into these vents is unknown but suggests that auxiliary ventilation that feeds the turbines is leaking. These vents are likely a much larger source of landfill gas emissions than the compressor vents since the emissions are continuous and involve a much larger volume of gas flow. It isn't known if there are also products of combustion in the emissions as well.

Image 1(Cooling Stack) : Turbine cooling stack on roof of turbine building

Staff used a SEM5000 methane detector and measured methane in excess 1500 ppm coming from cooling air ventilation stacks on the roof of the turbine building. These emissions are originating from enclosures that house each of the 3 turbines. (Turbine 4 was not examined.) This indicates that landfill gas diluted with air is being vented to the atmosphere. Landfill gas emissions from these vents have not been previously described by any permit application submitted by the Company.

AHE should investigate these vents to fully characterize emissions from them such as determining mass flow rates of landfill gas and other pollutants. The actual source of landfill gas that is getting into the cooling vents should be either eliminated or controlled per the requirements in AAAA.

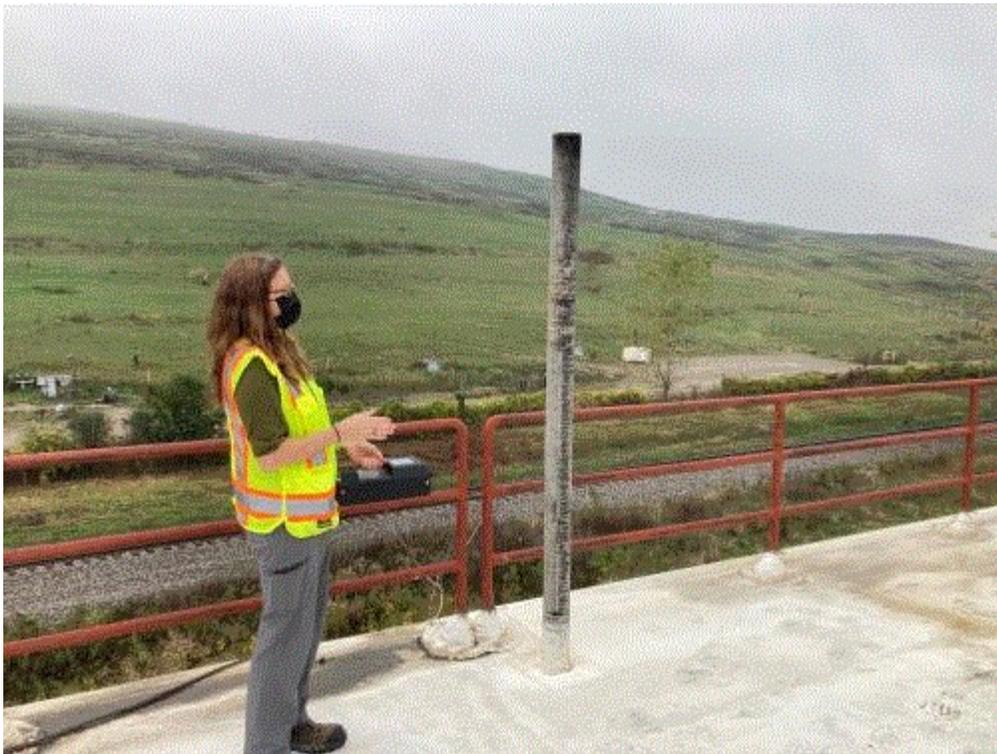
Next, we surveyed the roof of the treatment building. Overall, moderate H₂S odors were observed with occasional whiffs of intense/extreme odors. Significant methane and H₂S readings were detected. The most significant concentrations were encountered by sampling the condensate sump passive vent. (See attached photo. Note that almost all the vents of the roof were too high above the roof line to sample.) Methane readings were as high as 129,000 ppm from this stack. H₂S readings exceeded the detection limits of the device. (In excess of 50 ppm.) Note that methane levels in the 100,000 range are within the explosive range for methane which is concerning. Carlos confirmed that this is a passive vent from where all the condensate from all the liquids in the facility are collected into a sump. All the liquids appear to flow in the opposite direction to the condensate tank for disposal. Carlos estimated temperatures of the escaping gases would be the same as the gas temperature entering the facility so around 90 degrees F.

There are 7 passive sewer type vents present on top of the treatment building. 5 of the 7 vents are combined into the compressor vent stacks. It was one of the uncombined vents that was measured at 129,000 ppm methane and excess of 50 ppm H₂S. It appears that at least 2 of the passive sewer type vents (including the one that was sampled) are not part of rerouting that is scheduled to occur in the next 180 days. Emissions from these passive sewer types of vents have not been quantified. Note that between 350,000 to 450,000 gallons of condensate are being processed through treatment building per month so emissions of gas from this amount of liquid could be considerable. (In 2018, it was less than 50,000 gallons per month. In 2019, it was about 100,000 gallons per month. In May 2021 it was 468,271 gallons, August it was 335,990 gallons so the trend is dramatically upward which no doubt is negatively impacting methane/H₂S emissions.

Image 2(Passive vent) : Passive vent from condensate sump. Measured methane at 129,000 ppm with measured H₂S greater than 50 ppm.

In addition, AQD staff observed that meaningful landfill gas emissions coming from one or more vertical stacks on the treatment building roof that originates from the collection of gas coming from a basement sump that do not share a common stack with the compressor stacks. Please note that the Company has previously described this ventilation system as follows: "water collected by the sewer system is composed of condensate from the compressors and water from a sump that collects the "wash-down" water from cleaning of the compressor area. Sewer gas from the system is vented out of the roof of the treatment building via seven unobstructed vertical vents on the roof of the building. Five of the seven sewer gas vents are tied into vents associated with process equipment (primarily compressors servicing the turbines." Using a SEM5000 methane detector, AQD staff measured methane in excess 100,000 ppm from one of these vents. AQD staff also used a Jerome 631-X hydrogen sulfide meter and measured concentrations that exceeded the detection limit of the device which is 50 ppm. The amount of landfill gas condensate passing through the treatment building has dramatically increased in the last 2 years with over 350,000 gallons per month disposed of via a condensate storage tank. This has likely increased landfill gas emissions from the sump which resulted in these measured landfill gas emissions on the treatment building roof.

AHE should ensure that ALL condensate sewer vents are being ducted back into the treatment process to prevent high odor emissions and potential violations of the fire code.

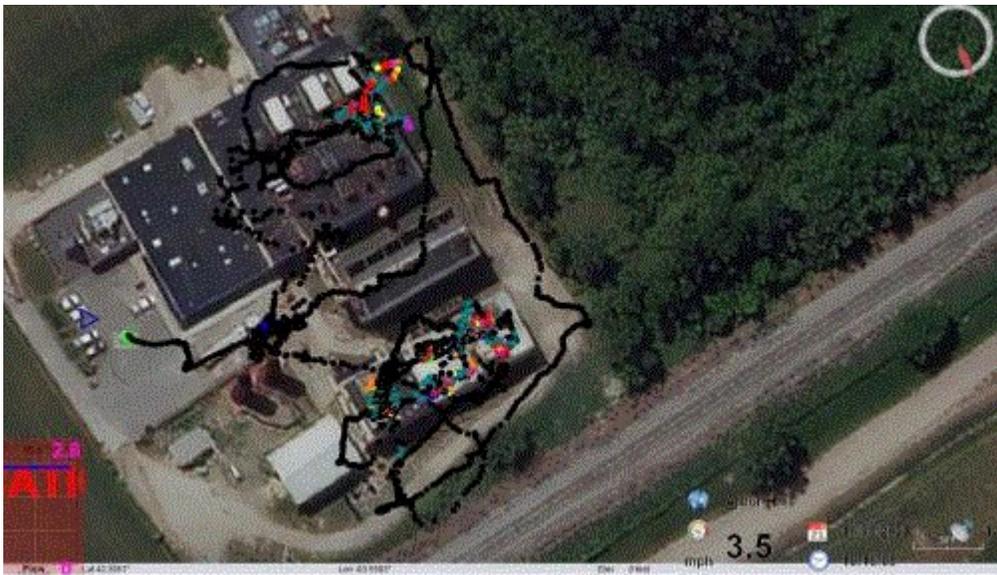
Image 3(Map of Results 1) : Map of route of methane survey. Red shows areas above 100 ppm.

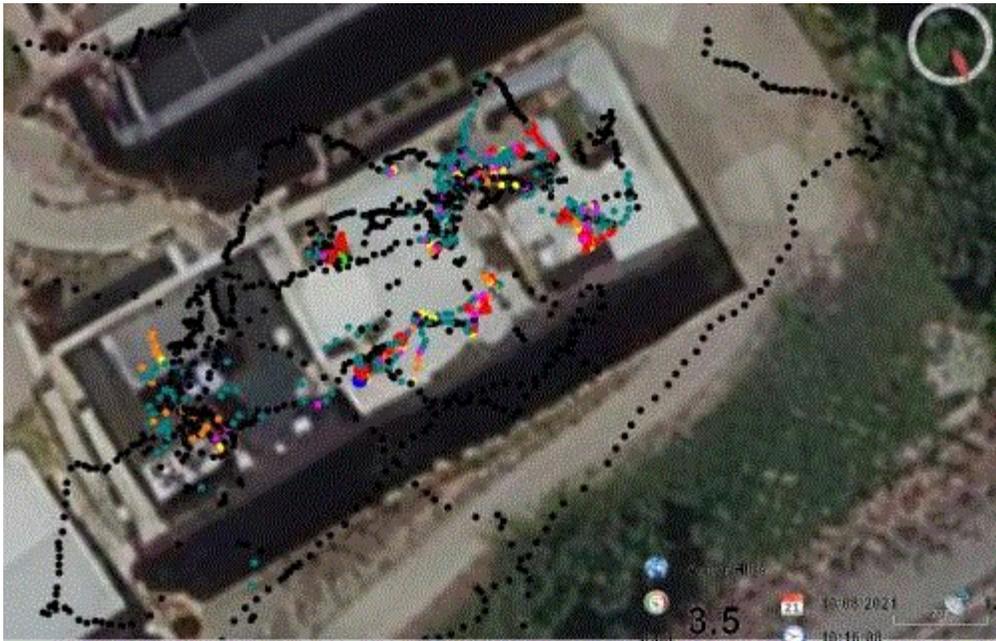
Image 4(Map 2) : Map of route of methane survey. Red shows where levels were above 100 ppm.

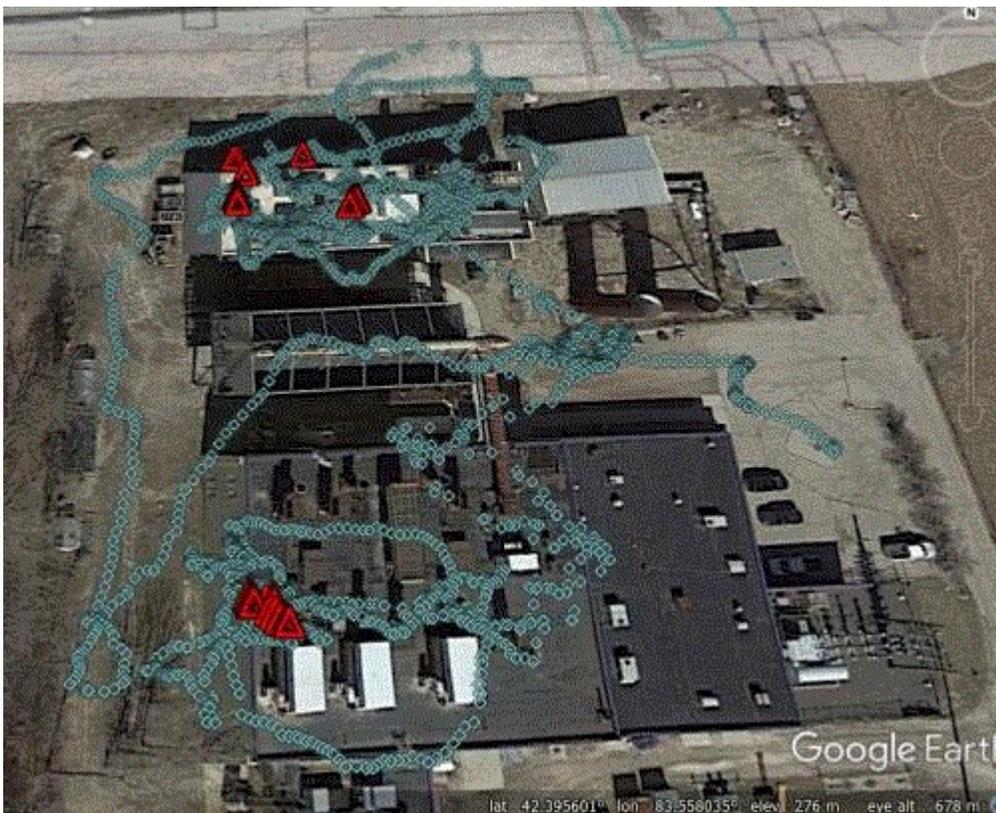
Image 5(Map 3) : Red triangles show where methane concentrations exceeded 500 ppm.

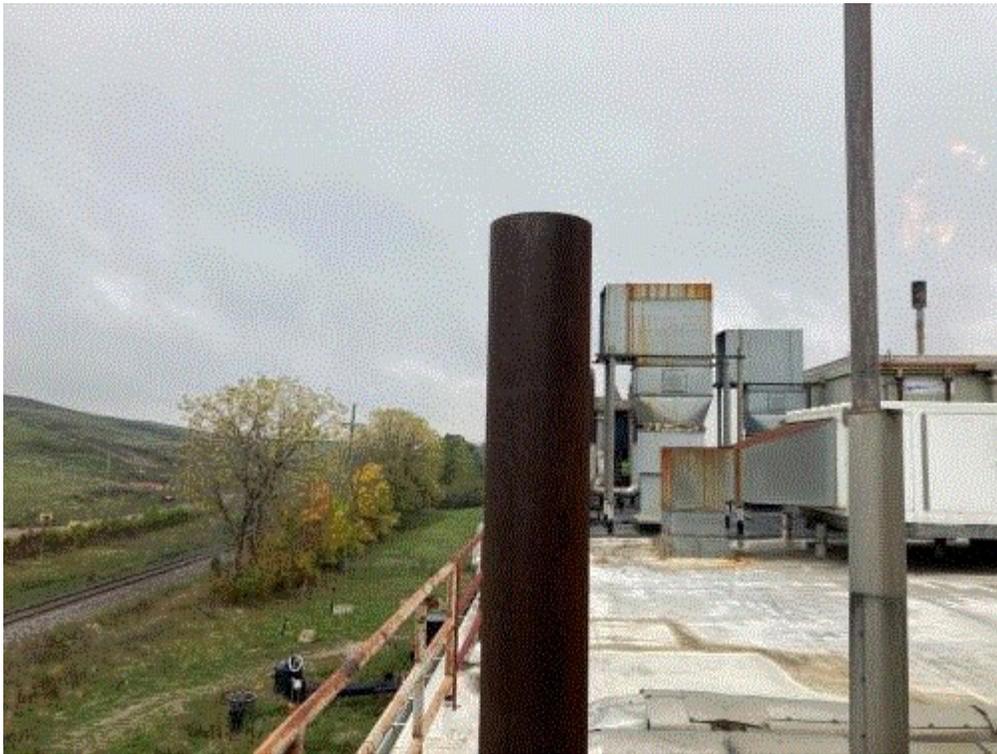
Other sources of high methane included previously identified vents from the compressors of which at least a couple were actively venting while others had exhaust stacks too high to sample. Oddly, a leaking air intake vent powered by an electric motor that exhausted back into the building also had elevated readings. (See attached photo.) Note that it was suspected that there are other significant sources of gas emissions on the roof but they could not be sampled due to the height of the

Down wind readings of the compressor vents showed that two or more than of them were actively venting landfill gas during the inspection. This was unexpected since the vents should only be venting for few seconds a handful of times per month during a compressor shutdown sequence. (There is no indication of this occurring

during the inspection.) One possible explanation is that the landfill gas measured was coming from the gas condensate sewer vents that are in some cases combined with the compressor vents.

Image 6(Compressor Vent) : Compressor Vent stack

AHE and AHRNG elect to pursue the RNG Option Compliance Pathway or AHE elects to pursue the STS Option Compliance Pathway, within 180 Days after the lodging of the Consent Decree, AHE shall ensure that the AHE Facility captures all emissions from the existing LFG compressor atmospheric vents and reroutes such LFG to the flares at the adjacent landfill, or back to the inlet of an operating turbine.”

The CD was lodged on September 9, 2021 so AHE has until March, 2022, to complete rerouting of the compressor atmospheric vents.
