DEPARTMENT OF ENVIRONMENTAL QUALITY  
AIR QUALITY DIVISION  
ACTIVITY REPORT: On-site Inspection

| <b>FACILITY:</b> Action Packaging | | <b>SRN / ID:</b> N3293 |
| <b>SUBJECT:</b> Self initiated, on site compliance inspection. | | |

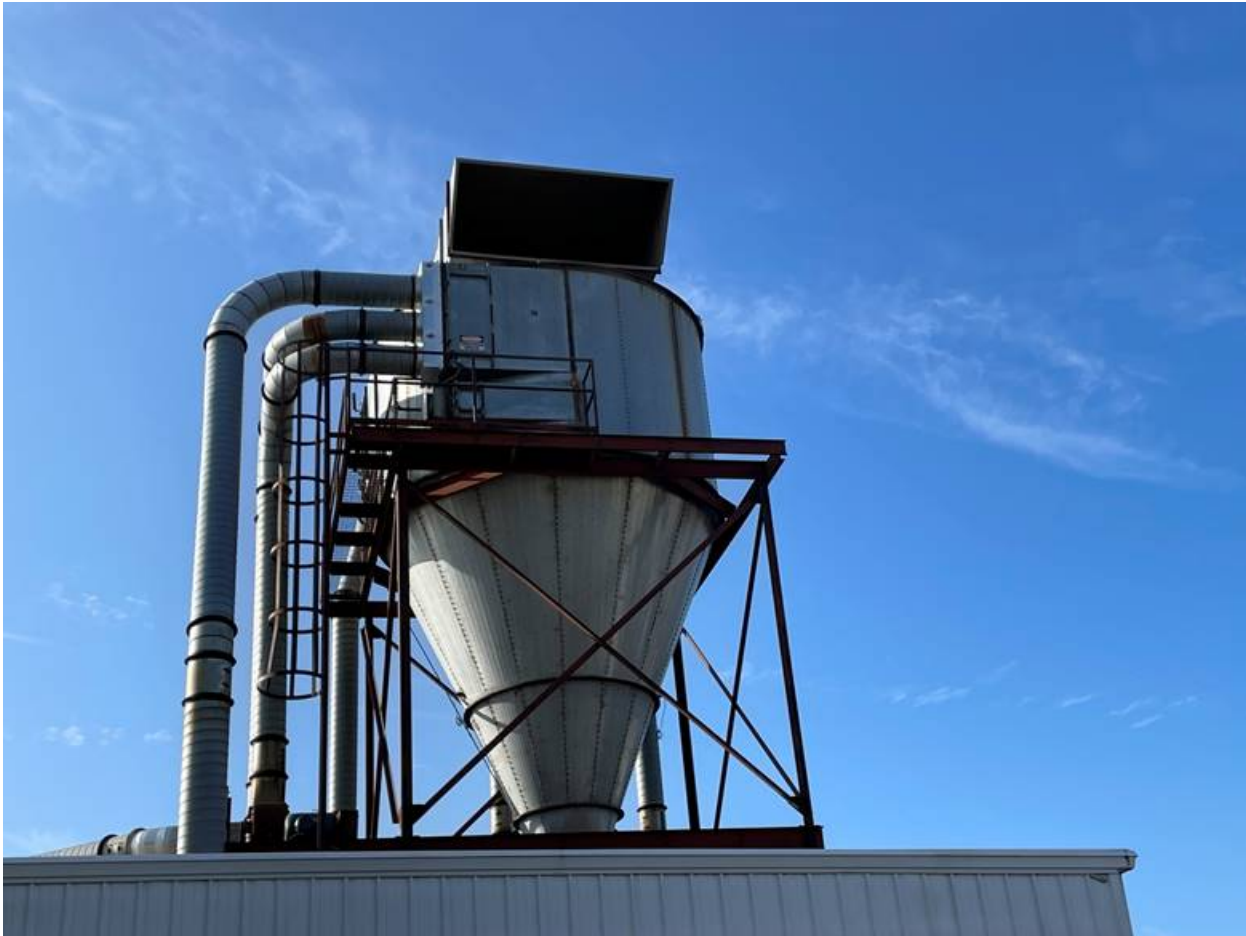
To go on the factory floor, safety glasses, safety boots, safety vest, and ear protection was required. Lucas led me over to the equipment, which was all operating. Each piece of equipment had a label over it matching the names from the previous inspection, as well as the new equipment. Lucas led me around the equipment towards the shredder/baler, which was permitted as the corrugated scrap removal system. Everything appeared to be in good working order and no issues were noted. We then went outside to look at the cyclone (Image 1). No visible emissions were reported. We then went back inside to the conference room.

**Image 1: Cyclone found at facility.**

The facility also informed me that before my inspection, they were not aware of their air permit and as a result had not been performing visible emission readings on the cyclone. Once informed, the facility has begun to perform visible emission readings in accordance with their air permit

(Attachment 2). Due to not being able to provide past records of visible emission readings, a violation notice will be issued.
