**DEPARTMENT OF ENVIRONMENTAL QUALITY  
AIR QUALITY DIVISION  
ACTIVITY REPORT: On-site Inspection**

<b>FACILITY:</b> OTTAWA FOREST PRODUCTS INC		<b>SRN / ID:</b> N3449
<b>LOCATION:</b> 1243 WALL ST, IRONWOOD		<b>DISTRICT:</b> Marquette
<b>CITY:</b> IRONWOOD		<b>COUNTY:</b> GOGEBIC
<b>CONTACT:</b> Don Jarvenpaa ,		<b>ACTIVITY DATE:</b> 03/15/2024
<b>STAFF:</b> Joe Scanlan	<b>COMPLIANCE STATUS:</b> Compliance	<b>SOURCE CLASS:</b> MINOR
<b>SUBJECT:</b> Unannounced activity to determine compliance with Michigan Air Pollution Control Rules.		
<b>RESOLVED COMPLAINTS:</b>

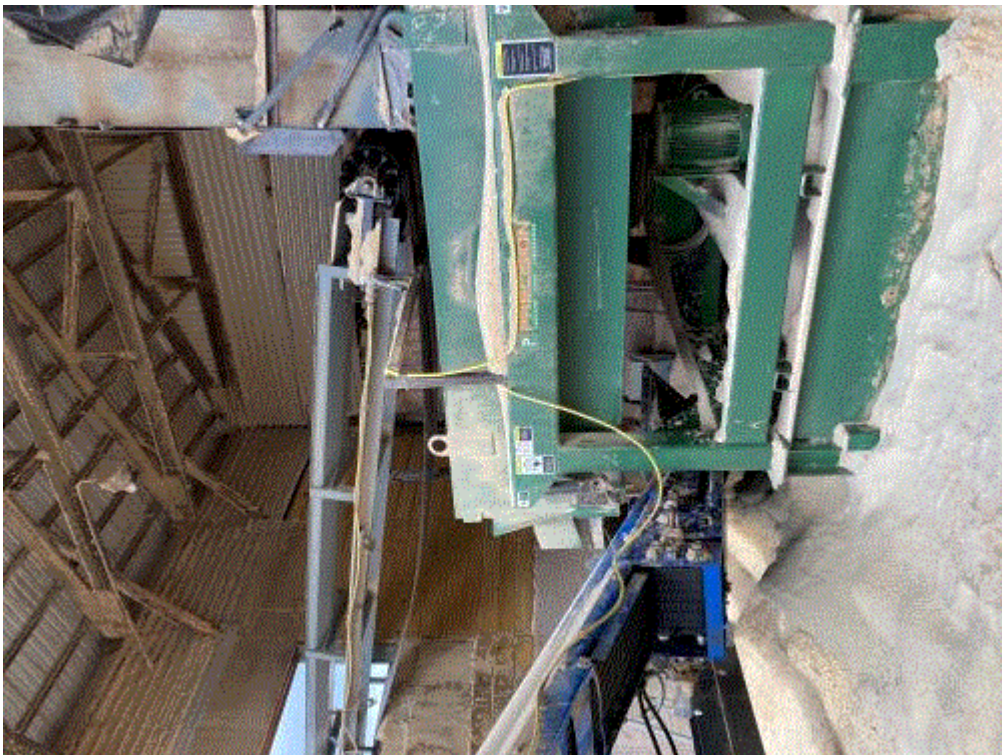
**Image 1(OFP1) :** Chip Screen

Other wood waste from the mill is sorted on a chip screen in a small, covered, three-sided building adjacent to the northwest corner of the building and debarking area. Wood fines are discharged from one end of the chip screen and sent out of the shed to the uncovered wood fines storage bunkers via an enclosed screw conveyor. Larger materials are discharged from the other end of the chip screen and sent out of the shed to the hogged bark conveyor and then deposited

in the hogged bark storage area. A small amount of particulate matter emissions was observed leaving the general area; however, this area has a potential risk for being a larger source of windblown particulate emissions during high wind events. The facility should be diligent in keeping wood fines within the confines of the storage bunkers to avoid windblown emissions of particulate matter. Wood waste is sold for boiler fuel to various sources.

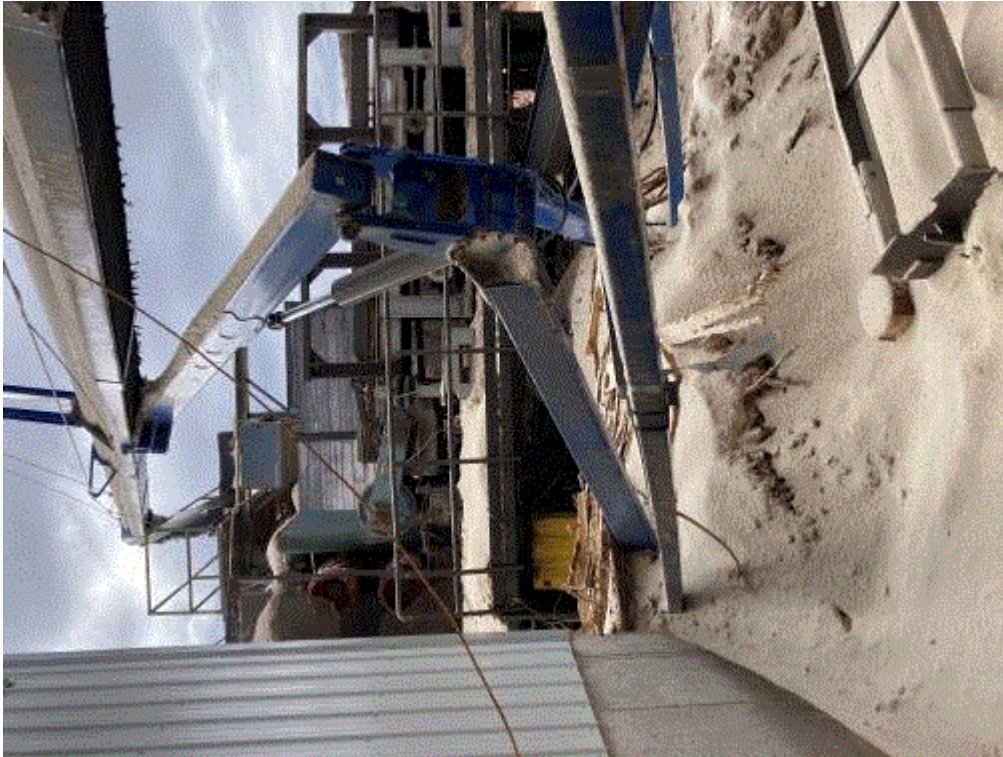
**Image 2(OWP2) :** Excessive fines

Wood fines were observed on the ground near the storage bunkers, but truck load-out did not occur during the inspection. Trucks are loaded using a front-end loader. Fugitive emissions may be generated during loading or from the trucks as they exit the yard. Haul drivers need to ensure that the storage bin opening is clean and the truck cover secure before the truck leaves the storage bunkers and yard.

The debarker, wood fines storage bunkers, and hogged waste storage area should be covered with a roof or in a fully enclosed building. All vehicle work areas should be watered as necessary, treated with effective dust suppressants, covered, or paved and cleaned as necessary to achieve maximum, reasonable control of fugitive dust emissions. Wood waste haulers need to ensure that truck covers, and trailer doors are secure before the truck leaves the storage bunkers. Track-out from haul trucks leaving the yard should be monitored and addressed as necessary to prevent fugitive emissions off-site.

While the facility is exempt from permitting, it is located on a small lot in an industrial park and has high potential to impact the surrounding roadways and businesses. It is recommended that Ottawa Forest Products design and implement a Fugitive Dust Control Plan to address these issues for the Ironwood Mill.

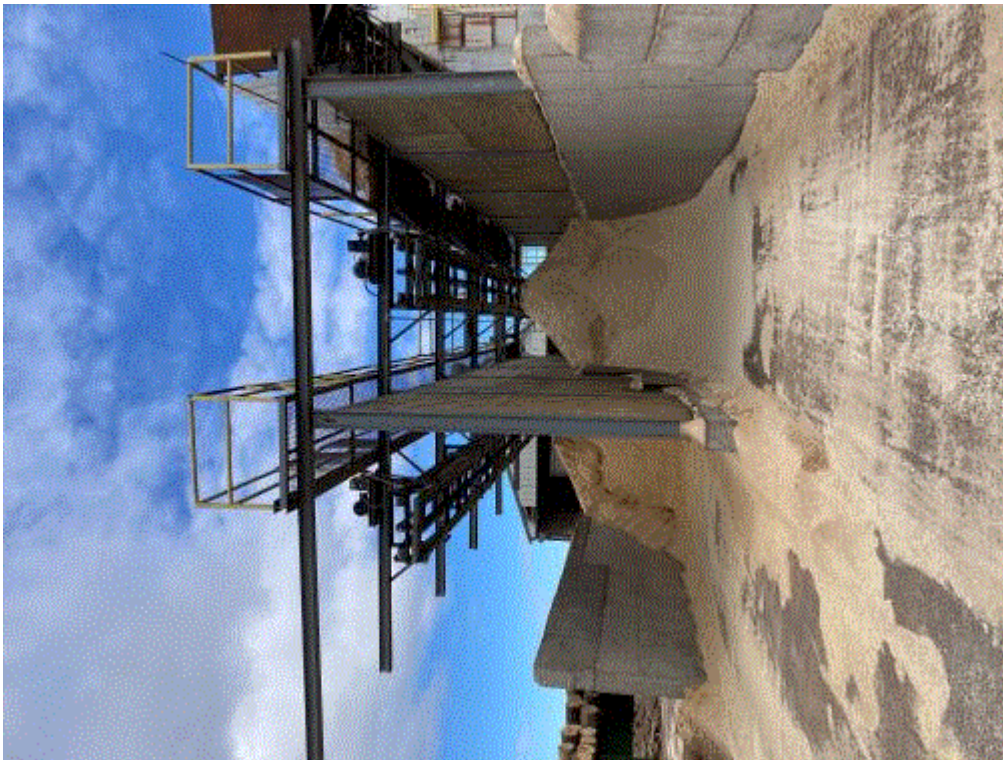
**Image 3(OWP3)** : Fines storage bunkers

Sawmill operations occur within the confines of the main structure, except for log debarking. From the yard, raw logs are loaded onto a roller conveyor on the west side of the wood fines storage bunkers. Logs are conveyed to the debarker, and hogged bark is sent to a storage area on the other side of the wood fines storage bunkers. This storage area for hogged material is fairly protected from wind, between the wood fines storage bunkers and the mill building. Debarked logs then enter the mill for processing. If there is excess hogged material in the storage area, hogged material is moved with a front-end loader and stored in other areas of the yard where the material is still accessible for loading trucks. Hogged material is transferred to trucks via the loader.
