DEPARTMENT OF ENVIRONMENTAL QUALITY
AIR QUALITY DIVISION
ACTIVITY REPORT: Scheduled Inspection

FACILITY: GRAND RAPIDS GRAVEL CO.		SRN / ID: N5284
LOCATION: 3800 7 MILE NE, PLAINFLD TWP		DISTRICT: Grand Rapids
CITY: PLAINFLD TWP		COUNTY: KENT
CONTACT: Chad Rose , Plant Manager		ACTIVITY DATE: 07/23/2020
STAFF: April Lazzaro	COMPLIANCE STATUS: Compliance	SOURCE CLASS: MINOR
SUBJECT: Announced, scheduled inspection.		
RESOLVED COMPLAINTS:

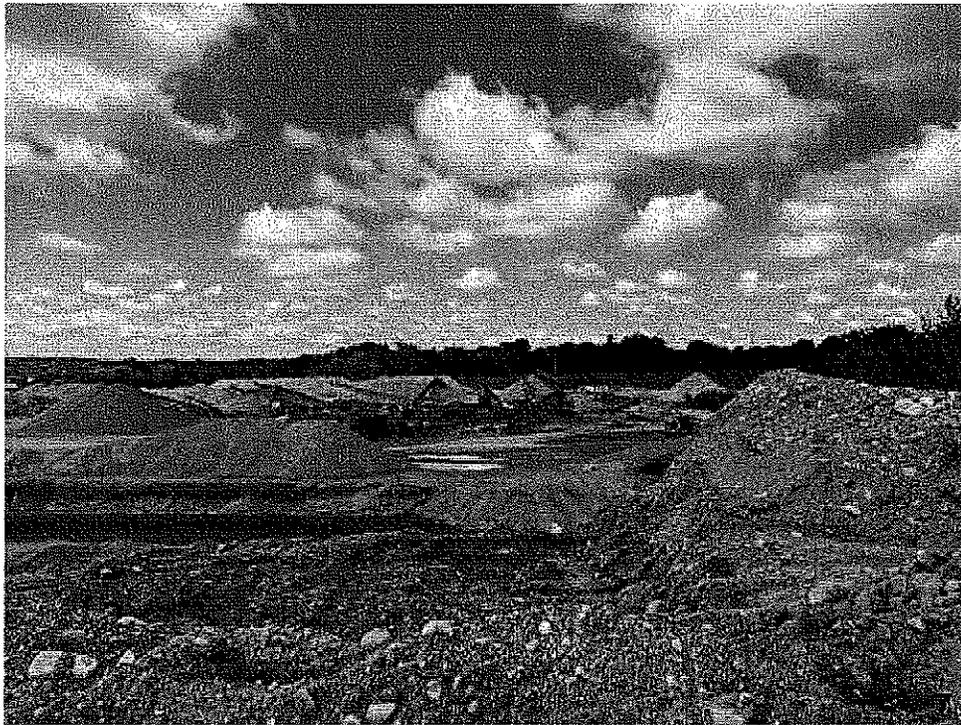
In general, the drop distances of the conveyors to the material piles were in good position to minimize the generation of fugitive dust. Photos of the plant are attached to this report. The photos show that the materials coming off the conveyor generally have residual moisture which reduces fugitive dust.

Image 1(Plant overview 1) : Overview of plant operations. Residual water observed at conveyor drop points.

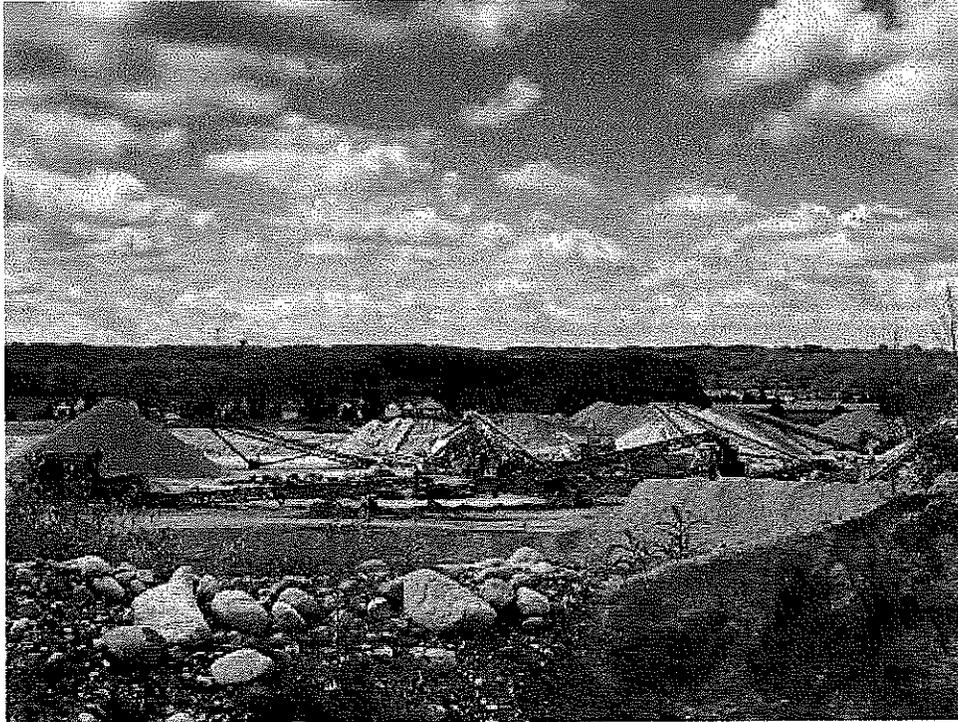
Image 2(Plant overview 2) : Overview of plant operations. Residual water observed at conveyor drop points.
