DEPARTMENT OF ENVIRONMENTAL QUALITY
AIR QUALITY DIVISION
ACTIVITY REPORT: Scheduled Inspection

FACILITY: SERVICE TECTONICS INC		SRN / ID: N5759
LOCATION: 2827 TREAT ST, ADRIAN		DISTRICT: Jackson
CITY: ADRIAN		COUNTY: LENAWEE
CONTACT: Jon Dalton, VP		ACTIVITY DATE: 12/21/2017
STAFF: Mike Kovalchick	COMPLIANCE STATUS: Compliance	SOURCE CLASS: MINOR
SUBJECT: Inspection of a pad printing machine manufacturer.		
RESOLVED COMPLAINTS:

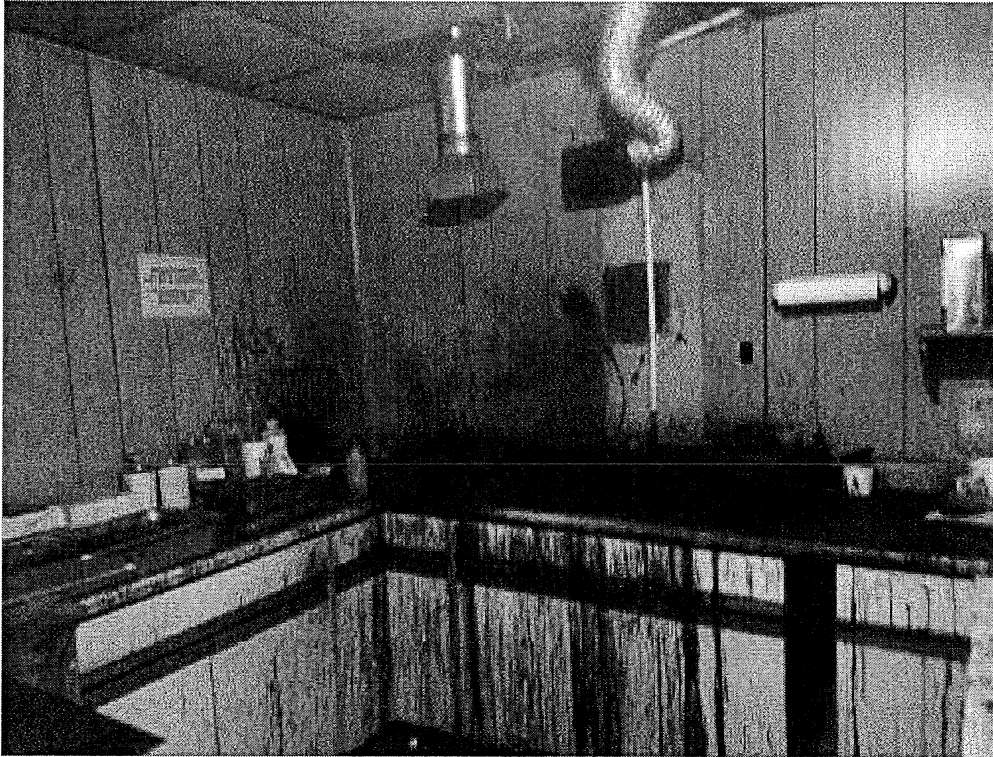
JD showed by a dark room that now is used for a type of printing operation. The ventilation system from that room is no longer used.

Image 4(Old dark room) : Old dark room

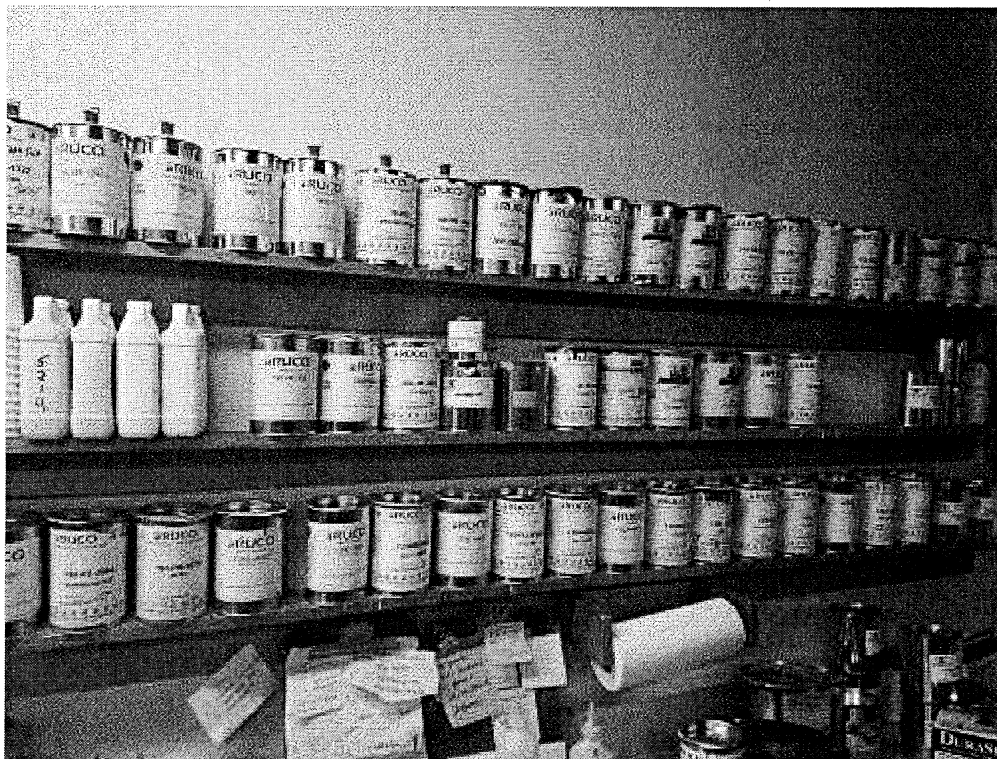
We walked by the area where they store the inks. See attached photo. They basically use only one brand name of ink but with many color variations.

Image 5(Ink storage) : Ink storage.
