DEPARTMENT OF ENVIRONMENTAL QUALITY
AIR QUALITY DIVISION
ACTIVITY REPORT: On-site Inspection

N609174211

FACILITY: Lambda Energy Resources, LLC - Chester 18		SRN / ID: N6091
LOCATION: 2998 Ranger Lake Rd, GAYLORD		DISTRICT: Gaylord
CITY: GAYLORD		COUNTY: OTSEGO
CONTACT:		ACTIVITY DATE: 10/22/2024
STAFF: David Bowman	COMPLIANCE STATUS: Compliance	SOURCE CLASS: SM OPT OUT
SUBJECT: Scheduled inspection FY 25		
RESOLVED COMPLAINTS:

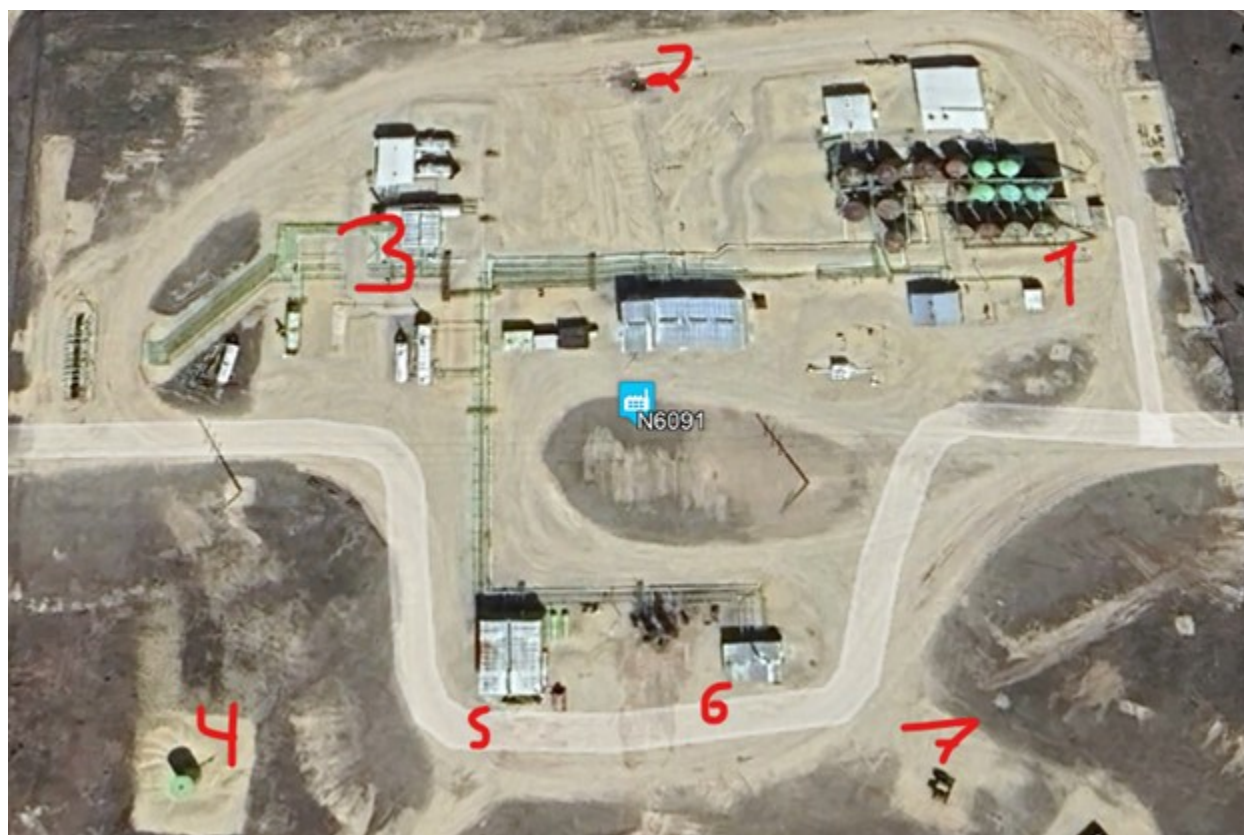
Figure 1 Google Earth imagery N6091

I began my inspection at the area labeled 1. This tank battery consists of several 300 to 500 bbl tanks. Not all appeared to be labeled, but upon very close inspection there are several that are labeled out of service, but the paint has been sun-bleached. During the FY22 unscheduled inspection this was noted and the labels were visible then. There is secondary containment in some areas of just the sand berm and in

In Area 2 was a semi and trailer uploading liquids from the facility. There was no spills and no odors when I passed the truck on my walk around the facility. The facility has a Vapor Return Unit (VRU) that was operating at the time of the load out.

In area 3 I inspected several large preheaters, but I was not able to find a data plate on them. At other sites when I have found the data plates these have been exempt under Rule 288 (2)(d). They were not operating at the time of the inspection. All but one appeared to be piped into the facility and capable of processing the gas.

In area 4 I noted a large (estimated slightly less than 250 bbl size) blowdown tank in secondary containment and fenced off for security. There was warning signs indicating staying back in case of H₂S in the area.

In area 5 is EUENGINE1, a Waukesha C5790GI, lean burn engine. There is no control on the engine and the data plate indicated the serial number is 398372. This is the same serial number that was recorded in the 2022 unscheduled inspection.

In area 6 is the Dehydrator. EUDEHY is located in a building with the heater vent exiting the building and venting vertically. Mi EGLE does not have delegated authority for 40 CFR part 63 Subpart HH so no determination of compliance to that regulation was made.
