DEPARTMENT OF ENVIRONMENTAL QUALITY
AIR QUALITY DIVISION
ACTIVITY REPORT: On-site Inspection

N788573332

FACILITY: R.J. Torching, Inc.		SRN / ID: N7885
LOCATION: G-5167 N DORT HWY, FLINT		DISTRICT: Lansing
CITY: FLINT		COUNTY: GENESEE
CONTACT: Jason Roughton , President		ACTIVITY DATE: 08/28/2024
STAFF: Daniel McGeen	COMPLIANCE STATUS: Compliance	SOURCE CLASS: MINOR
SUBJECT: Unannounced inspection.		
RESOLVED COMPLAINTS:

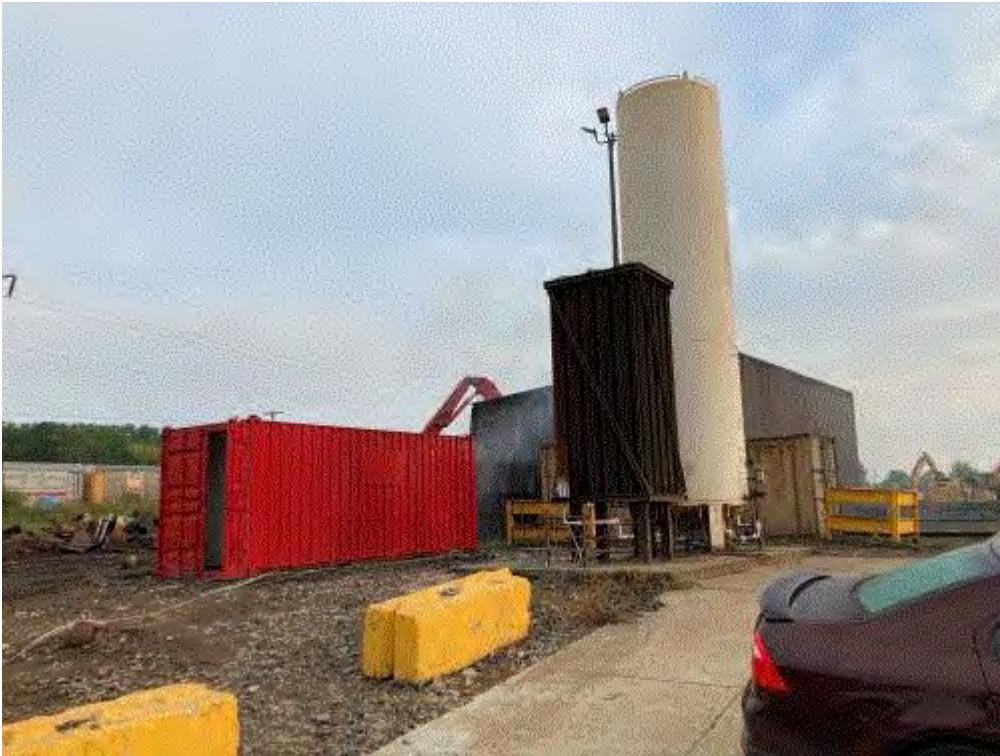
D. McGeen exited the car and immediately photographed yellow brown smoke of roughly 5% opacity rising above the west side of the enclosure, please see photo 001. The yellow brown smoke had disappeared, seconds later, please see photo 002. To the south of the enclosure, a Buffalo turbine was spraying a mist of water directly over the south fan system, which is the company's name for the rebuilt Smoke Particulate Air Reduction Cyclone System (SPARCS) units. No smoke emissions could be verified exiting the twin

Image 1(001) : Roughly 5% opacity rising from west (left) side of rolling enclosure. Mist at center of image is water spray from Buffalo turbine aimed at exhaust from south fan system.

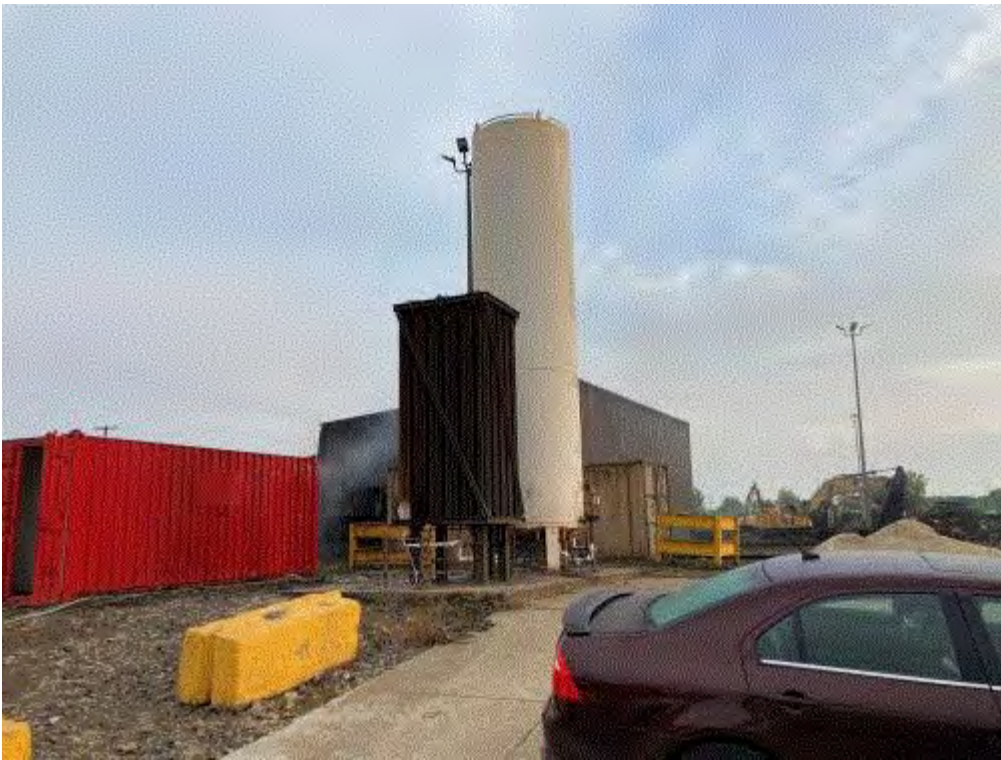
Image 2(002) : Yellow brown opacity from rolling enclosure ceased, seconds after first photo. The Buffalo turbine continued to spray mist, even after torch cutting ceased.

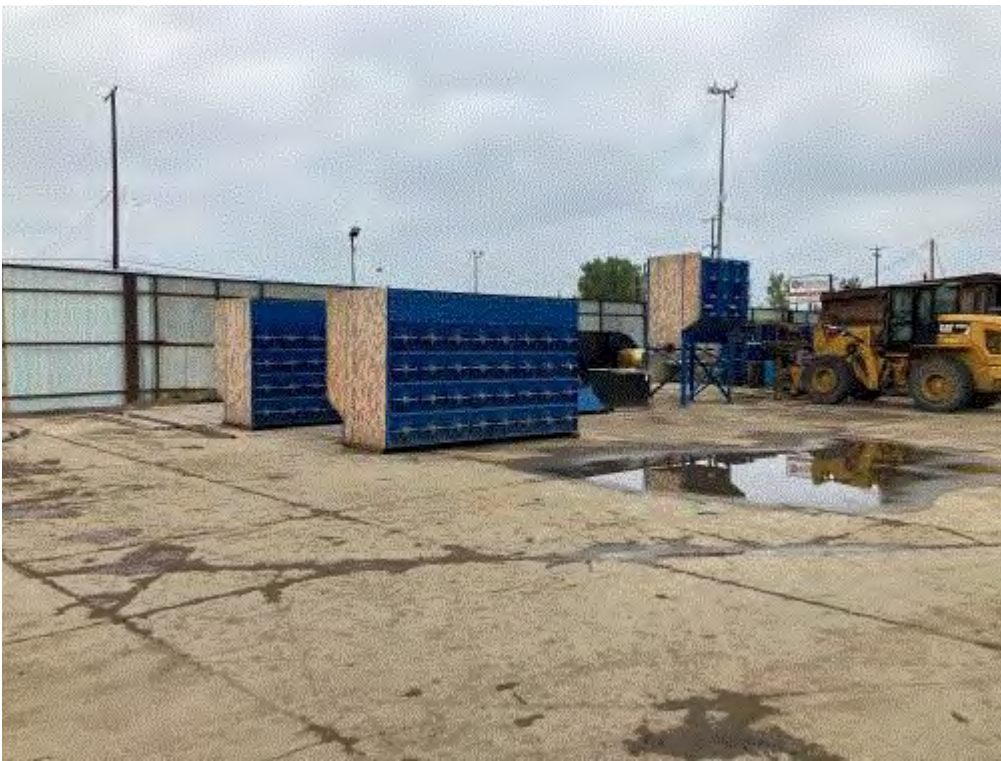
J. Roughton said that once the consent decree is signed by a judge, they will begin to install the new fabric filter system. This system will use cartridge filters. Aside from a plenum which is on order, almost all of the components have been stored onsite for 3 months, he pointed out; please see photo 003. The plenum was ordered 2 weeks ago once they realized the cartridge filters had not come with one, and will take 4-6 weeks to deliver, he said. A fan is onsite, along with a silencer, which reportedly will keep noise levels below 85 decibels.

Image 3(003) : Components of cartridge filter air pollution control device stored onsite, awaiting signing of consent decree.

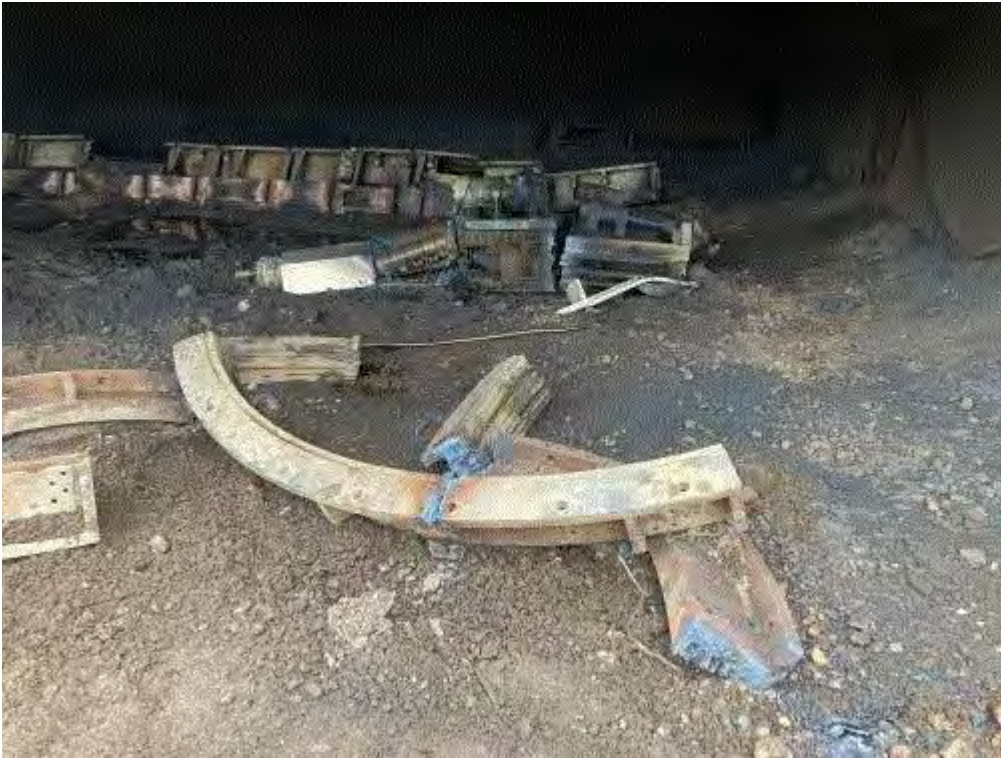
Image 4(004) : Steel scrap underneath the south half of the rolling enclosure.

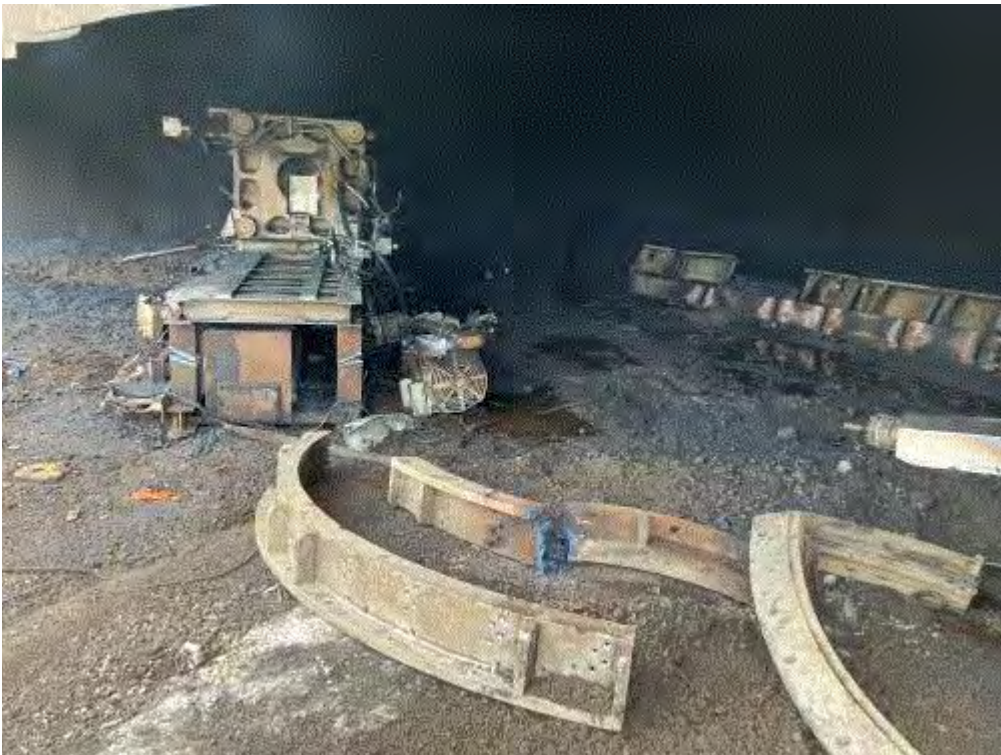
Image 5(005) : Steel scrap under the north half of the rolling enclosure. Faint smoke visible at upper left.

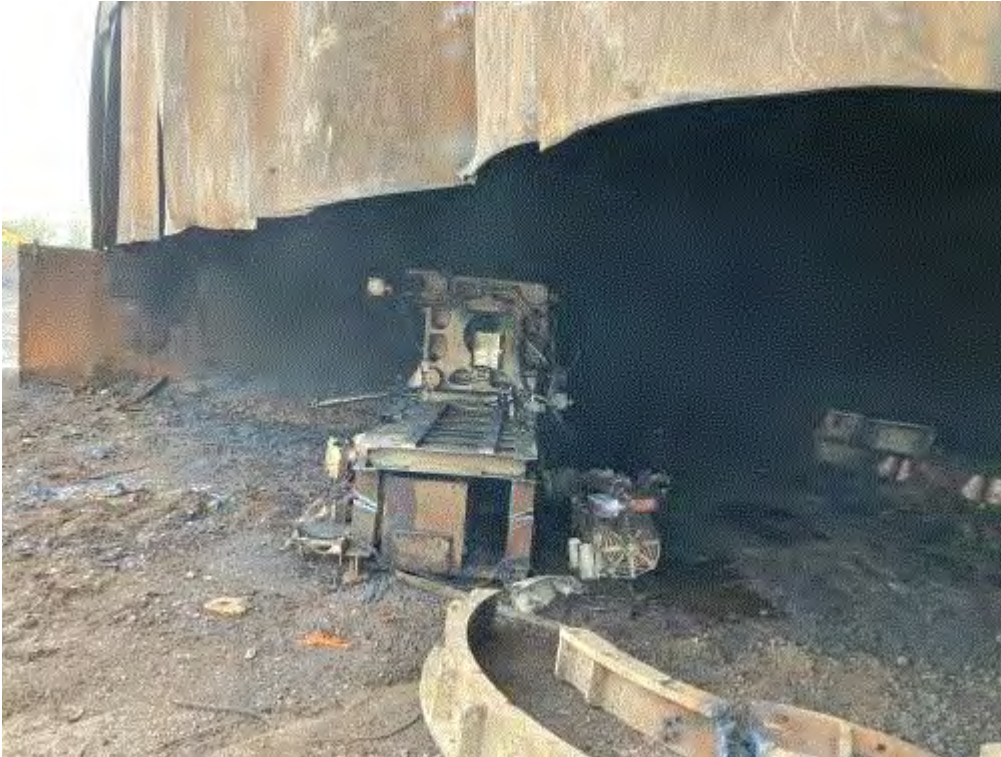
A small amount of smoke briefly exited the doorway of the enclosure, please see photo 007. A piece of machinery in the northeast corner of the enclosure emitted a narrow stream of smoke from smoldering material, which B. Brown extinguished with a nearby hose. Putting out smoldering or burning material was said to be a regular practice, based on prior guidance from the AQD.

Image 6(006) : Small amount of smoke at doorway of enclosure. Smoldering material within enclosure was promptly extinguished.

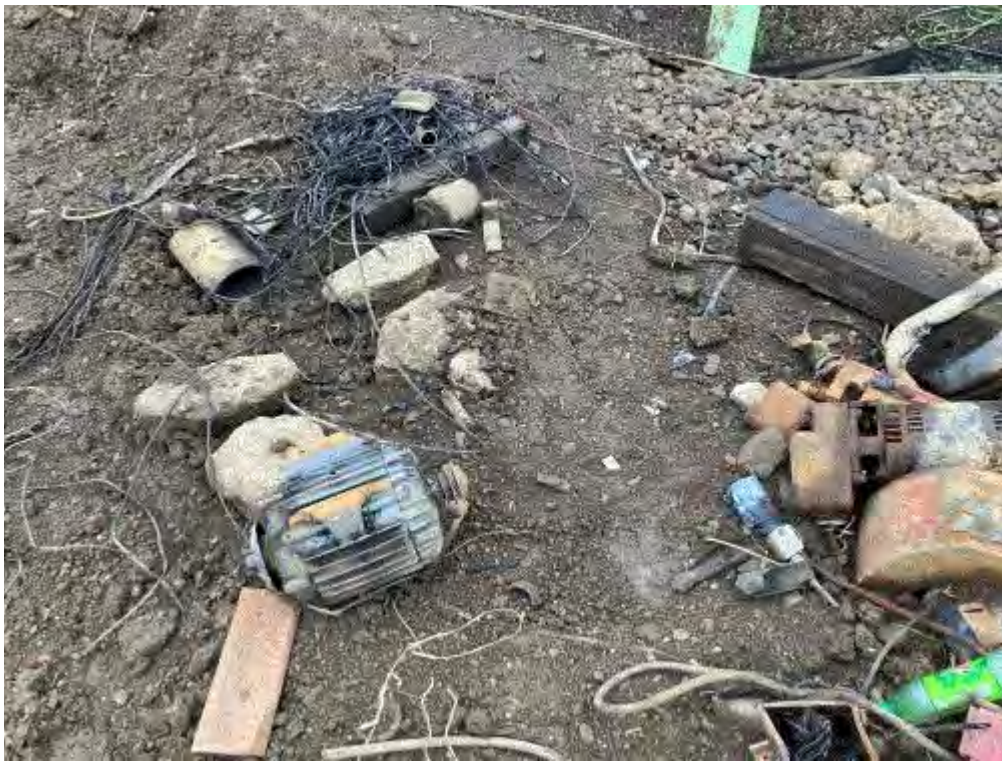
J. Roughton pointed out all the materials they are removing from machinery prior to torch cutting, please see photos 008 and 009. This included cables, wires, and other electrical components. He indicated that they are doing this per AQD's guidance. Previously removed materials were in a bin awaiting disposal, please see photo 010.

Image 8(008) : Materials removed from steel scrap prior to torch cutting the scrap.

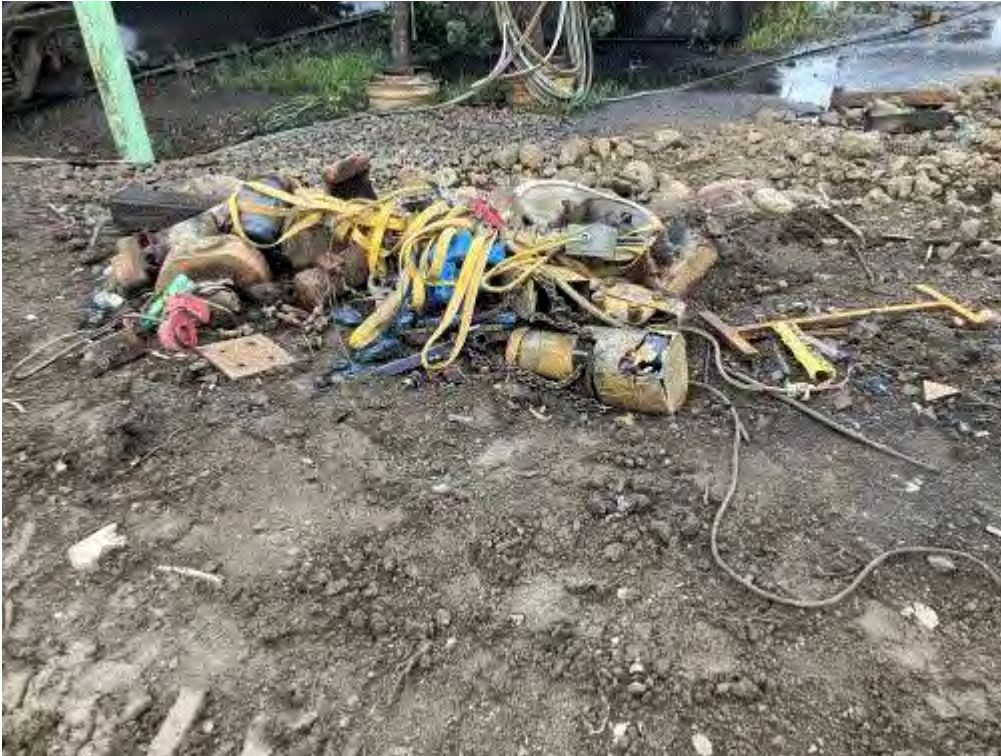
Image 9(009) : More materials removed from steel scrap prior to torch cutting, including electrical system components.

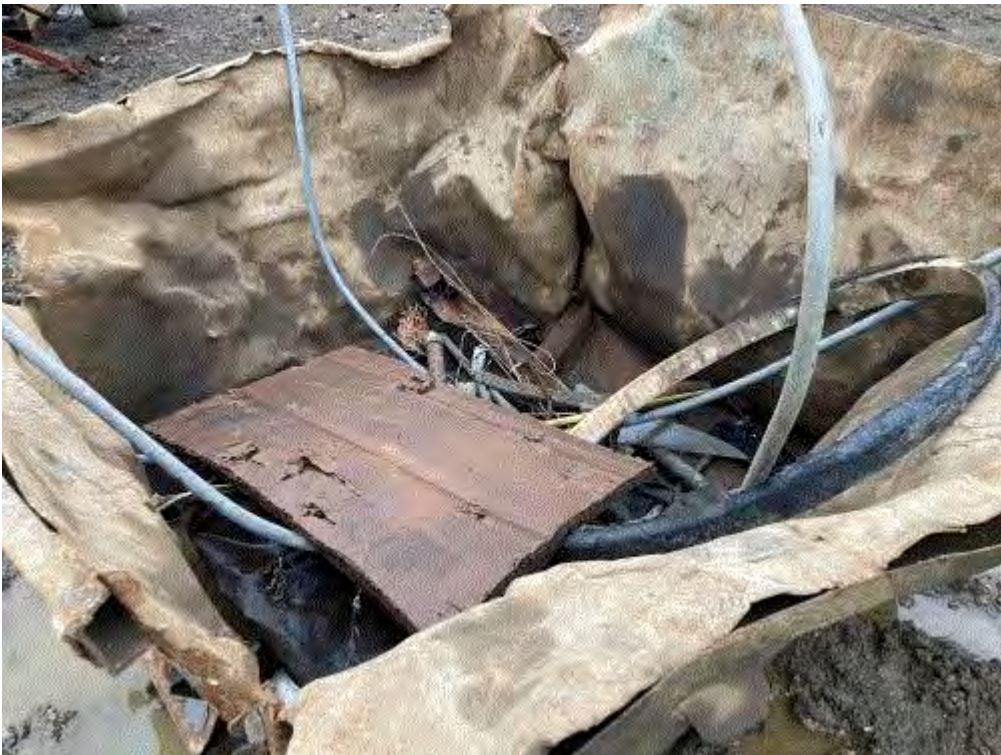
Image 10(010): Materials removed from scrap awaiting waste disposal.
