DEPARTMENT OF ENVIRONMENTAL QUALITY  
AIR QUALITY DIVISION  
ACTIVITY REPORT: Scheduled Inspection

FACILITY: W2Fuel LLC		SRN / ID: N7927
LOCATION: 1571 W BEECHER RD, ADRIAN		DISTRICT: Jackson
CITY: ADRIAN		COUNTY: LENAWEE
CONTACT: Adam Gibson , EHS Manager		ACTIVITY DATE: 12/17/2018
STAFF: Mike Kovalchick	COMPLIANCE STATUS: Non Compliance	SOURCE CLASS: SM OPT OUT
SUBJECT: Unannounced inspection/FCE of W2Fuel LLC.		
RESOLVED COMPLAINTS:

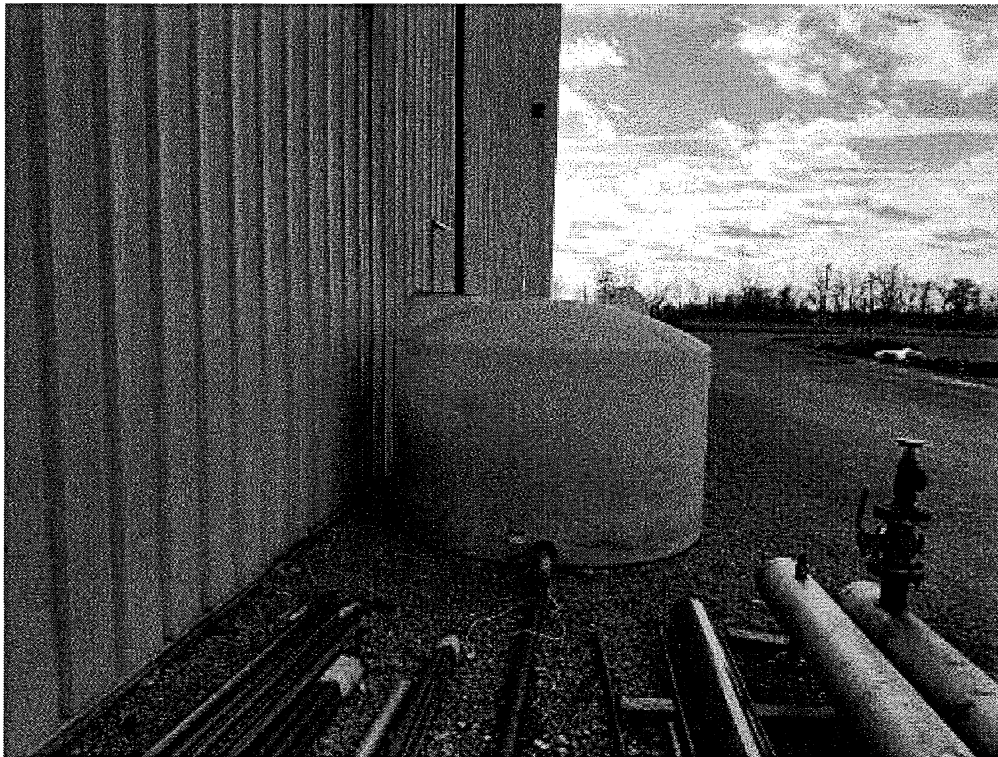
**Image 1(Dryer Exhaust) :** Feedstock dryer exhaust being directed into water tote. Only emissions expected to be water vapor.

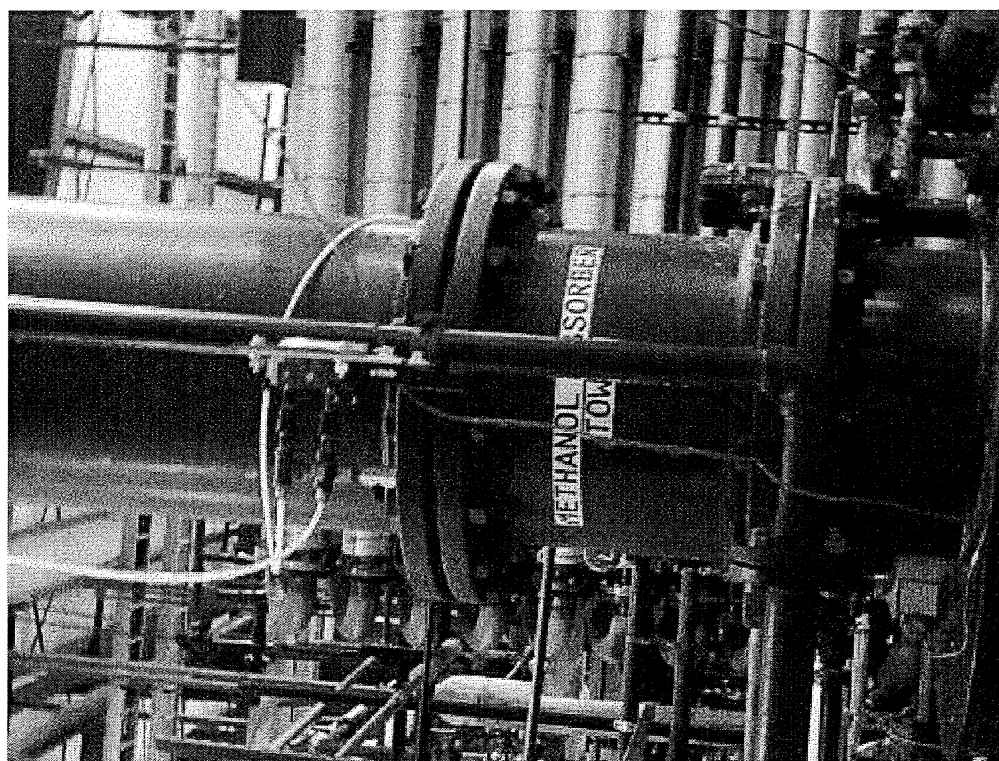
**EUTRANSESTER:** See attached photos. Observed the absorption tower. No methanol was entering the tower as the transesterification process was being shutdown per operator in the control room. All methanol flashing had already ceased, and the vacuum pump was off. Feedstock was entering the absorption tower but then stopped when a pump kicked off. The pressure gauge showed a reading of 0.02" while it was still operating.

**Image 3(Absorber tower) :** Absorber tower

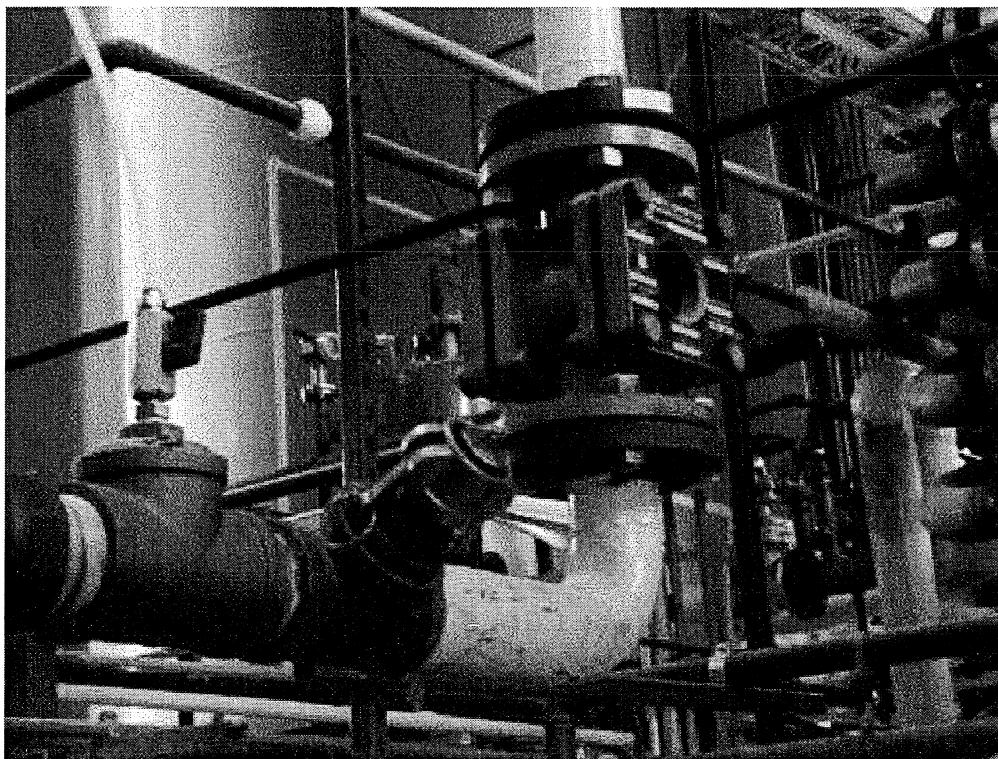
**Image 4(Absorber)** : Methanol pipe(yellow) going into absorber. Visual gauge showed no methanol flow.

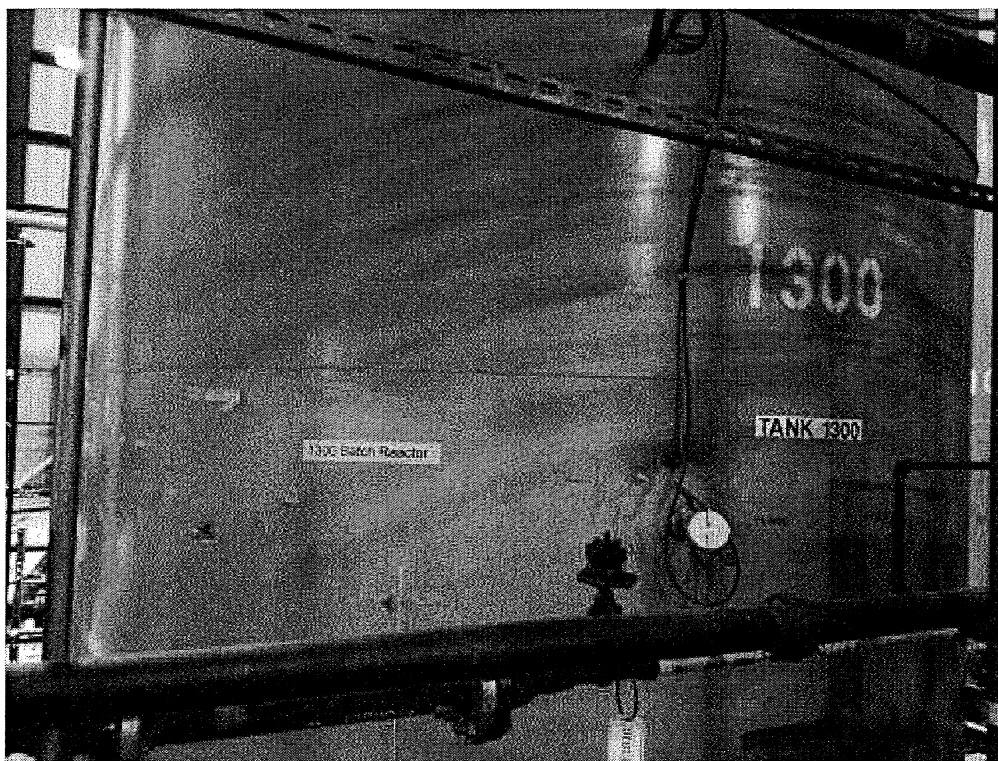
**EUBATCH:** See attached photos. Not operating. AG noted that a conservation vent had been installed on one of two reactors (triggers at 3 psi?) that vent out the roof in attempt to minimize methanol emissions. A second conservation vent had been purchased but not installed. As previously noted, the process has not been active since April 2018 and there are no plans to restart it.

**Image 5(Reactor vessel)** : One of the Enzymatic reactor vessels

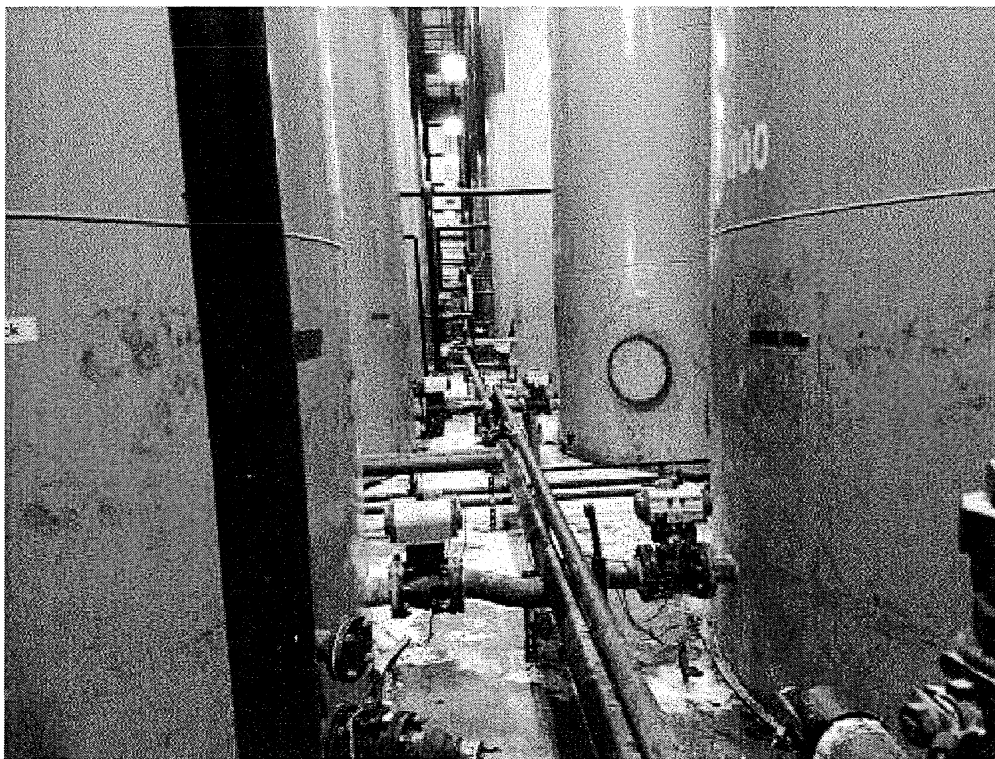
**EUINTANKS:** See attached photos. The tanks along with the rest of the process equipment appeared to be properly labeled with an identification sticker.

**Image 6(Feedstock storage)** : Feedstock storage tanks.

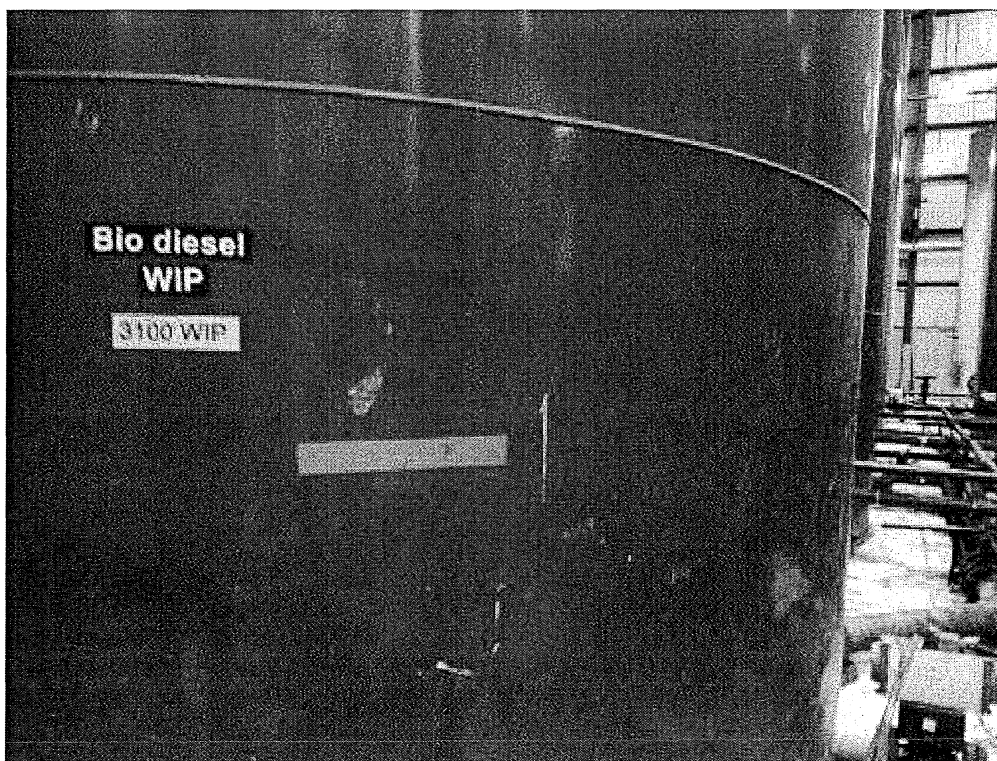
**Image 7(Indoor Bio diesel)** : Indoor biodiesel storage tanks.

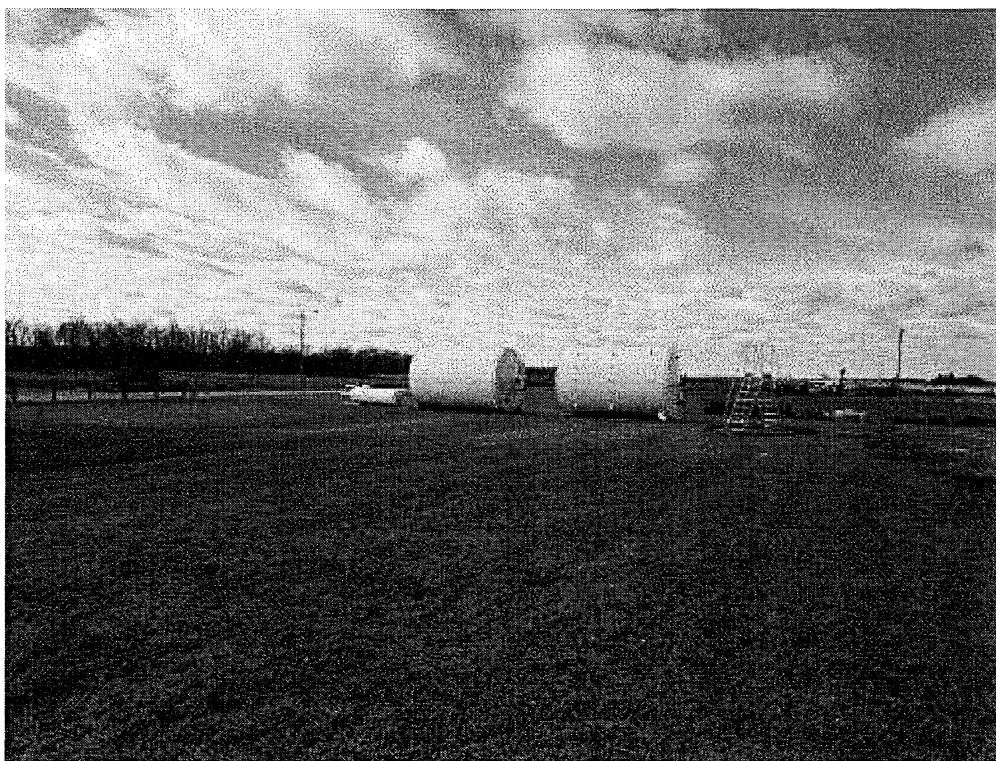
EUOUTTANKS: See attached photos. Some new uninstalled tanks were seen outside adjacent to the existing installed tanks.

**Image 8(Outdoor new storage)** : Outdoor new storage tanks not yet installed.

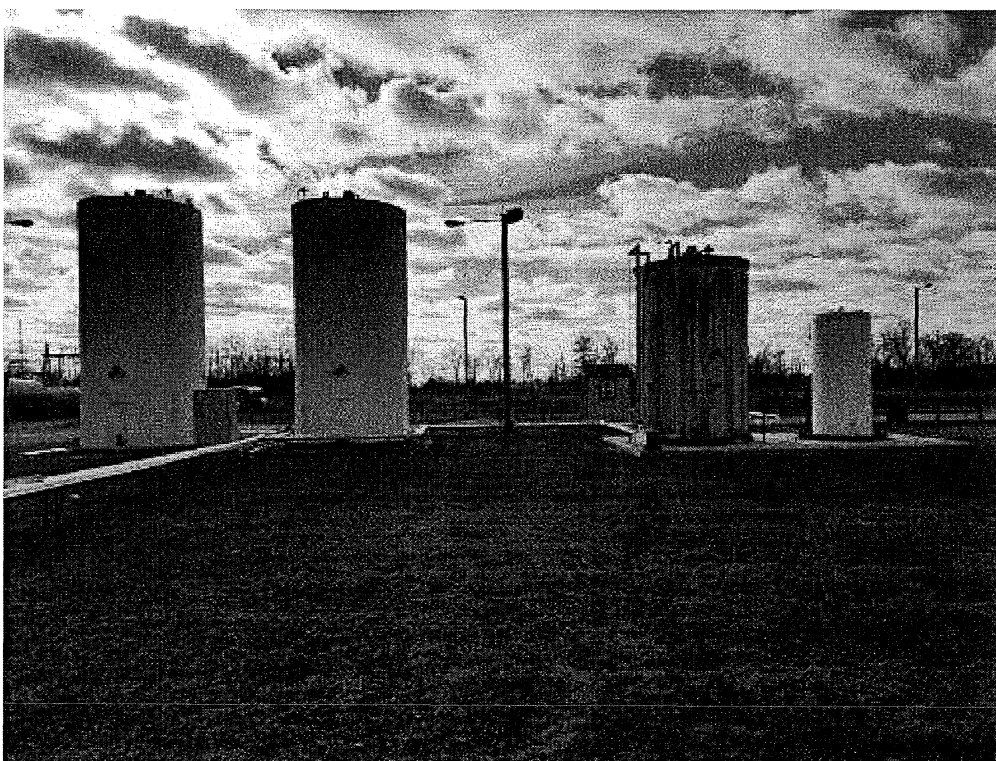
Image 9(Existing tanks) : Existing outdoor storage tanks

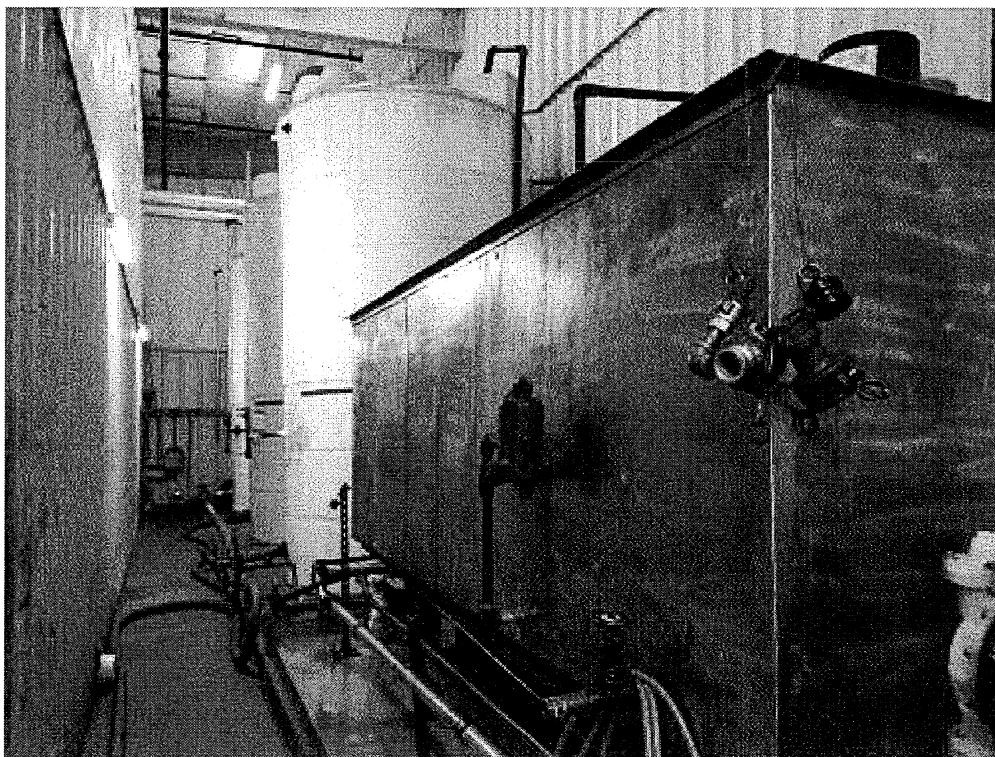
EUWWTMS: See attached photos. Most of the wastewater is coming from the biodiesel washing process and minor contributions from flooring washing etc. Almost all the oil is biodiesel and is a sellable product. The wastewater itself must be shipped offsite for disposal as it does not meet the local sanitary sewer requirements for discharge due acidity, phosphate content etc.

Image 10(Oil separator) : Oil separator in wastewater treatment section

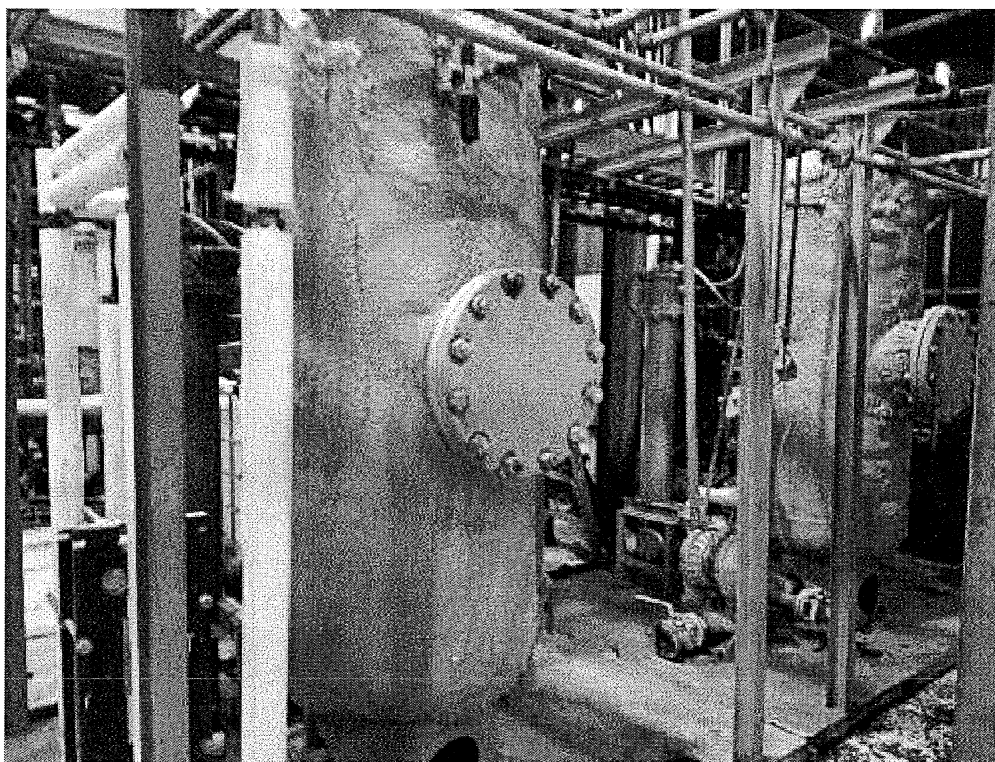
**EUMODULAR:** See attached photos. Not operating. The whole process was contained in a small area on several skids.

Image 11(Modular reactors) : Modular reactors

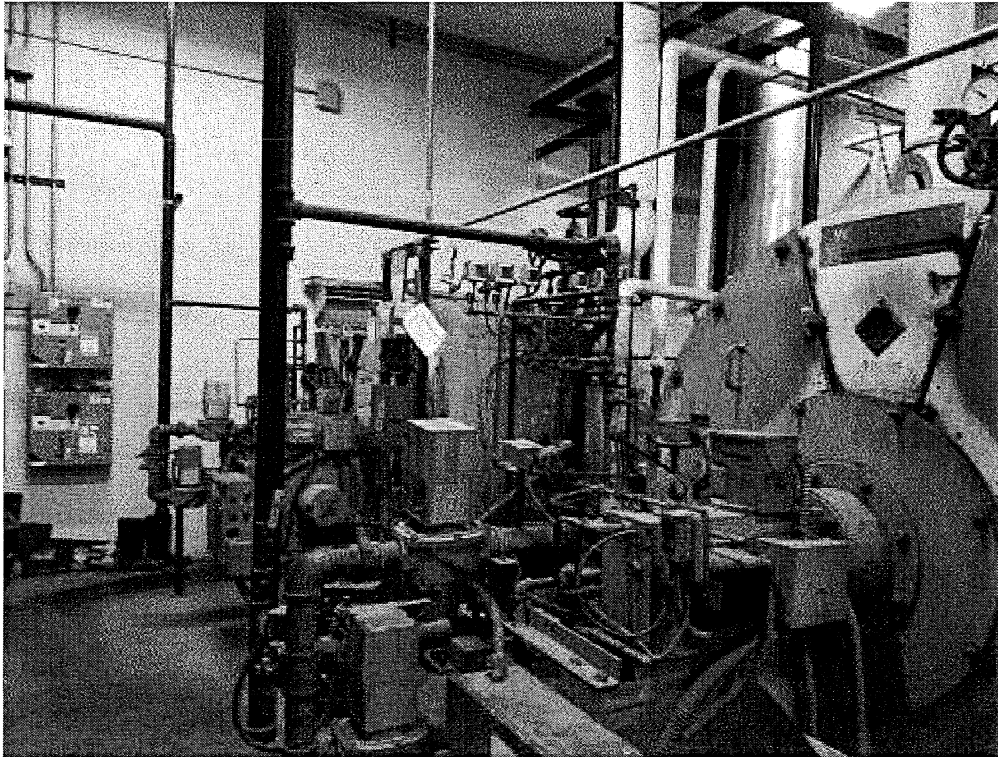
EUBOILERS: See attached photos. The 2 150 HP boilers appeared to be the same boilers noted during the previous inspection. The new 3<sup>rd</sup> boiler will go in directly adjacent to the two existing boilers and will be used for the new distillation columns.

Image 12(Boilers) : Boilers
