## DEPARTMENT OF ENVIRONMENTAL QUALITY AIR QUALITY DIVISION ACTIVITY REPORT: On-site Inspection

FACILITY: NuEnergy Operating, Inc. (Zebulon 16 CPF)		SRN / ID: P0556
LOCATION: Clinton Twp., Section 16, COMINS		DISTRICT: Gaylord
CITY: COMINS		COUNTY: OSCODA
CONTACT:		<b>ACTIVITY DATE</b> : 10/09/2024
STAFF: Tammie Puite	COMPLIANCE STATUS: Compliance	SOURCE CLASS: SM OPT OUT
SUBJECT: On-site inspection to become familiar with the source as the newly assigned inspector.		
RESOLVED COMPLAINTS:

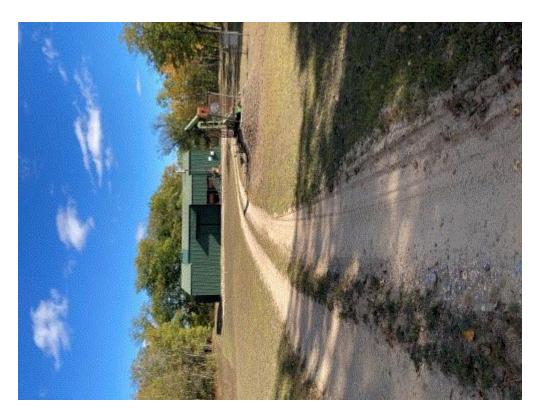
Image 1(P0556): CPF Exterior View

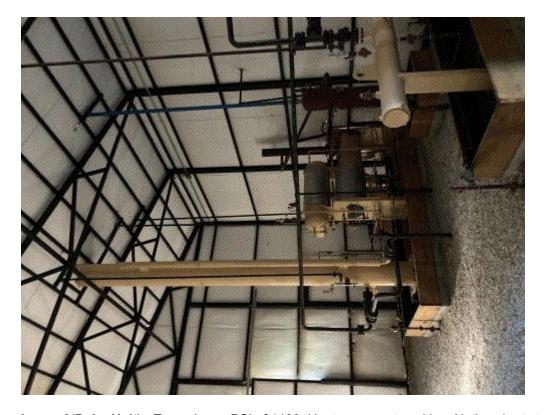
A Tri-Ethylene Glycol Dehydrator was onsite, but the heater was not operating. The glycol dehydrator is exempt per R288(b)(ii).

<u>Image 3(Dehy Unit)</u>: Tower has a PSI of 1100; Heater was not working. Notice short stack on Dehy.
