DEPARTMENT OF ENVIRONMENTAL QUALITY
AIR QUALITY DIVISION
ACTIVITY REPORT: Self Initiated Inspection

FACILITY: BPV Environmental LLC		SRN / ID: P1036
LOCATION: 511 76th Street SW, BYRON CENTER		DISTRICT: Grand Rapids
CITY: BYRON CENTER		COUNTY: KENT
CONTACT: Jacob Draaisma, Plant Manager		ACTIVITY DATE: 06/17/2019
STAFF: Chris Robinson	COMPLIANCE STATUS: Compliance	SOURCE CLASS: Minor
SUBJECT: FY '19 on-site inspection		
RESOLVED COMPLAINTS:

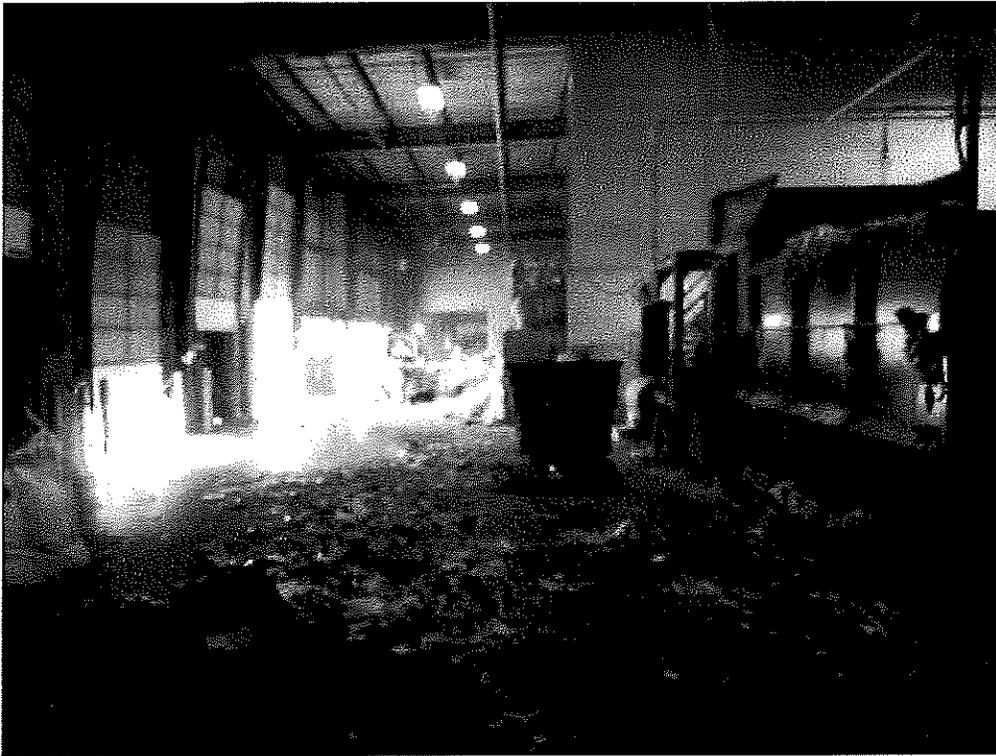
Image 1(BPV Environmental) : Staging Area

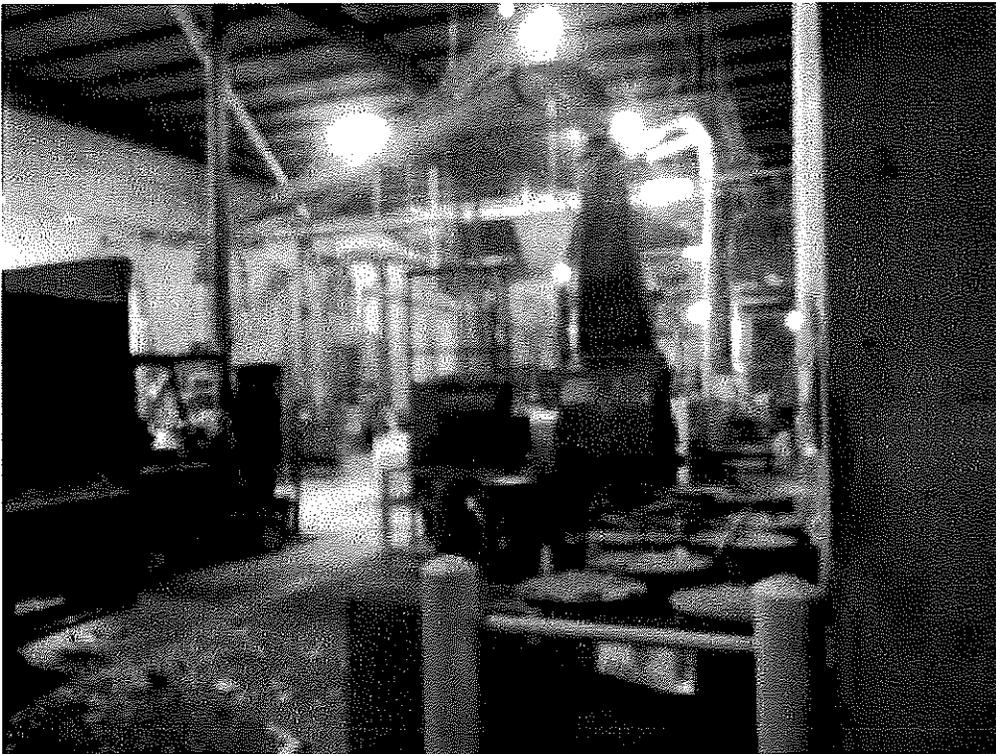
Image 2(BPV Environmental) : Pre-Processing Area

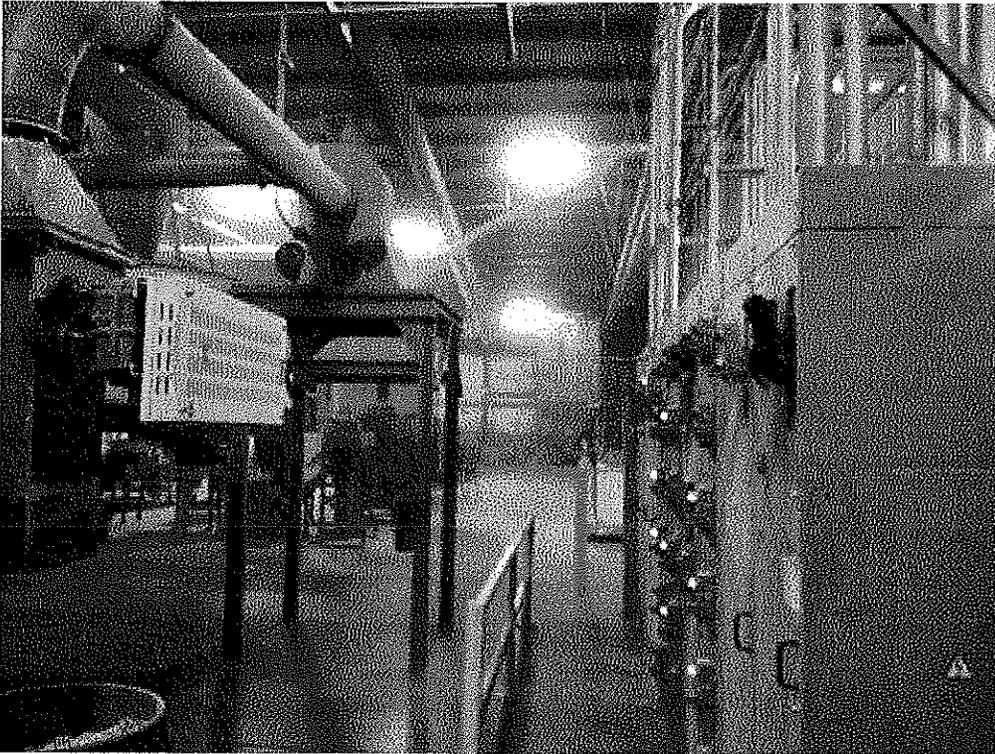
Image 3(BPV Environmental) : Pre-Processing Area - Dust from cleaning of BH 407

Mr. Draaisma informed CR that Baghouse BH 407 was offline due to mechanical issues. Even though some of the baghouses are vented internally, they are all equipped with safety doors that open when the unit malfunctions to prevent further issues. Once opened the baghouses vent externally (See Pictures Below). This is the most likely source of the emissions observed by AQD staff. The dust observed in the picture below is caused from staff cleaning the unit. CR discussed the magnehelic readings for baghouses BH1 and BH2. Baghouse BH2 had a reading of zero, which is lower than the operating range indicated on the gauge, while Baghouse BH1 was higher than the indicated operating range. Assuming that the gauges are working correctly,

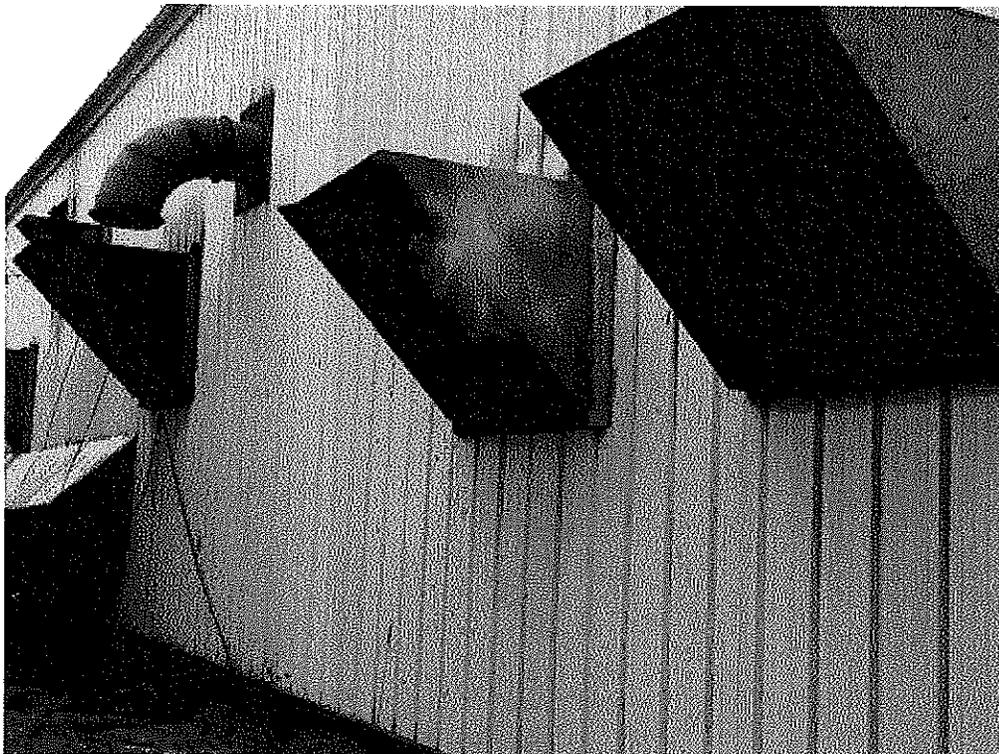
Image 4(BPV Environmental) : Baghouse exhaust points - Dust is from the cleaning of BH 407.

a low, but not zero, reading indicates that either the bag filters were just cleaned or leaking. High pressure indicates that the system is potentially plugged. This was discussed and corrective action was immediately taken. Per follow-up call on 6/20/2019 staff determined and unplugged the tubing for the baghouse BH2 magnehelic gauge. In addition, the facility's air compressor was offline due to mechanical issues. A temporary smaller air compressor was installed that is not as effective at pulsing the baghouse filters, therefore maintenance is more frequent. A new air compressor has been ordered. The operating range was not provided on the magnehelic gauges for baghouses BH408 and BH409. However, these two baghouses are similar to the remaining three, therefore it's being assumed that baghouse BH409 is operating on the high side and will also need attention soon.
