**DEPARTMENT OF ENVIRONMENTAL QUALITY  
AIR QUALITY DIVISION  
ACTIVITY REPORT: On-site Inspection**

<b>FACILITY:</b> RECLAIMED AGGREGATE INC DBA L & L AGGREGATES		<b>SRN / ID:</b> P1390
<b>LOCATION:</b> 6153 AURELIUS RD, LANSING		<b>DISTRICT:</b> Lansing
<b>CITY:</b> LANSING		<b>COUNTY:</b> INGHAM
<b>CONTACT:</b> Aaron Perrault , Owner		<b>ACTIVITY DATE:</b> 08/15/2024
<b>STAFF:</b> Michelle Luplow	<b>COMPLIANCE STATUS:</b> Compliance	<b>SOURCE CLASS:</b> MINOR
<b>SUBJECT:</b> Onsite inspection to determine compliance with General PTI 88-23.		
<b>RESOLVED COMPLAINTS:</b>

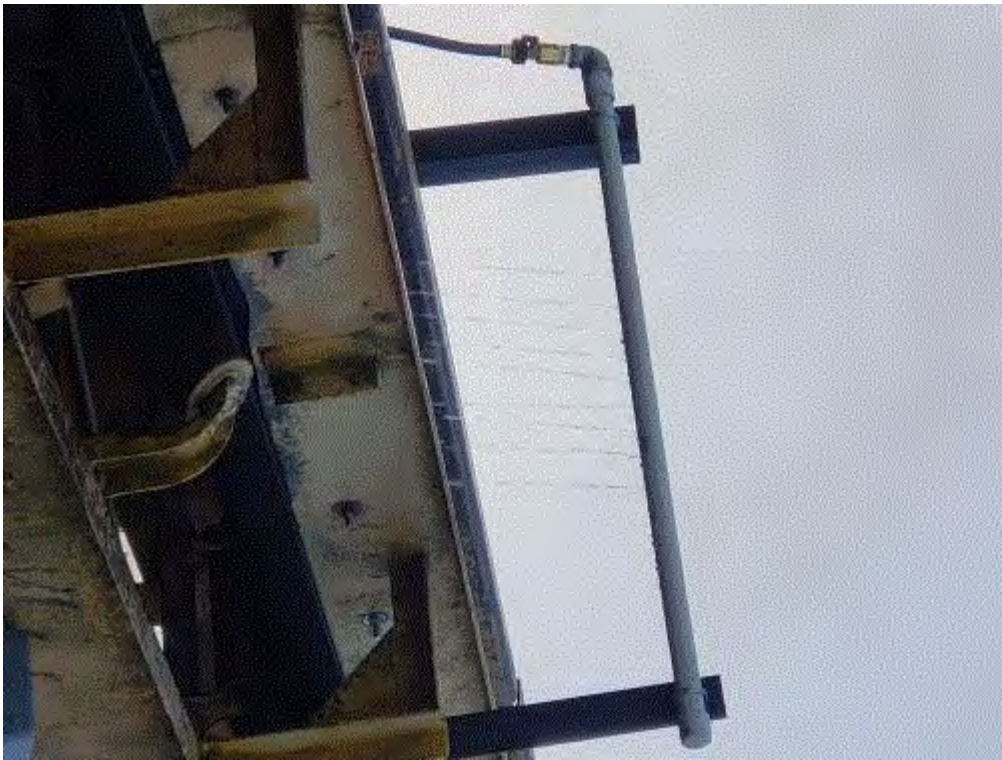
**Image 1(Return Spraybar)** : Spray bar added to crusher return. Photo credit: L & L Aggregates

R. Flannery said he planned to install water spray on the crusher return conveyor, as he believes this will further minimize dust from the process. He provided a photo of the installed spray bar on Wednesday, August 21, and said that they did not operate the equipment on Monday or Tuesday, and installed the spray bar on Tuesday, August 20, around 3:00 p.m. I will assess whether this is sufficient water spray at a future site visit.

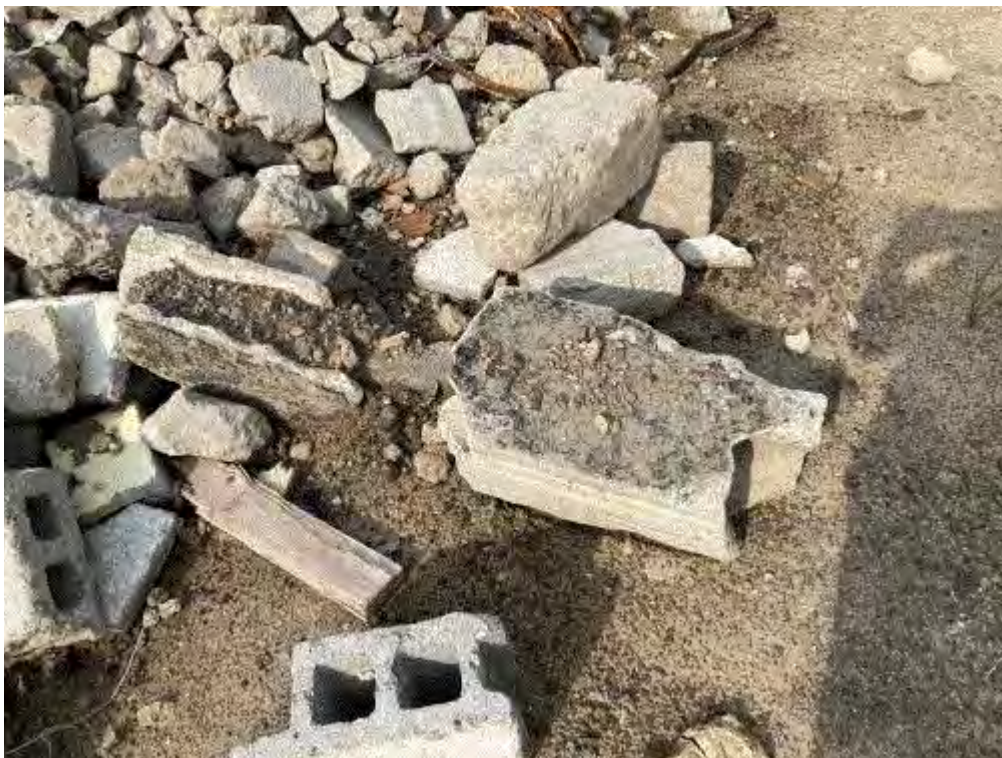
L & L is required to ensure that no asbestos tailings or asbestos-containing waste materials are crushed. Jeremy Brown and I surveyed the various source piles across the site. Based on Jeremy Brown's professional judgment as an asbestos inspector, all piles appeared to be acceptable, except for a pile that specifically originated from the McLaren demolition. This pile was intentionally kept separate from the other piles because it consisted of transformers, scrap metals, and other debris in addition to concrete materials. L & L staff remove all materials except for concrete to prior to crushing from this pile. Jeremy Brown found suspect ACM material in this McLaren pile and took 2 samples of

**Image 2(Suspect Source Pile)** : Pile of concrete mixed with other materials (transformers, scrap metal, etc). This pile is where J. Brown found suspect ACM.

J. Brown and I had a post-inspection follow-up call to ensure owner, Aaron Perrault, understood the company's responsibility for managing materials coming into the site and ensuring that the materials coming in are ACM-free if they plan on crushing it, noting that in the event L & L has a pile on-site that contains ACM, they are responsible for the cost of landfilling the pile or removing all ACM materials prior to crushing. Aaron Perrault expressed that he understood these requirements. J. Brown recommended that L & L receive proof from the hauler that the materials were tested and documented as ACM-free.

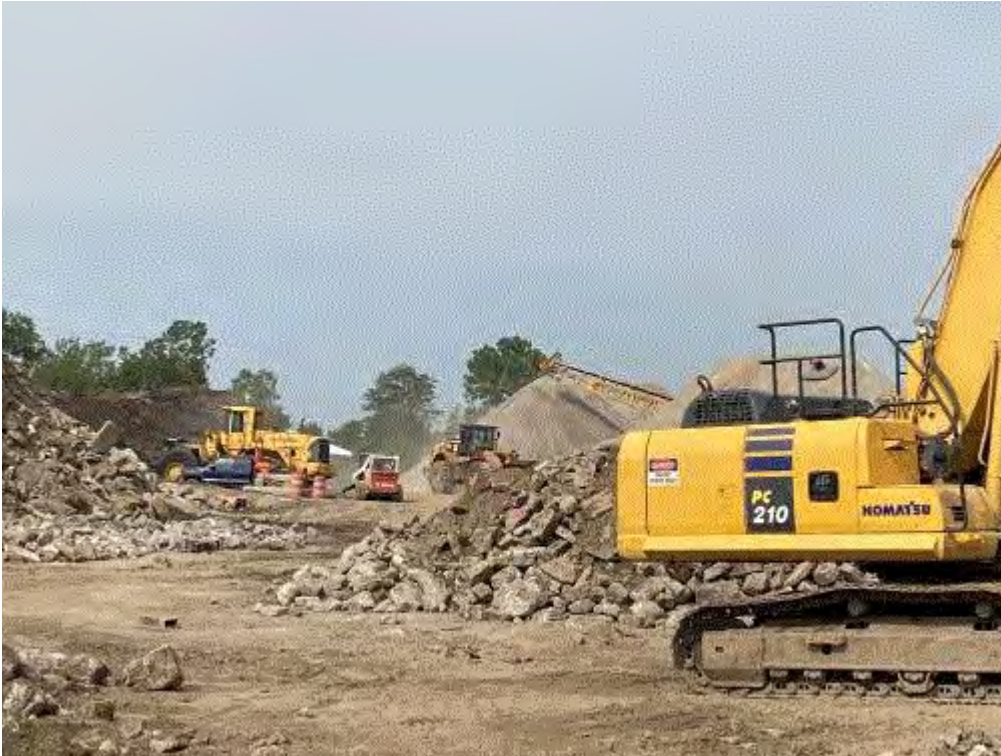
**Image 3(Fugitive Dust)** : truck traffic dust present in the distance.

The dust on the site roadways and plant yard are required to be controlled by applications of water, calcium chloride, or other approved fugitive dust control compounds. This shall be done as needed to ensure the 5% opacity limit is met. During the inspection, loader and truck traffic on the unpaved roads and plant yard were causing fugitive dust in excess of the 5% opacity limit. I informed R. Flannery of this issue and they immediately responded by using their on-site water truck to water down these areas. The water appeared to be sufficient to ensure compliance with the limit.

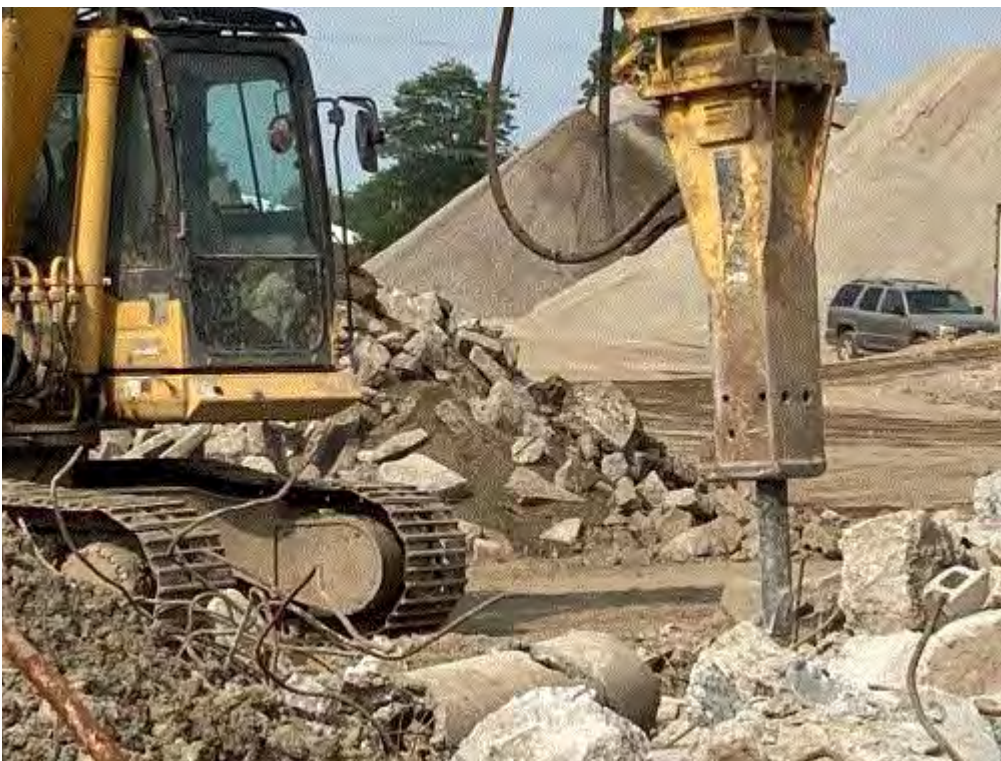
One Rock Drill being used to break down concrete into smaller chunks prior to crushing.	At or below 5% opacity
--	---	------------------------

**Image 4(Rock Drill)** : Rock drill used to break large pieces of concrete into small pieces of concrete.
