# DEPARTMENT OF ENVIRONMENTAL QUALITY AIR QUALITY DIVISION

#### **ACTIVITY REPORT: Self Initiated Inspection**

FACILITY: A-1 Auto Salvage & Scrap		SRN / ID: U811706525
LOCATION: 2574 State Street		DISTRICT: Jackson
CITY: Ypsilanti		COUNTY: WASHTENAW
CONTACT:		ACTIVITY DATE: 08/23/2017
STAFF: Mike Kovalchick	COMPLIANCE STATUS: Non Compliance	SOURCE CLASS:
SUBJECT: Inspection of a meta	l scrap yard.	
RESOLVED COMPLAINTS:

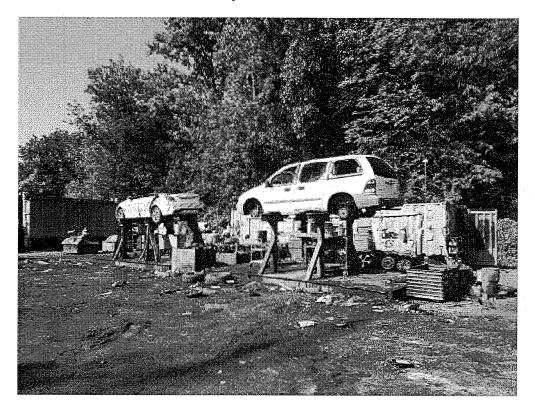
Lance, a facility employee, and Jim gave me a tour of the facility. He showed me the depollution station. See attached photos. It appeared that they were removing gasoline and oil. However, there was a large area where the soil was stained with oil nearby suggesting that they are not getting all the oil of the vehicles.

Image 2(Depollution area): Depollution area

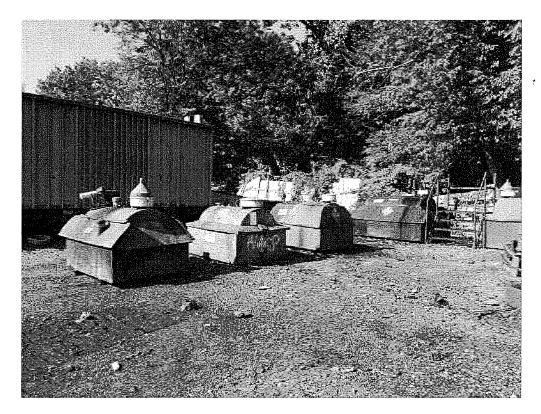
<u>Image 3(Depollution area)</u>: Storage tanks associated with car depollution area.

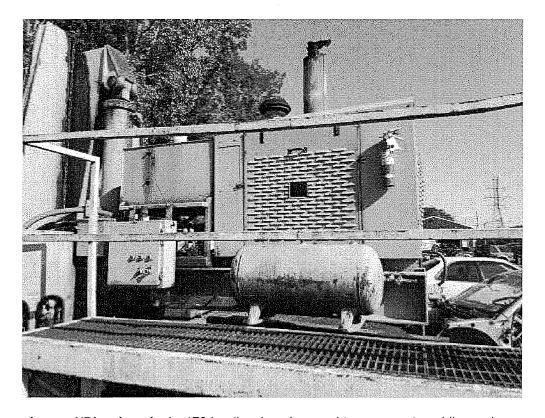
Next, we went and looked at diesel engine associated with the automobile crusher. The diesel engine was rated 170 hp that was built in 2000 and has 20,949 hours of use on it and was on during the inspection. I discussed briefly with him about the RICE MACT requirements.

40 CFR Part 63 Subpart ZZZZ. RICE MACT applies to a less than 500 hp CI diesel fired engine located at an area source. The engine pre-dates 2007 and the New Source Performance Standards (NSPS) for Stationary Compression Ignition (CI) Internal Combustion Engines, which are codified in the Code of Federal Regulations (CFR) at 40 CFR part 60 subparts IIII. The nonroad engine exemption does not apply to the crusher diesel engine since it has been located on site for more than 12 months.

<u>Image 4(Diesel engine)</u>: 170 hp diesel engine used to power automobile crusher.

The Company is out of compliance with federal RICE MACT requirements for the diesel engine associated with the automobile crusher.

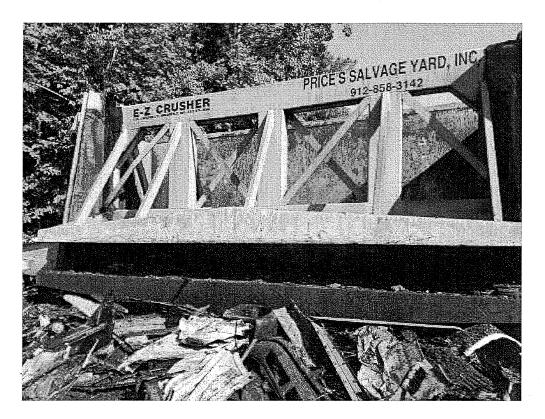
Next, we looked at the adjacent automobile crusher. See attached photos. Lance indicated that basically no dust is created when the vehicles are crushed. It isn't equipped with a water spray bar. Large oil stains were located on the ground next to it. The main pollutant of concern is mercury since the Company had stopped removing mercury switches when a local environmental firm stopped taking them. See attached photos.

Rule 201 applies to the automobile crusher since the mercury in mercury switches is potentially being released when the vehicle is smashed.

Image 5(auto crusher): Auto crusher

The Company is out of compliance with the automobile crusher. Mercury switches need to be removed to avoid the requirement for a permit.

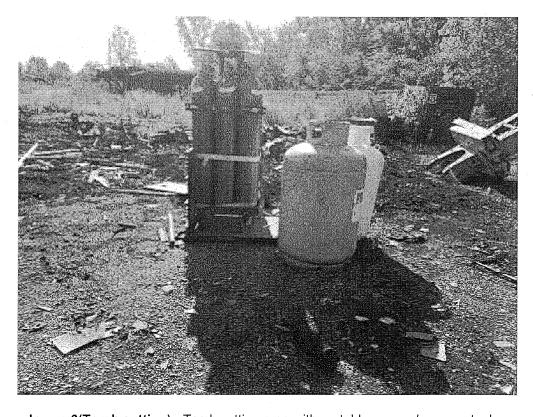
We then proceeded to walk over to the area where torching was conducted. There was some metal in small piles waiting for torching to resume. They use only one torch at a time on the ground that is supplied by small/portable oxygen/propane tanks. I discussed with the new rule chances associated with torch cutting. See attached photo.

Rule 201 applies to torch cutting as that type of process is no longer exempt from permitting requirements.

<u>Image 6(Torch cutting)</u>: Torch cutting area with portable oxygen/propane tanks.

The Company is out of compliance with their torch cutting operation. They will need to either obtain a PTI permit, torch cut indoors in a building properly controlled by a dust collector or cease operations to get back into compliance.

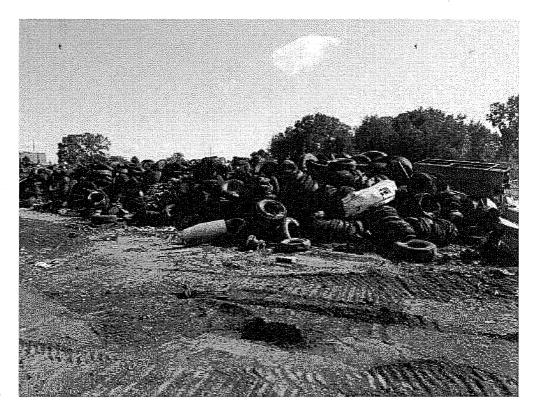
Not far from where the torch cutting is done were 2 large piles of tires. See attached photos. They appear to have been there a long time and suspect there is more than 500 of them. They use a crane shear to slice up the tires and place them in the same metal box that is shipped offsite with the crushed cars.

lmage 7(Tire pile #1) : Tire pile # 1.

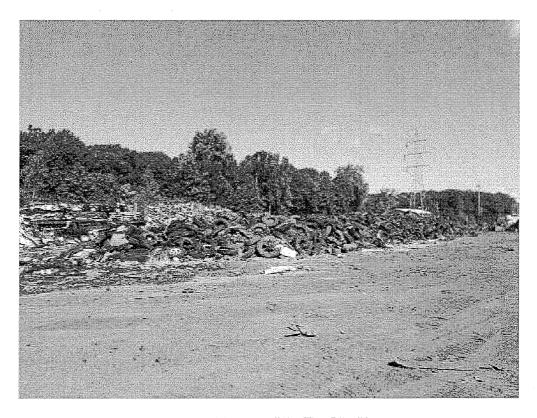
Image 8(Tire Pile #2): Tire Pile #2.

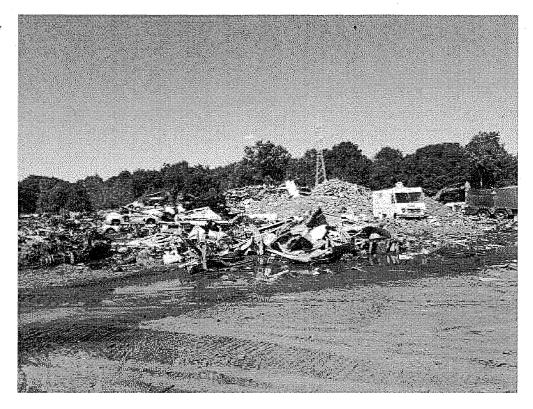
Image 9(General scrap pile): General scrap pile.
