DEPARTMENT OF ENVIRONMENTAL QUALITY
AIR QUALITY DIVISION
ACTIVITY REPORT: Scheduled Inspection

FACILITY: INDUSTRIAL STEEL TREAT CO		SRN / ID: A1864
LOCATION: 613 CARROLL ST, JACKSON		DISTRICT: Jackson
CITY: JACKSON		COUNTY: JACKSON
CONTACT: Jim Matthews , Facilities Manager/Environmental		ACTIVITY DATE: 06/24/2016
STAFF: Michael Gabor	COMPLIANCE STATUS: Non Compliance	SOURCE CLASS: SM OPT OUT
SUBJECT: Full Compliance Evaluation (FCE) and Inspection (PCE) of Industrial Steel Treat Co., a Synthetic Minor / Opt-Out Source. A Rule 201 Violation was identified.		
RESOLVED COMPLAINTS:

Synthetic Minor / Opt-Out Source. Full Compliance Evaluation (FCE) and Inspection (PCE) of Industrial Steel Treating, located at 613 Carroll Street, Jackson, Michigan 49202.

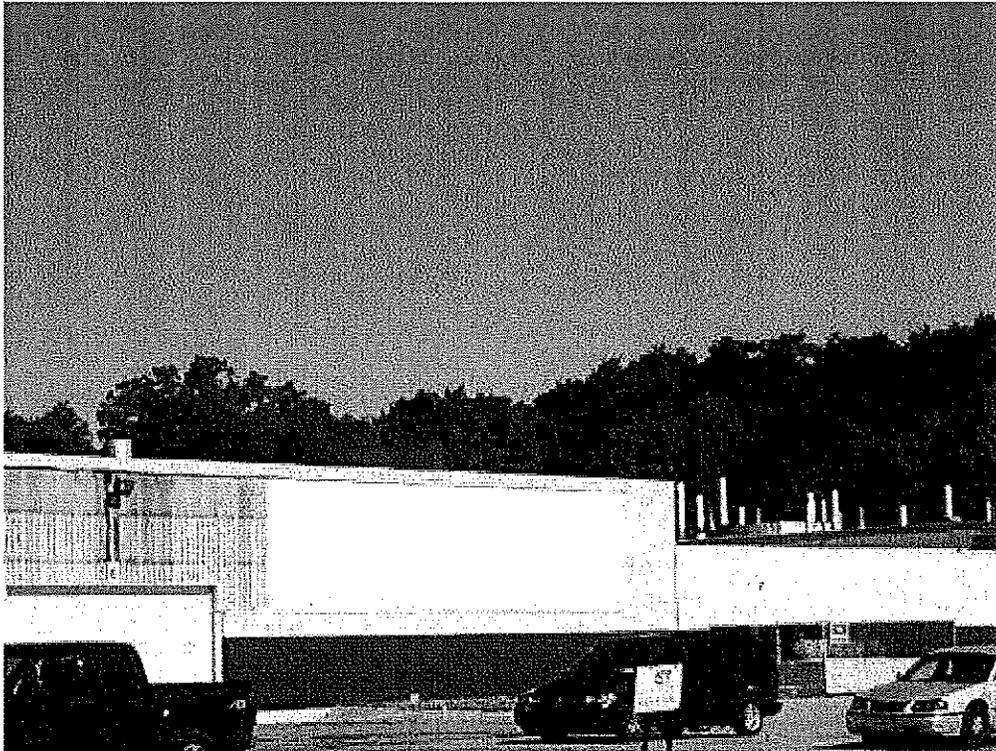
Slight visible emissions were observed upon my approach to the facility via Carroll Avenue, and appeared from a stack located on the northwest corner of IST's second building (see Figure 1). Later in the inspection, as documented below, I determined that the emissions were associated with EU9HTEMPER. I arrived at approximately 9:45 am, proceeded to the facility office to request access for an inspection, provided my identification to JM, and asked if he or someone else was available to meet with me, etc. JM escorted me to his office and a pre-inspection conference was held. I provided a copy of the Michigan Department of Environmental Quality (MDEQ) brochures entitled *Rights and Responsibilities Environmental Regulatory Inspections and Boiler NESHAP Navigation Tool*, and invited JM to complete the customer service survey upon receipt of my inspection report. I informed JM of my intent to conduct a facility inspection and to review the various records required by their permit. JM extended his full cooperation during the inspection and he accompanied me during the site tour portion of the inspection.

Image 1(Figure 1) : Slight visible emissions were observed upon my approach to the facility via Carol Avenue, and appeared from a stack located on the northwest corner of IST's second building.

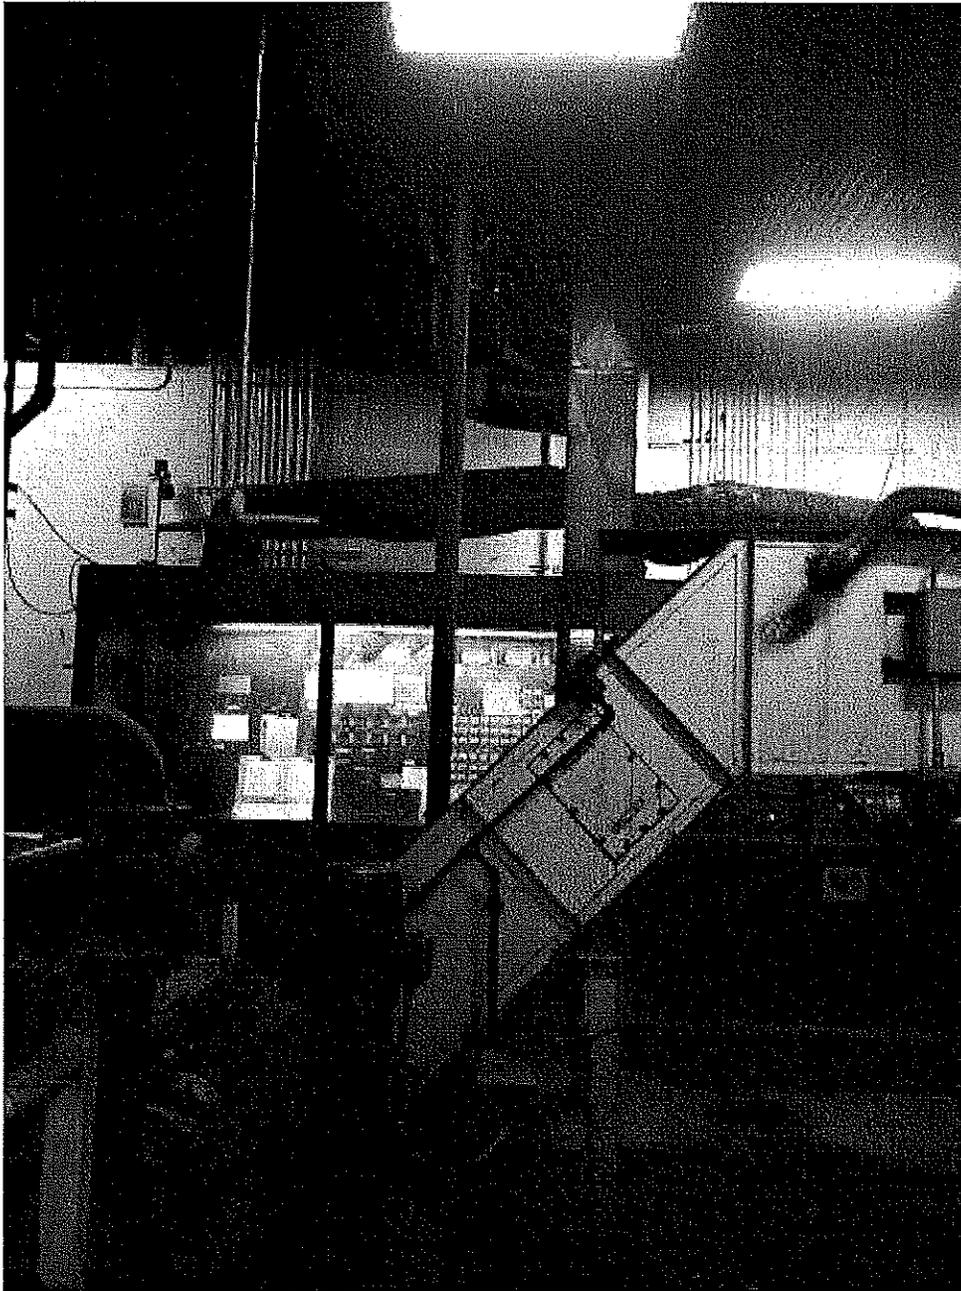
EU ID	Observations / Comments
EU1CHARDENTEMPER	Observed excess emissions emanating from the wash tank and from the temper furnace. Some emissions were not captured by the hood and routed outside via the stacks (see Figures 2 and 3). During the inspection I asked JM to investigate the cause and report his findings to me. On 6/27/2016, I sent an email request to investigate and report findings by

Image 2(Figure 2) : Observed smoky emissions emanating from EU1CHARDENTEMPE's temper furnace during the inspection. Some emissions were not captured by the hood and routed outside via the stacks.

<p>COB 7/11/2016. JM responded timely via email (attached) and reported that maintenance staff found that the stack fan on the temper furnace hood was not operating due to broken bearings, which was to be replaced by 7/11/2016. Additional emissions observed during the inspection were caused by a combination of air induction caused by the operation of blowers designed to blow off excess water from the parts after going through the wash tank, and to excessively wet parts. This will be addressed by tweaking the blower fans at the end of July. Proposed resolutions are satisfactory.</p>
EU2CHARDENTEMPER	Observed operation and it was recently rebuilt by IST. It was equipped with 2 of the 3 flares indicated by the EU description. One of the flares was removed due to impacts upon the process.
EU3CHARDENTEMPER	No longer onsite. Dismantled and removed from the site.
EU4CHARDENTEMPER	Observed a clean operation. This EU was rebuilt and was equipped with 2 of the 4 flares indicated by the EU description.

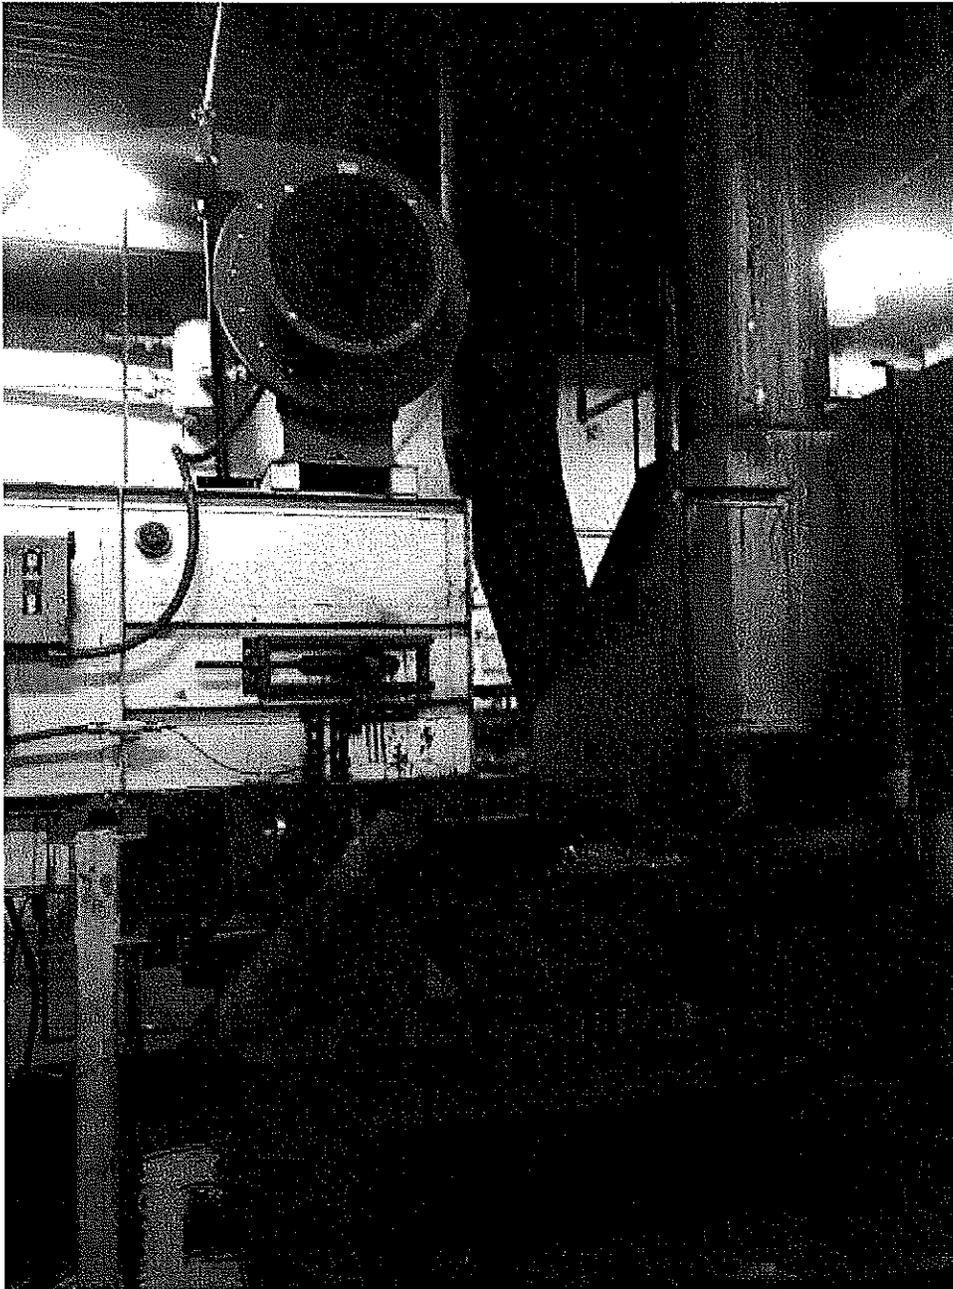
Image 3(Figure 3) : Observed smoky emissions emanating from EU1CHARDENTEMPE's temper furnace during the inspection. Some emissions were not captured by the hood and routed outside via the stacks.
