DEPARTMENT OF ENVIRONMENTAL QUALITY
AIR QUALITY DIVISION
ACTIVITY REPORT: Self Initiated Inspection

FACILITY: DIAMOND CHROME PLATING INC		SRN / ID: A2931
LOCATION: 604 S MICHIGAN, HOWELL		DISTRICT: Lansing
CITY: HOWELL		COUNTY: LIVINGSTON
CONTACT: Scott Wright , Environmental Manager		ACTIVITY DATE: 11/21/2019
STAFF: Daniel McGeen	COMPLIANCE STATUS: Non Compliance	SOURCE CLASS: MINOR
SUBJECT: Check to verify that the BACT-72A vapor degreaser was in "chill mode." Status of noncompliance reflects Violation Notice sent on 10/30/2019 for Rule 201 and Subpart T, which was not fully resolved, as of 11/21/2019.		
RESOLVED COMPLAINTS:

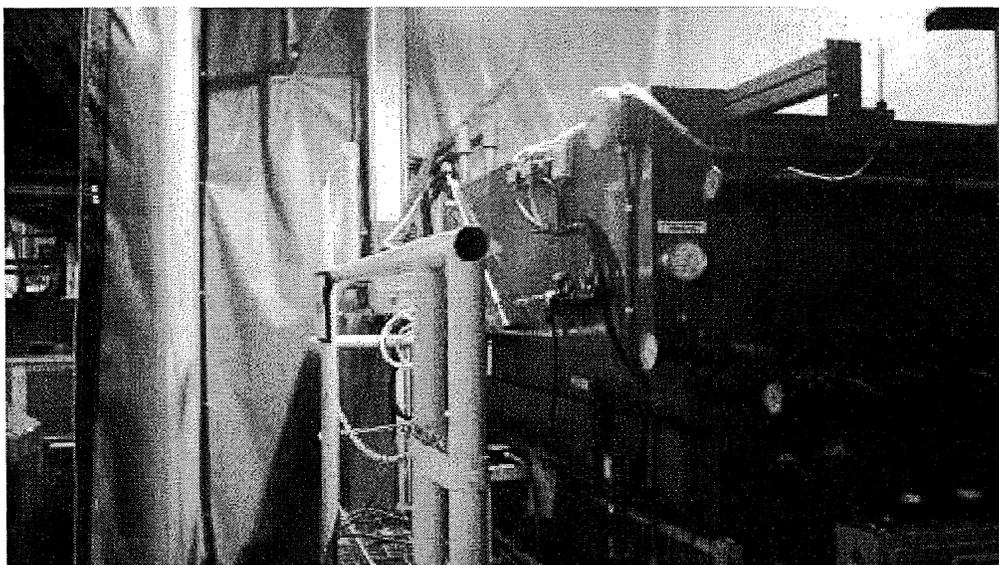
I was taken to the degreaser, and saw that a room-like enclosure was in the process of being made with hanging sheets of thick plastic tarps, as shown in photo Nos. 001 and 002. My understanding was that these are made of PVC, and coated with vinyl, as described in the DCP Sampling Work Plan emailed to AQD and RRD on 11/20/2019, and that the intent is to block vapors from escaping. It was also my understanding that two carbon filtration units have been ordered, and will be located within the enclosure.

Image 1(001) : Degreaser w/enclosure (partially done).

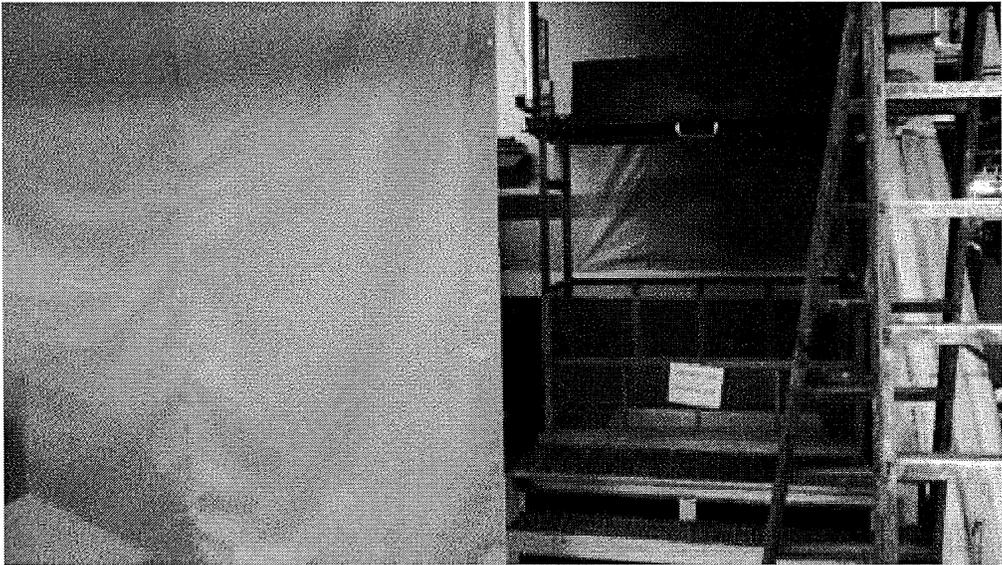
Image 2(002) : Partially completed enclosure.

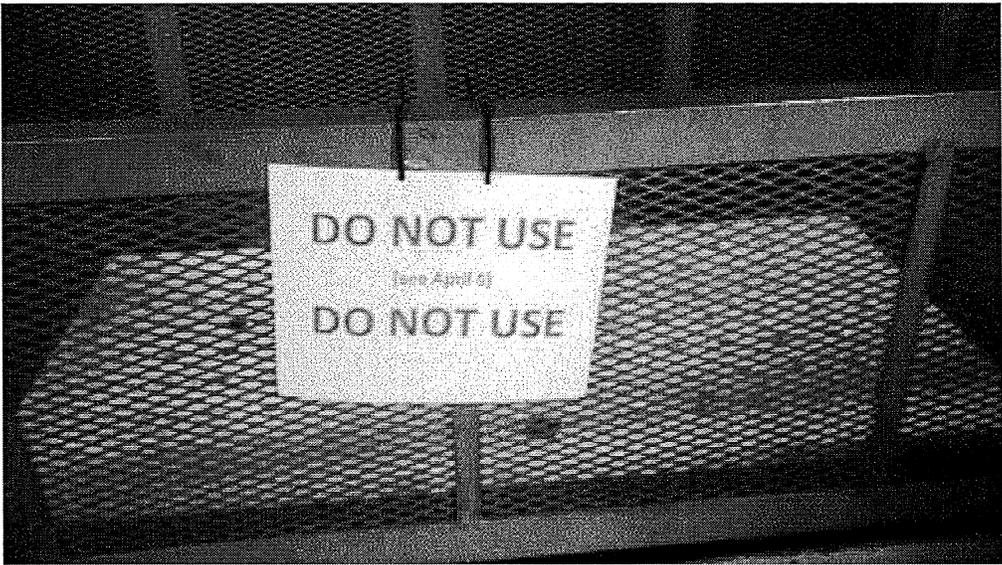
Parts were not being cleaned in the degreaser at this time. The parts basket was empty, other than the Teflon pad which is kept at the bottom of the basket, and a sign, which stated, in part, "DO NOT USE." Please see photo Nos. 003 and 004.

Image 3(003) : DO NOT USE sign on parts basket.

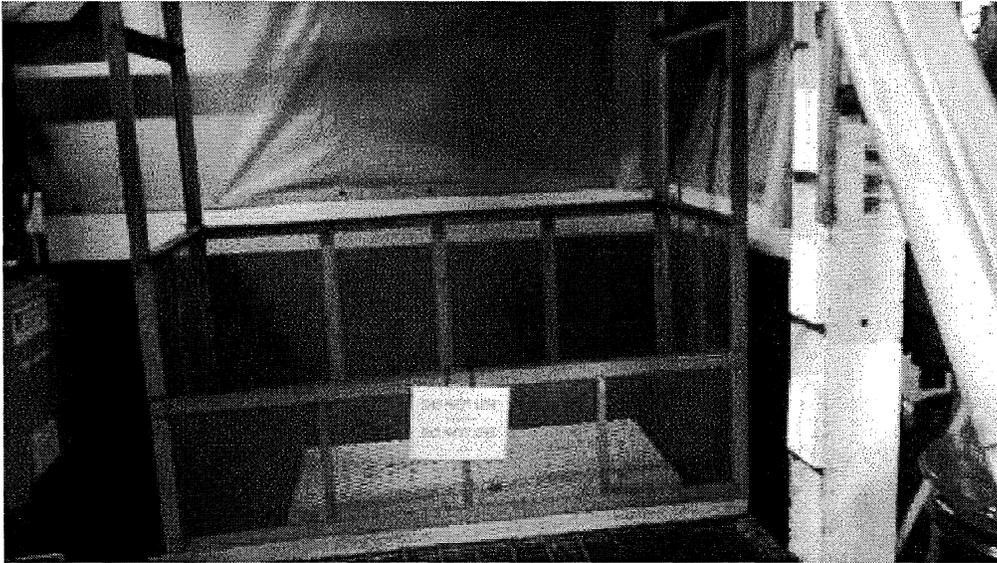
Image 4(004) : Parts basket, with sign.

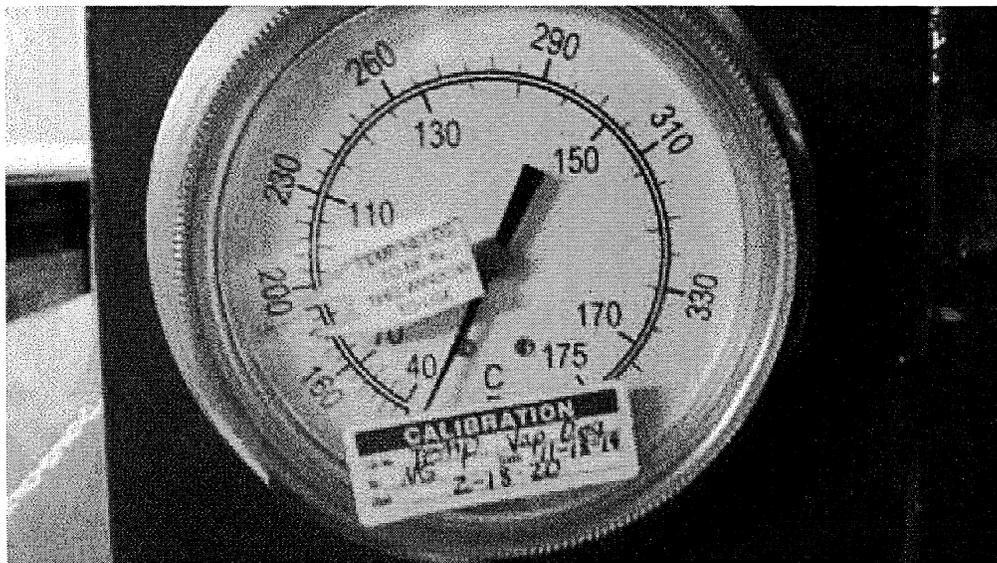
The sump heater was not running, as evidenced by the temperature gauge reading so low, as to be off the scale. It was below 40 degrees C, which equates to 104 degrees F. Please see attached photo No. 005, of the temperature gauge.

Image 5(005) : Solvent sump temperature gauge.

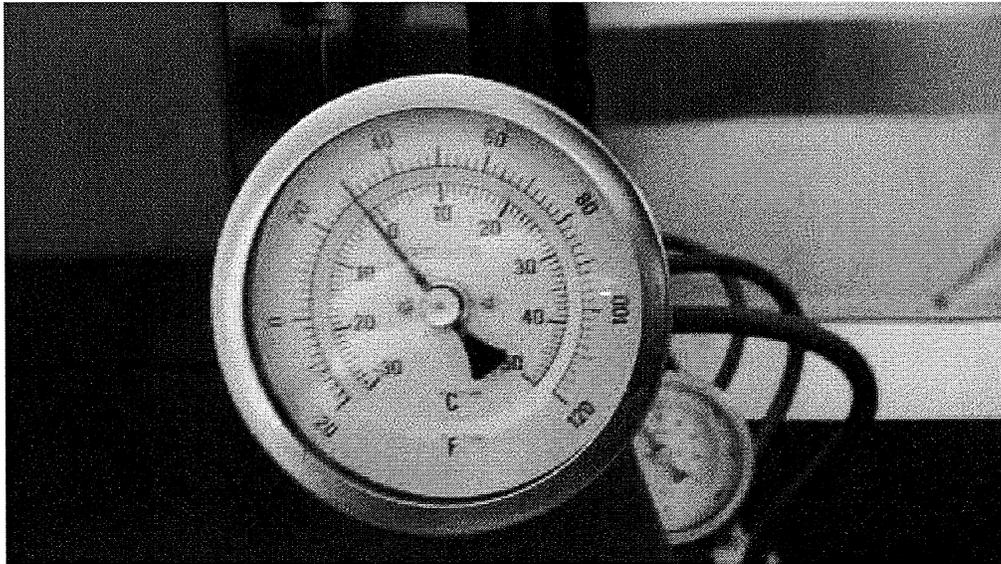
The chiller line going into the degreaser read 30 degrees F, as shown in the attached photo No. 006. The chiller outlet line for the upper level read 34 degrees F, as shown in the attached photo No. 007. The chiller outlet line for the lower level read 32 degrees F, as shown in the attached photo No. 008.

Image 6(006) : Chiller inlet temperature gauge.

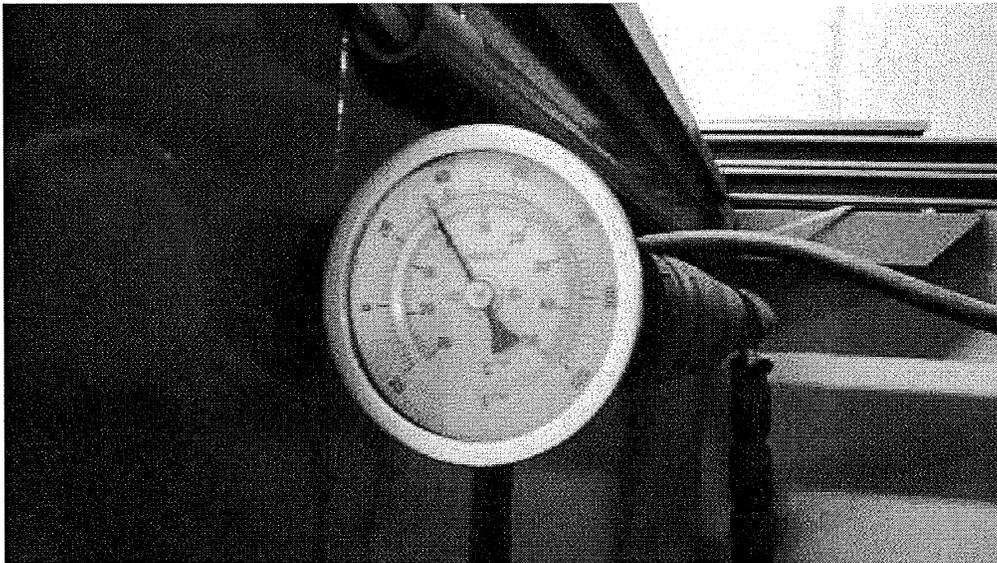
Image 7(007) : Chiller outlet, upper level gauge.

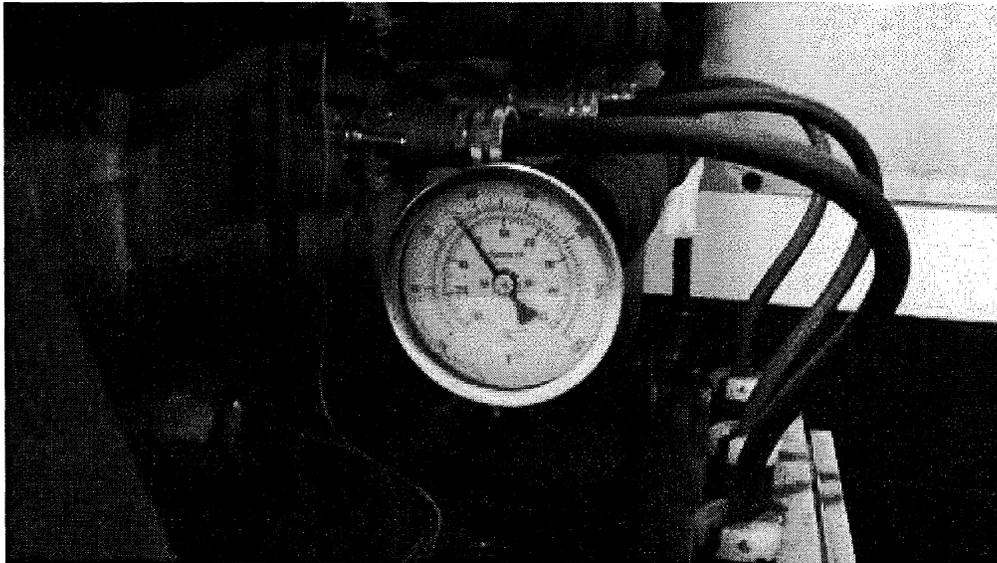
Image 8(008) : Chiller outlet, lower level gauge.

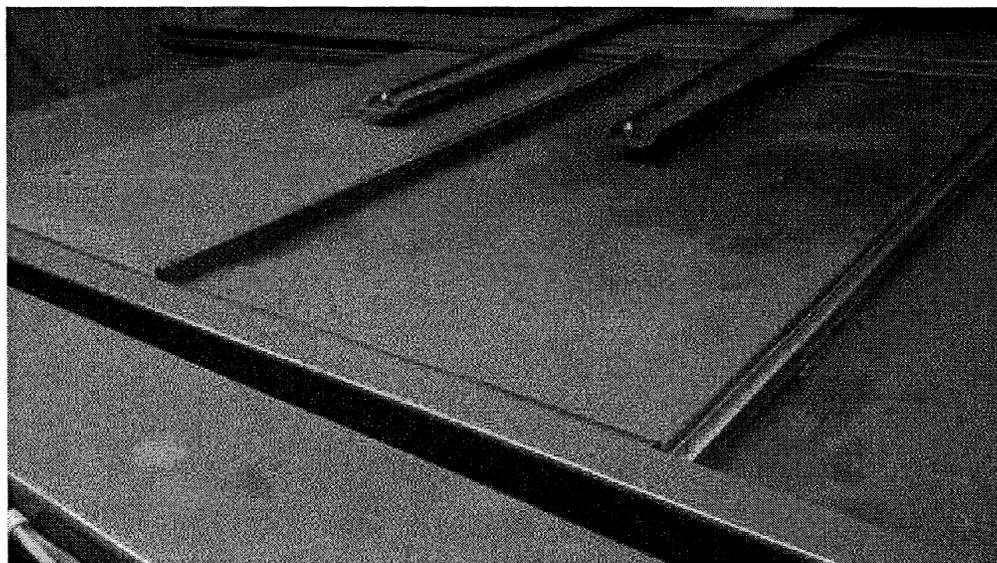
the unit. I observed a new seal, a white strip of material, on the degreaser's idling mode cover, shown in the attached photo No. 009. The 11/21 Sampling Work Plan describes this as consisting of water and weather-resistant foam weather strip material, and a nylon brush seal made of anodized aluminum. I could not detect any odors of TCE, while examining the idling mode cover today, and the bi-parting sliding doors appeared to be closed tightly.

Image 9(009) : Degreaser idling mode cover, seal (white).

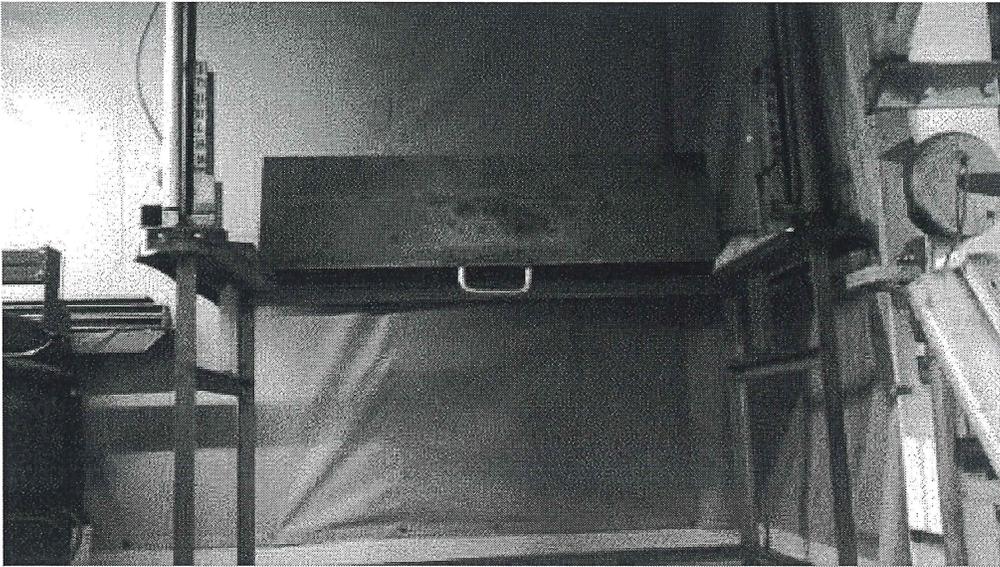
The part basket roof, or the working mode cover, has a seal of flexible, black PVC material, as shown in Photo 010. It is described as corrosion-resistant and said to be 1/8 inch thick in the 11/21 Sampling Work Plan. AQD was informed that it was installed on 11/1/2019. Since the degreaser was in "chill mode" and not cleaning parts, it was not possible to observe the fit of the seal with the degreaser. However, the corrective action plan provided to EGLE on 11/20/2019 contains several photos, showing the seal, which overall appeared to be a good fit.

Image 10(010) : Working mode cover, with seal (black trim).
