DEPARTMENT OF ENVIRONMENTAL QUALITY
AIR QUALITY DIVISION
ACTIVITY REPORT: Scheduled Inspection

FACILITY: Cadillac Asphalt LLC		SRN / ID: B1960
LOCATION: 51777 W 12 MILE RD, WIXOM		DISTRICT: Southeast Michigan
CITY: WIXOM		COUNTY: OAKLAND
CONTACT: Alan Sandell , General Manager		ACTIVITY DATE: 07/09/2013
STAFF: Robert Elmouchi	COMPLIANCE STATUS: Compliance	SOURCE CLASS: SM OPT OUT
SUBJECT: Scheduled inspection		
RESOLVED COMPLAINTS: C-13-01016, C-13-01032

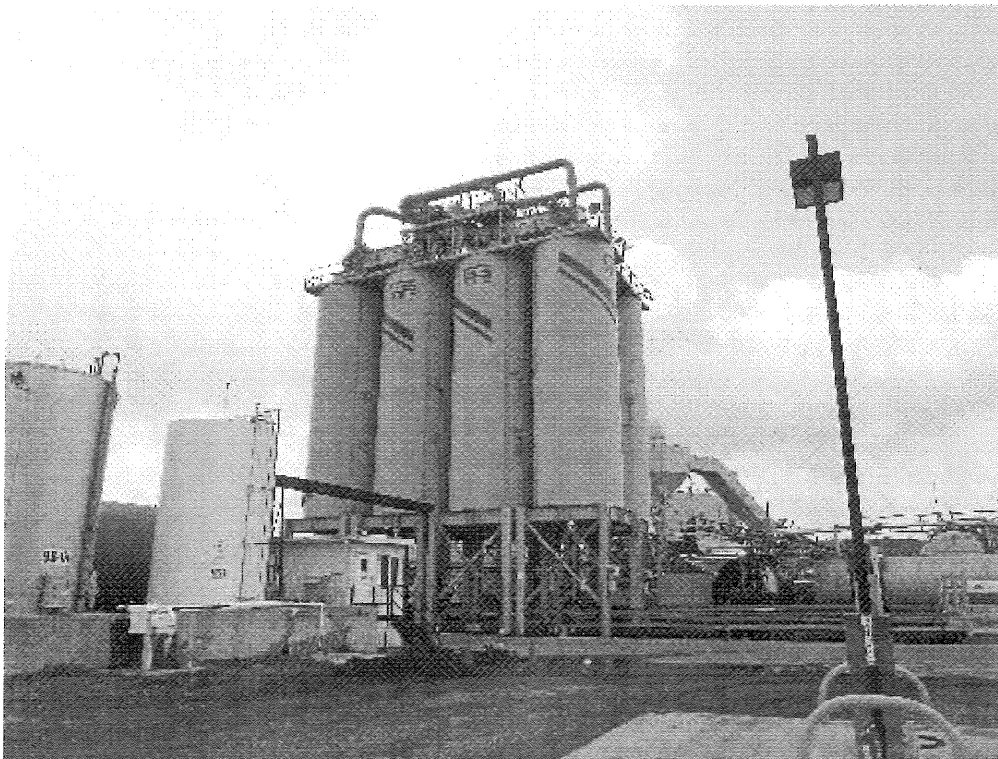
Image 1(P1240267.JPG) : View of HMA silos from the north with top mounted fugitive emission capture system that was installed on top of the silos between the 2012 and 2013 production seasons.

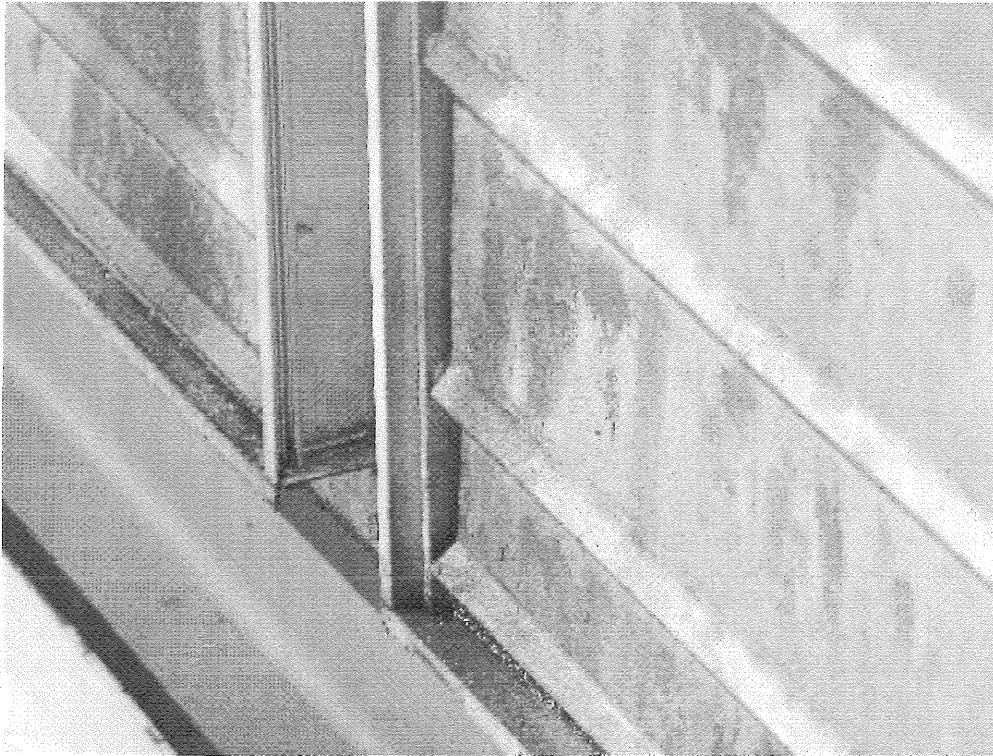
Image 6(P1240292.JPG) : Close-up view of post particulate control condensation on the exhaust louvers. Control system is undergoing engineering review to correct this issue.
