DEPARTMENT OF ENVIRONMENTAL QUALITY
AIR QUALITY DIVISION
ACTIVITY REPORT: Self Initiated Inspection

FACILITY: Omnisource Corporation		SRN / ID: B2281
LOCATION: 701 LEWIS ST, JACKSON		DISTRICT: Jackson
CITY: JACKSON		COUNTY: JACKSON
CONTACT: C. Kevin Gross , Safety/Environmental Manager		ACTIVITY DATE: 08/04/2015
STAFF: Michael Gabor	COMPLIANCE STATUS: Non Compliance	SOURCE CLASS: Minor
SUBJECT: Unannounced site-inspection, conducted jointly with Water Resources, and odor complaint investigation.		
RESOLVED COMPLAINTS:

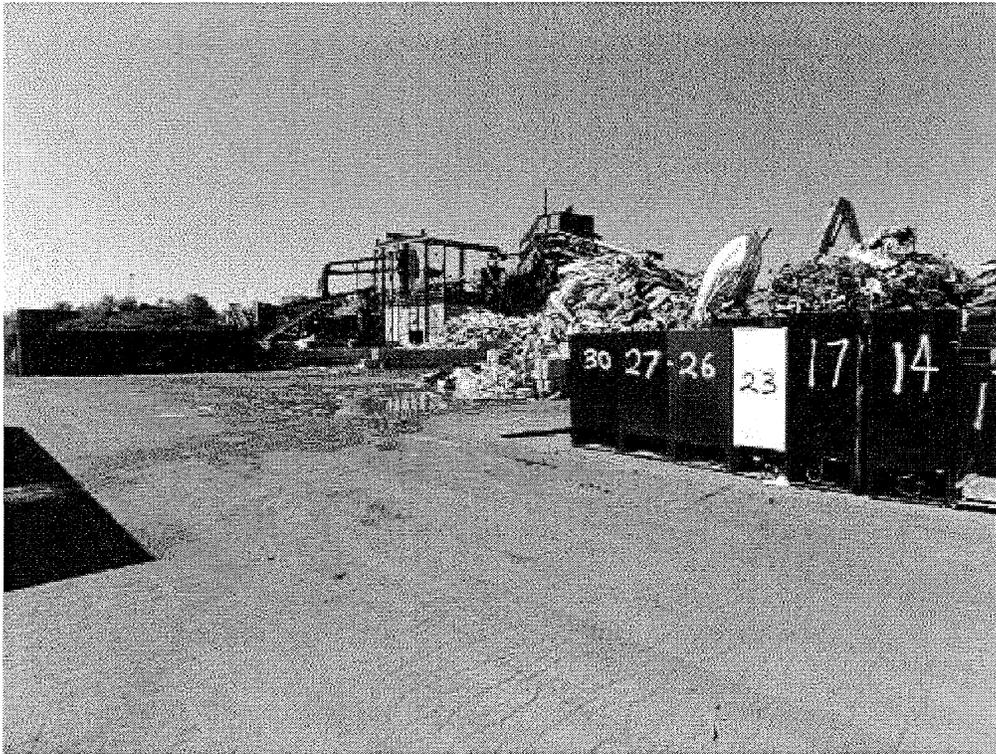
Image 1(Figure 1) : Shredder scrap pile (8/3/2015, 10:15 am).

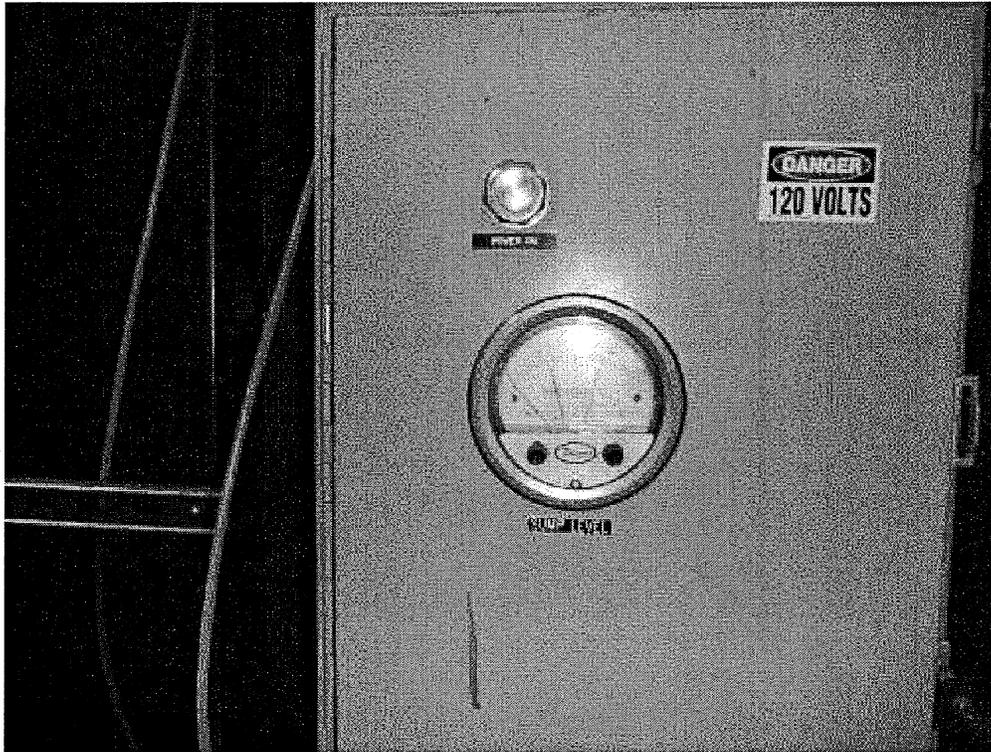
Image 3(Figure 3) : Venturi scrubber sump level gauge (8/3/2015, 10:36 am).

AQD staff then requested to observe the air pollution control equipment, and initially observed the venturi scrubber and its control room (see Figures 3 through 5). The control room housed (1) the water injection system for the venturi scrubber, (2) a sump level gauge that indicated the pressure in inches of water (not currently used by the facility), (3) a water level gauge installed by the facility to indicate when the system requires addition of water, and (4) a collection area for the generated sludge. While in the control room, staff suspected that the venturi scrubber was not in operation. The facility confirmed that it was turned off because aluminum-based scrap was then being processed, which did not generate large levels of fugitive emissions. Per SC 2.4, the shredder may not be operated unless the cyclone and venture scrubber are installed, maintained, and operated in a satisfactory manner.

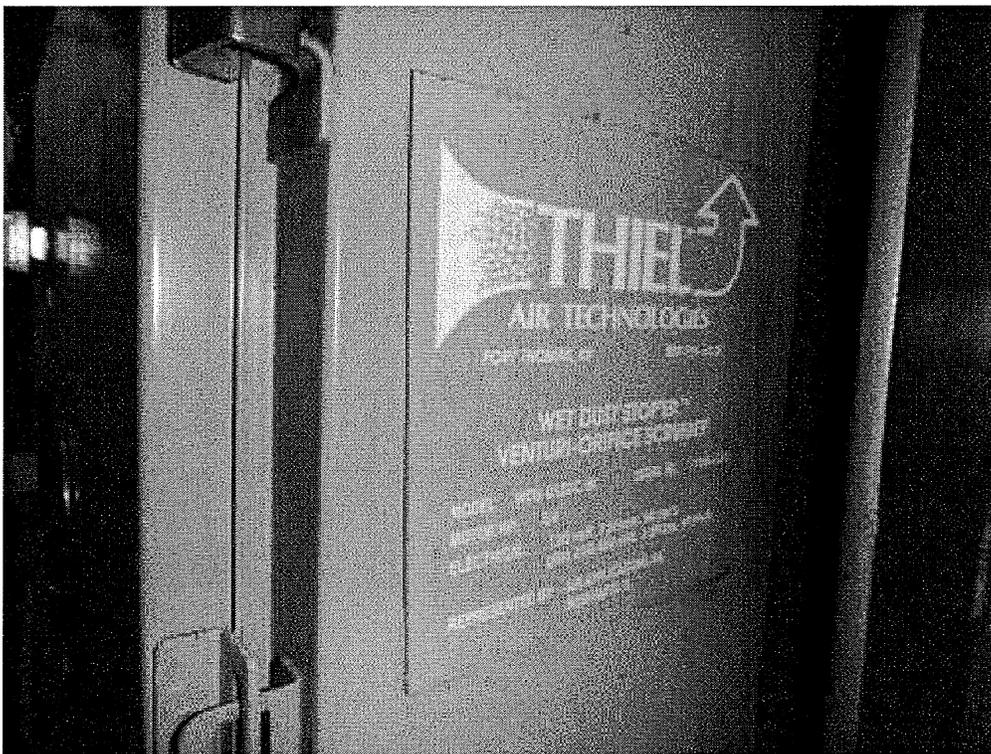
Image 4(Figure 4) : Venturi scrubber make and model plate. Thiel Air Technologies, Wet Dust Stop'er Venturi-Orifice Scrubber, Model WDS-0S22C-BL, Serial Number 1104-2366 (8/3/2015, 10:36 am).

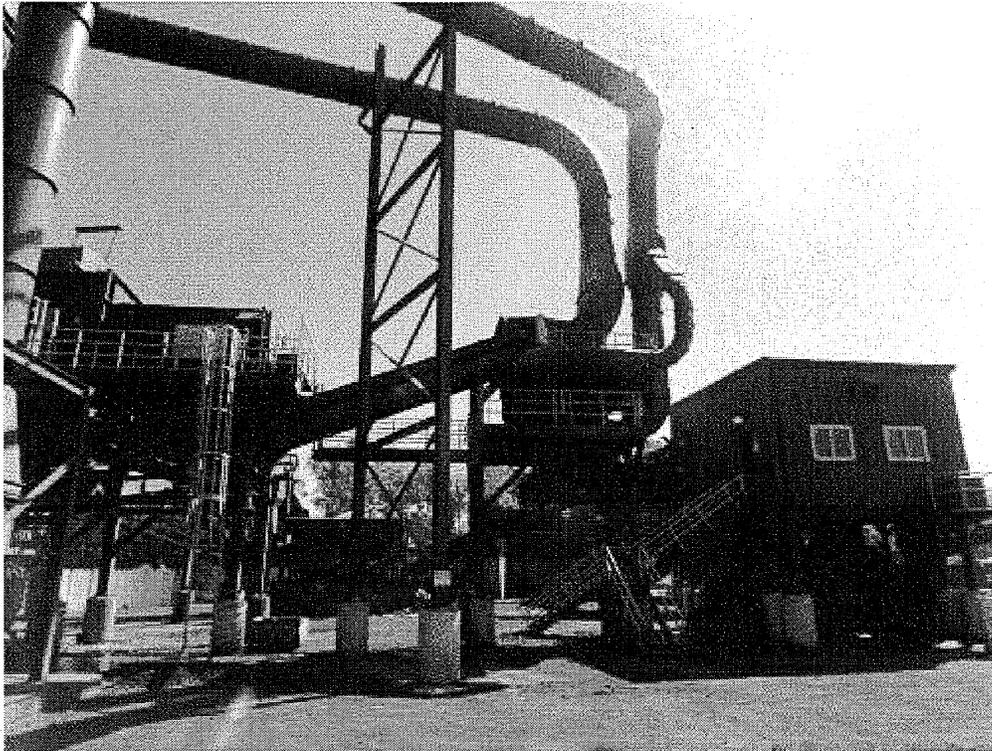
Once the venturi scrubber was activated, staff observed a high velocity exhaust exiting the stack with minimal opacity and the effluent appeared to be mostly water vapor. Staff then observed the Z-box or cascade box (see Figure 6), which removed larger items (e.g. rags, light plastics, etc.) from the shredded material by using an air knife, however, most separation occurred with magnets. The Z-box exhaust gases are not discharged to the ambient air, per SC 3.2.

Image 6(Figure 6) : Z-box/Cascade Box (8/3/2015, 10:36 am).

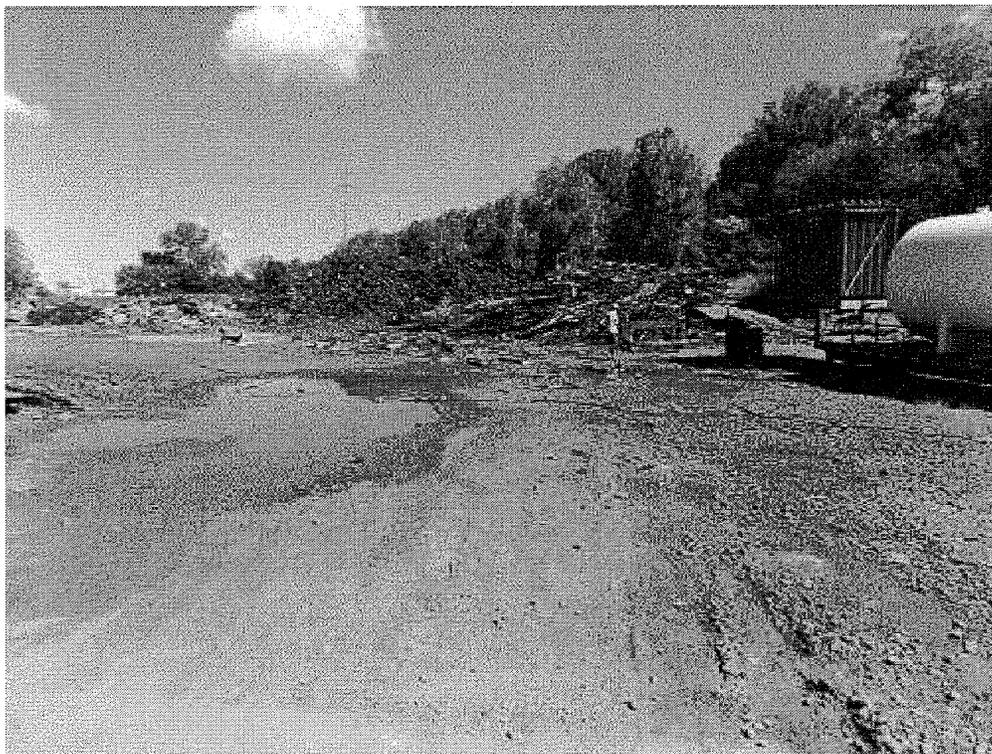
KG to the northeast corner of the facility's property (see Figures 7 through 12). KG stated that the portable torching operation does not take place all day, every day. Instead, an outside contractor is brought onsite to process the buildup of scrap material that contains pieces too large to send through the shredder. Torching occurs during regular hours and does not occur during afterhours. If it were to occur outside of the normal work schedule, a union facility worker must be onsite while the contractors conduct torching operations. The facility does not wish to incur additional labor expenses, so it requires contractors to work during business hours.

Image 7(Figure 7) : Torch-cutting area, northeast corner of facility's grounds (8/3/2015, 11:12 am). This is an example area where torch-cutting occurs directly on the ground.

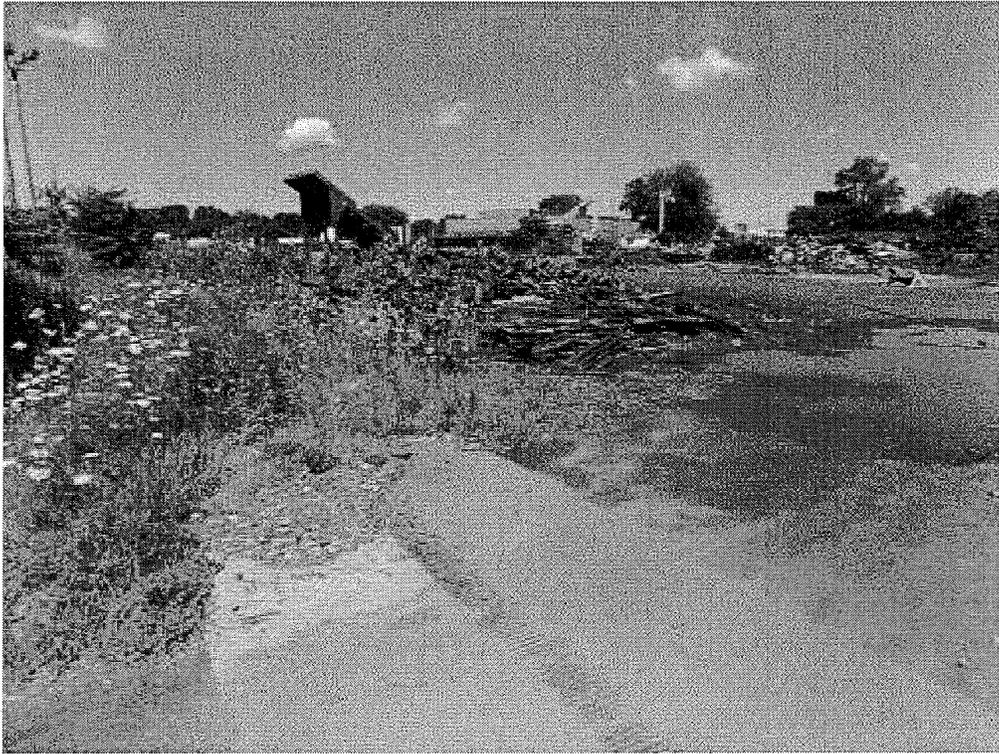
Image 8(Figure 8) : Stockpile for torching activities (8/3/2015, 11:12 am).

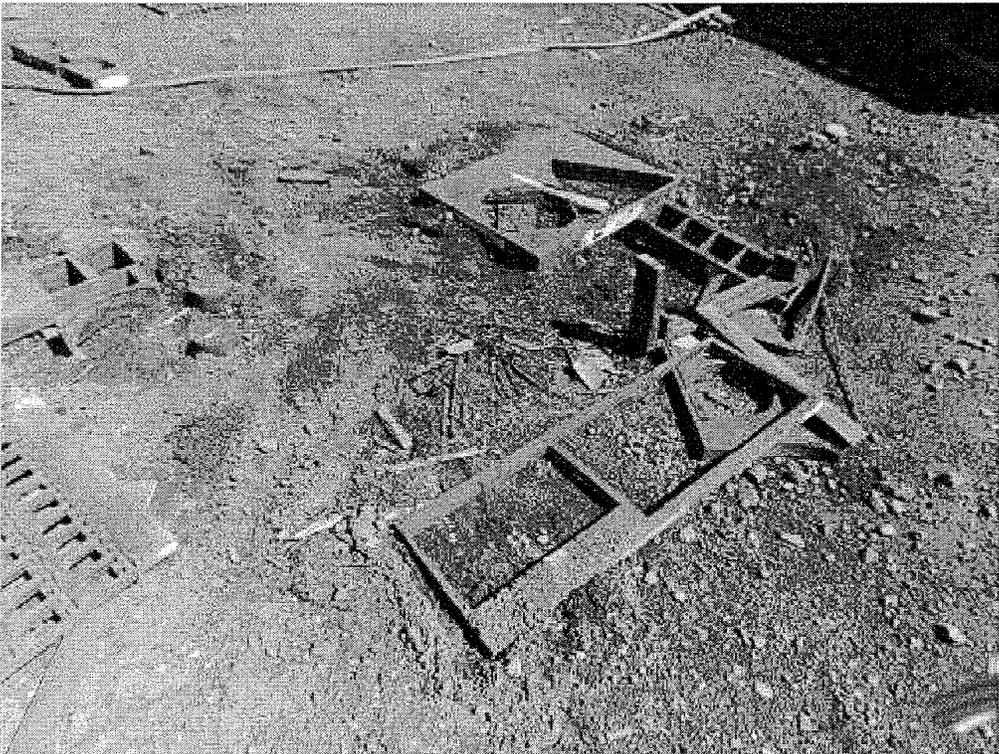
Image 9(Figure 9) : This is an example of a typical torching workstation/work area (8/3/2015, 11:18 am). The

material to be cut appeared to be clean.

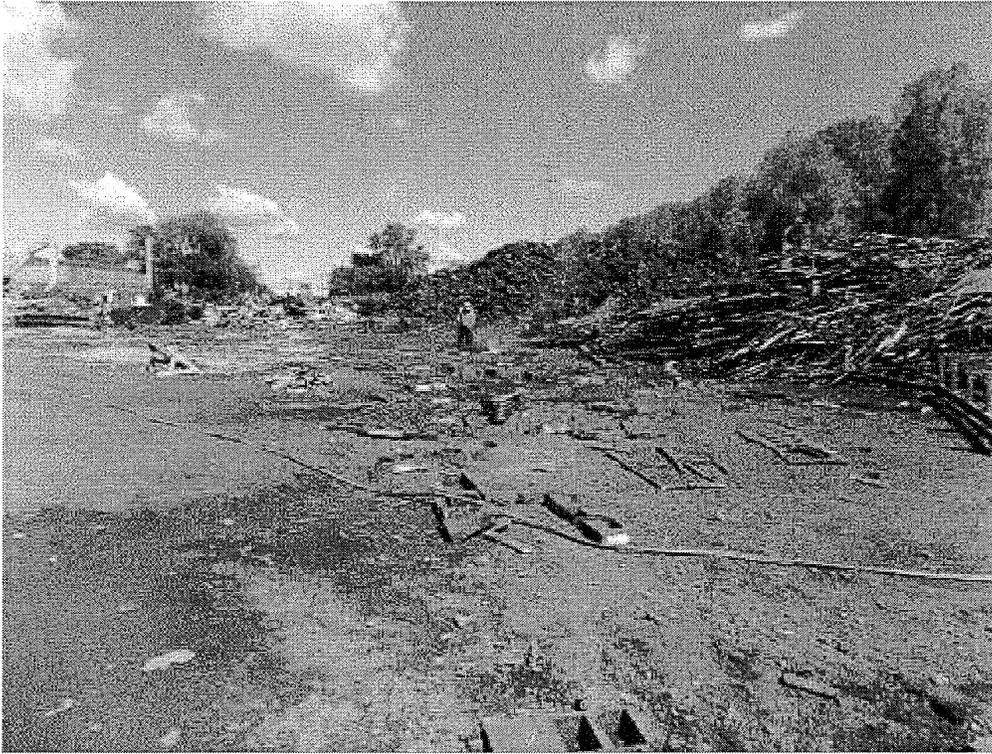
AQD staff observed torching emissions that may have been the potential source for the previous odor complaint. Torching was done on both rocks and on the ground, with the latter producing an orange / yellow-colored plume. Staff brought these observations to the attention of KG and DM, and stated that a recent complaint was received by AQD that alleged an afterhours odor originating from OmniSource. DM stated that additional rocks will be added to the torching area and KG, as noted above, confirmed that torching does not occur afterhours. Staff suggested that torching may be an activity that may need additional mitigation measures to reduce emissions. Facility staff was receptive to AQD staff's concerns and indicated that further work to minimize torching emissions may be required.

Image 10(Figure 10) : Torch-cutting operation (8/3/2015, 11:21 am). This is an example of the opacity observed during torch-cutting. An orange-colored plume was observed.

1. Excessive smoke generated by the onsite, portable torching operations.
2. Need for improved control of fugitive emissions from the south side storage / processing area, as required by Appendix A of the permit.

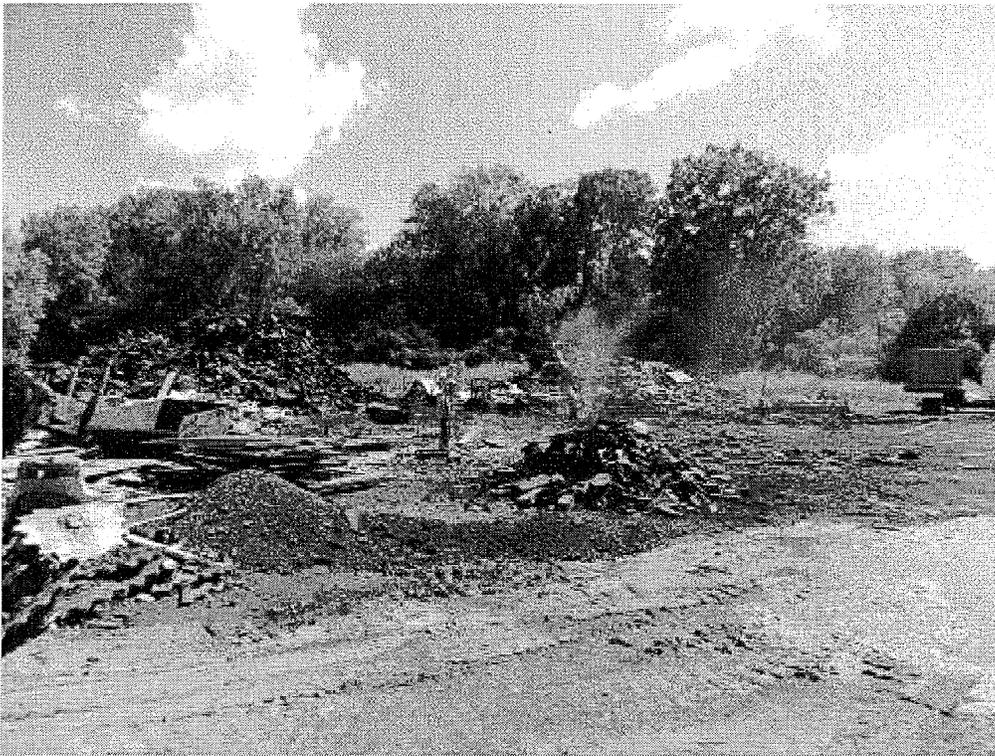
Image 11(Figure 11) : Torch-cutting operation (8/3/2015, 11:23 am).

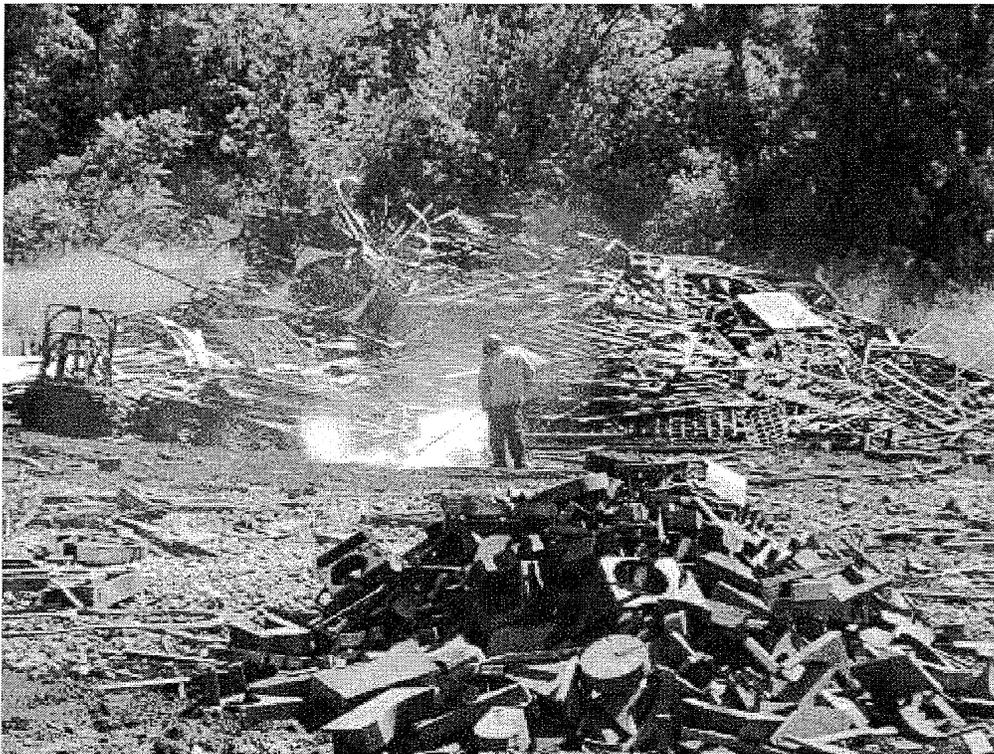
Image 12(Figure 12) : Torch-cutting operation (8/3/2015, 11:26 am).
