DEPARTMENT OF ENVIRONMENTAL QUALITY
AIR QUALITY DIVISION
ACTIVITY REPORT: Scheduled Inspection

FACILITY: Drummond Dolomite, Inc.d/b/a Carmeuse Lime & Stone		SRN / ID: B2362
LOCATION: HC 53 PO BOX 529, DRUMMOND IS		DISTRICT: Upper Peninsula
CITY: DRUMMOND IS		COUNTY: CHIPPEWA
CONTACT: Patrick Lamb , Site Operations Manager		ACTIVITY DATE: 07/02/2019
STAFF: Michael Conklin	COMPLIANCE STATUS: Compliance	SOURCE CLASS: MINOR
SUBJECT: Targeted inspection for FY 19		
RESOLVED COMPLAINTS:

Inspection

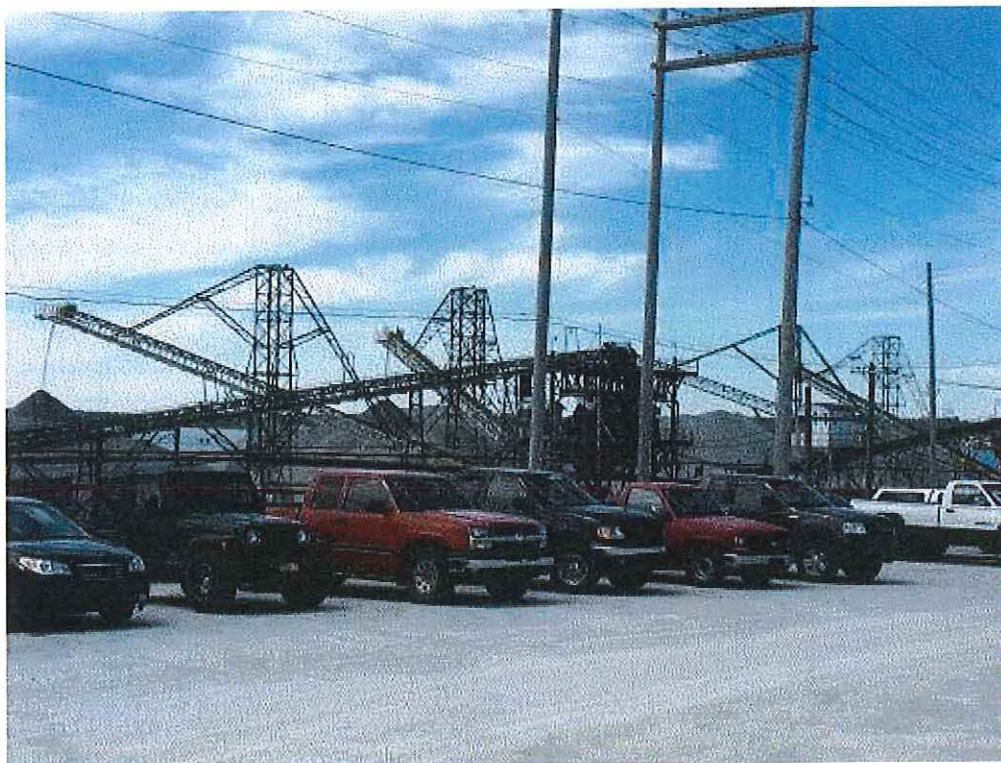
Image 2(Storage Piles) : Drop points for different product sizes.

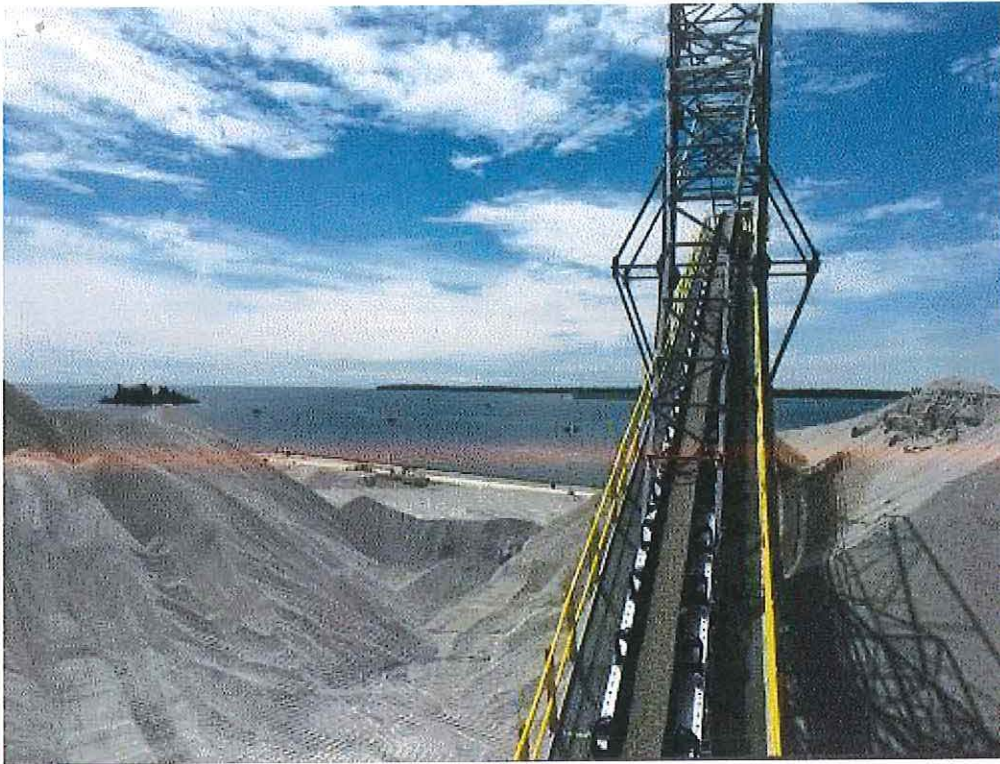
We began the inspection by discussing changes to the plant since the last inspection and upcoming plans. Mr. Lamb stated that the plant had begun replacing the belt conveyors in 2016 and that plans for replacing the screens would occur next year for 2020 operations. Drummond Dolomite typically operates from mid-April to the end of October for a given year. Mr. Lamb stated that the screens are from the 1950s and have not been modified or reconstructed. The primary, secondary, and tertiary crushers are from the 1930s and also have not been modified or reconstructed. Mr. Lamb stated that there are no plans to replace the crushers anytime soon. A PTI application will be submitted to the AQD for the replacement of the screens and belt conveyors.

Image 3(Belt Conveyor) : New belt conveyor

Drummond Dolomite will be requested to submit a fugitive dust plan to maintain control of fugitive dust on the haul road from truck traffic. Also, a PTI application will need to be submitted for the replacement of screens and belt conveyors in the crushed limestone processing mill. Following the submittal of a fugitive dust plan, Drummond Dolomite will be in compliance with state air quality rules and federal regulations.
