DEPARTMENT OF ENVIRONMENTAL QUALITY AIR QUALITY DIVISION

ACTIVITY REPORT: Scheduled Inspection

FACILITY: DETROIT STREET MAINT & CONST		SRN / ID: B3656	
LOCATION: 2633 MICHIGAN AVE, DETROIT		DISTRICT: Detroit	
CITY: DETROIT		COUNTY: WAYNE	
CONTACT:		ACTIVITY DATE: 08/14/2015	
STAFF: Stephen Weis	COMPLIANCE STATUS: Compliance	SOURCE CLASS: Minor	
SUBJECT: Compliance inspect in FY 2015.	ion of the Detroit DPW Street Maintenance Division fa	cility. The DPW facility is scheduled for inspection	
RESOLVED COMPLAINTS:	V

Detroit Department of Public Works (SRN B3656) Street Maintenance Division and Traffic Engineering 2633 Michigan Avenue Detroit

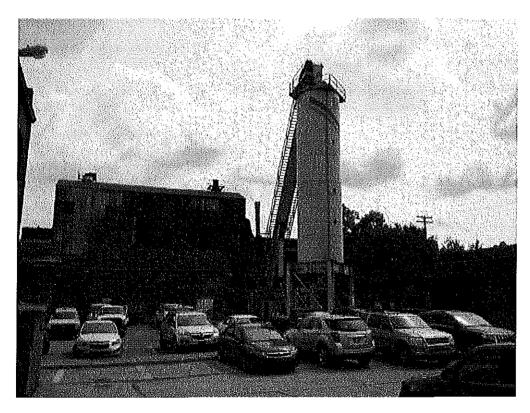
Image 1(asphalt production): Idled, permanently shut down asphalt production facility.

- A large building referred to as the Asphalt/Construction plant. This building houses part of the asphalt
 plant that used to operate at the facility. The asphalt plant is no longer in operation. The aggregate drying
 kiln no longer has drive belts, and the conveyors no longer have drive belts or motors. The building is
 currently used to store cold patch, which is placed in a pile at the west end of the building.

be in good shape. I asked if the boiler had been decommissioned, or if it had been rendered physically inoperable. Wonda replied that she was unsure of the status of the older boilers, but she knows that they have not operated for some time. We then stopped at the asphalt/construction plant. The DPW facility used to operate an asphalt production operation on site, which included material conveyors, aggregate dryers, rotary mixers and heaters, asphalt storage tanks, and associated air pollution control equipment (i.e. baghouses, dust collectors). The asphalt production equipment has not operated in a long time, and it is now physically incapable of operating. Wonda told me that the drive belts on the kilns and conveyors are gone, as well as the motors.

Since the asphalt production equipment is no longer in operation, any permits associated with this process will be voided.

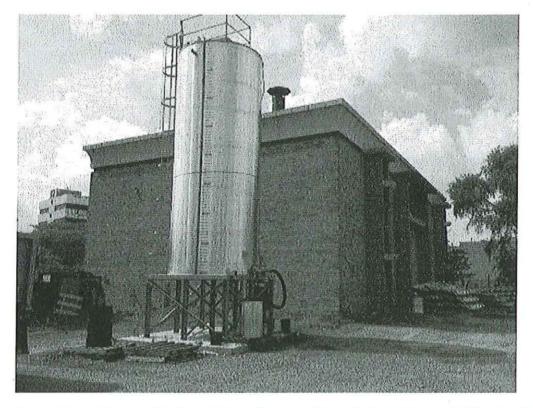
Image 2(emulsion tank): New 8,000 gallon capacity asphalt emulsion tank (electrically heated).

The asphalt emulsion tank was installed in April 2015. It is manufactured by Duraco, Inc. The tank at the DPW facility has an 8,000 gallon capacity, and the material is heated electronically. Recall that the heater is powered by the Winco generator.

David told me that the agitator's electrical motor is not sealed, which allows heat and water vapor to vent from tank. David provided that if there were vapors associated with the material, they would be ignited by the electrical motor as they vented from the top of the tank.

I printed out a CRS-2 Product Data Sheet for reference that states that the percent volatiles of the material is zero. The asphalt emulsion storage tank appears to be exempt from DEQ-AQD permitting requirements per the provisions of Michigan Administrative Rule 284(i).
