## DEPARTMENT OF ENVIRONMENTAL QUALITY AIR QUALITY DIVISION

**ACTIVITY REPORT: Scheduled Inspection**

B426030843		
FACILITY: L'ANSE WARDEN ELECTRIC COMPANY LLC		SRN / ID: B4260
LOCATION: 157 S MAIN STREET, LANSE		DISTRICT: Upper Peninsula
CITY: LANSE		COUNTY: BARAGA
CONTACT: John Polkky , Plant/Fuel Supply Supervisor		ACTIVITY DATE: 08/27/2015
STAFF: Ed Lancaster	COMPLIANCE STATUS: Compliance	SOURCE CLASS: MAJOR
SUBJECT: Began unannounce	d, scheduled inspection.	
RESOLVED COMPLAINTS:

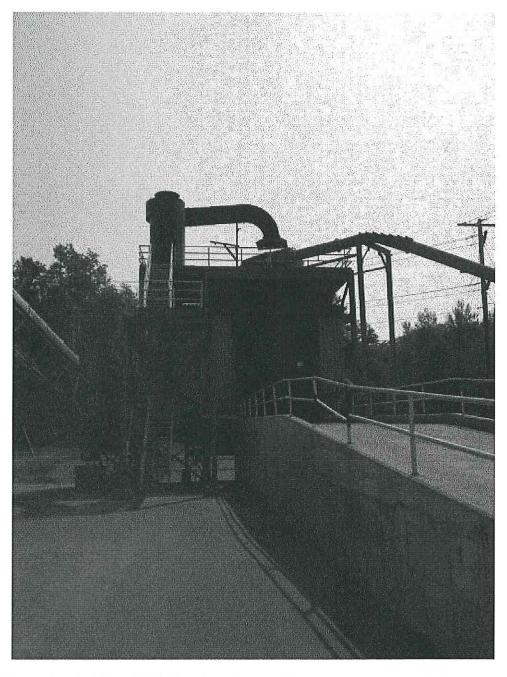
Prior to entering the facility, on 27 August, I walked around the perimeter of the property and noted fugitive emissions coming from the approximate 18-inch gap between the cyclone stack and capture hood (see photo below). These emissions were intermittent, as the fuel types are kept separate and there is a break between when RR ties, wood chips or the pentachlorophenol RR ties are being blown over.

<u>Image 1(LWEC Cyclone)</u>: View of LWEC cyclone fuel receiving hopper, note space between stack and hood. Photo taken 8/27/2015, looking south.

I then entered the property and met with Mr. John Polkky, Fuel Procurement Supervisor, and informed him I was there to do an air compliance inspection and informed him of my observations regarding the fugitive dust. As we walked out to the cyclone, Mr. Polkky informed me the company was aware of the issue and were planning to address it during an upcoming planned maintenance outage, September 13th through the 18th, as part of the conditions in EU-FUEL. He later showed me the bell-shaped hood they planned to modify and install during the outage. Mr. Polkky added for the rest of my inspection he would be more comfortable if the plant manager was present. I rescheduled to return the following Wednesday, on September 2nd.

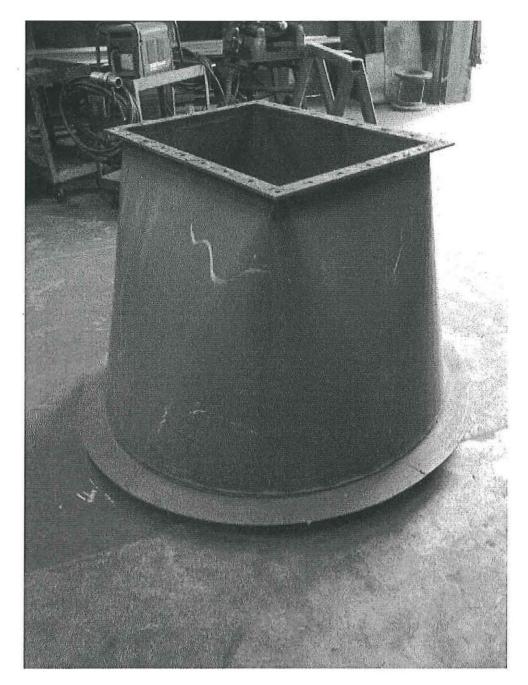
Image 2(LWEC new hood): Replacement hood for cyclone fuel receiving hopper. Photo taken on 8/27/2015.
