### **ACTIVITY REPORT: Scheduled Inspection**

#### M351155153

FACILITY: MACOMB COUNTY ANIMAL CONTROL		SRN / ID: M3511
LOCATION: 21417 DUNHAM, CLINTON TWP		DISTRICT: Warren
CITY: CLINTON TWP		COUNTY: MACOMB
CONTACT: Chief Randazzo , Chief Animal Cntrol Officer		<b>ACTIVITY DATE:</b> 08/18/2020
STAFF: Robert Elmouchi	COMPLIANCE STATUS: Non Compliance	SOURCE CLASS: MINOR
SUBJECT: Scheduled inspection.		
RESOLVED COMPLAINTS:

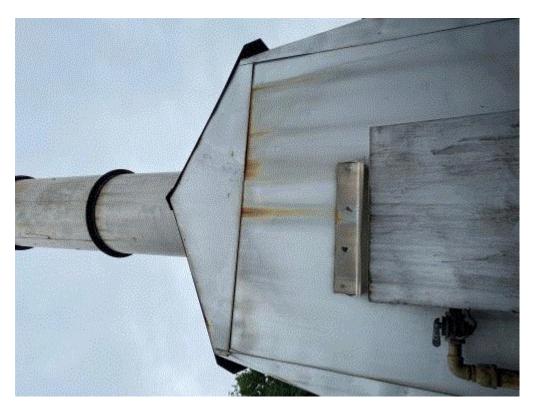
**Image 1(REPAIRED FACIA):** Image from permittee demonstrating repair of triangular exterior panel.

This pathological incinerator is located outside and therefore is exposed to the weather. I observed that an exterior metal panel was bent, which would allow water to penetrate the incinerator's shell. I asked Chief Randazzo to have the sheet metal repaired. On August 28, 2020, I received a photo by email that showed the repair had been completed.
