**DEPARTMENT OF ENVIRONMENTAL QUALITY  
AIR QUALITY DIVISION  
ACTIVITY REPORT: Scheduled Inspection**

FACILITY: TUSCOLA ENERGY - NIXON FARMS		SRN / ID: N1586
LOCATION: 7611 BAY CITY FORESTVILLE RD, AKRON		DISTRICT: Saginaw Bay
CITY: AKRON		COUNTY: TUSCOLA
CONTACT: Jeff Adler , President		ACTIVITY DATE: 10/08/2019
STAFF: Matthew Karl	COMPLIANCE STATUS: Compliance	SOURCE CLASS: SM OPT OUT
SUBJECT: Scheduled inspection to determine compliance with PTI No. 20-12B.		
RESOLVED COMPLAINTS:

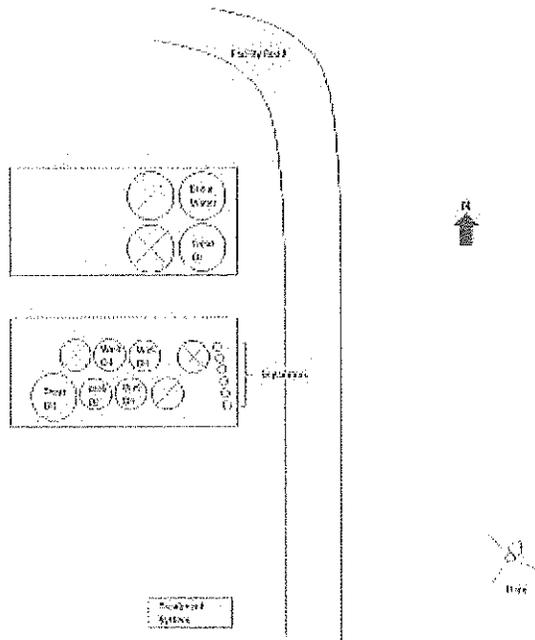
**Image 1(Site Map) :** Site Map

The attached site map shows the setup of equipment at the facility. In the site map, storage tanks with an “X” overlaid are currently not in use. Currently, the facility has four (4) storage tanks dedicated to storing oil from the wells, two (2) storage tanks dedicated to storing treated oil, one (1) storage tank dedicated to storing brine water, six (6) separators, a heater treater treatment system and a flare control. The attached reference photo (Photo 1) shows the separators and storage tanks of the southern storage tank battery as they appeared at the time of our inspection. Photo 2 shows the four storage tanks in the northern storage tank battery as they appeared at the time of our inspection. Photo 3 shows the heater treater treatment system as it appeared at the time of our inspection. Photo 4 shows the flare control (SVFLARE) which is a 50-foot-tall flare which was operating at the time of our inspection.

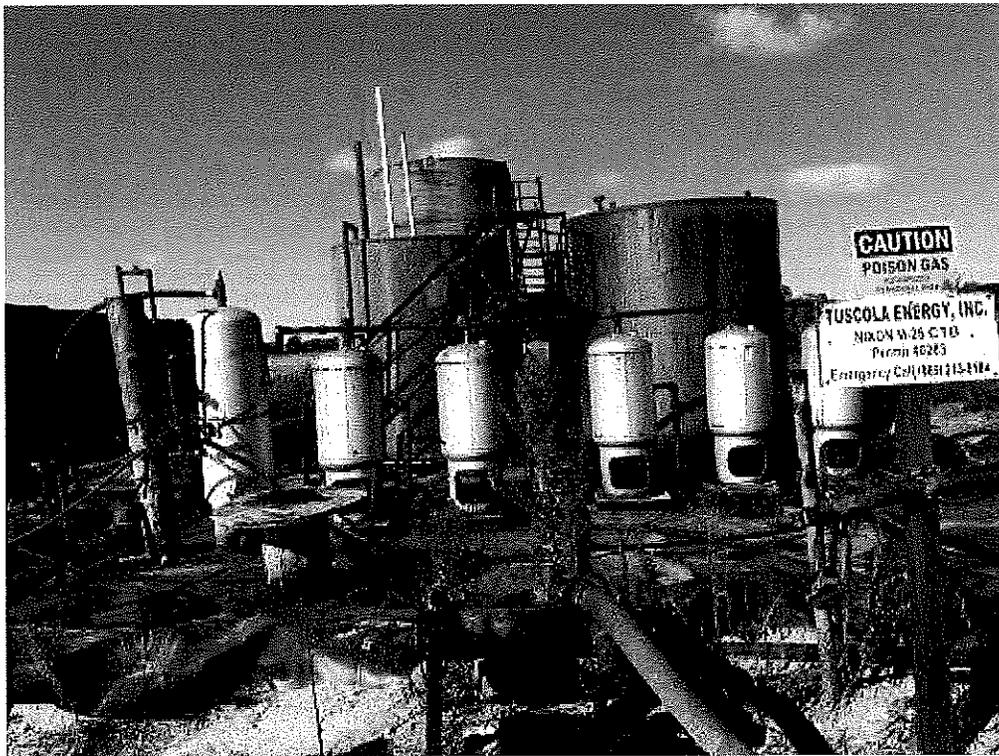
**Image 2(Photo 1) :** Photo 1. Reference photo of separators and storage tanks in the southern storage tank battery as it appeared on 10/8/19. Perspective facing west.

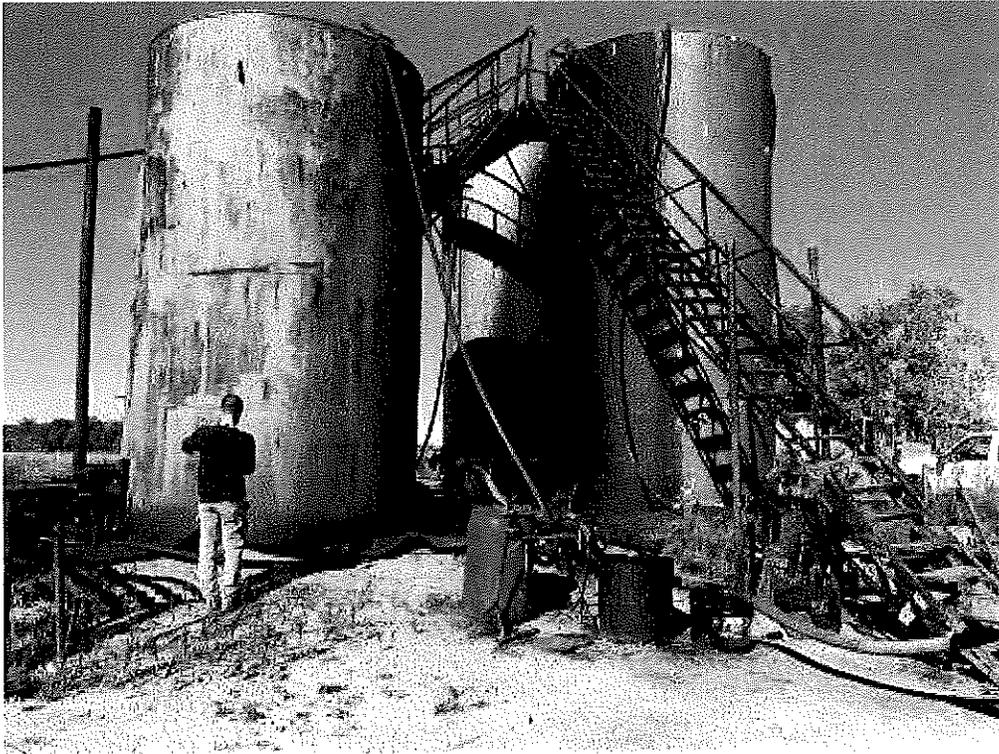
**Image 3(Photo 2.)** : Photo 2. Reference photo of the storage tanks in the northern storage tank battery at the time of our 10/8/19 inspection. Perspective facing west.

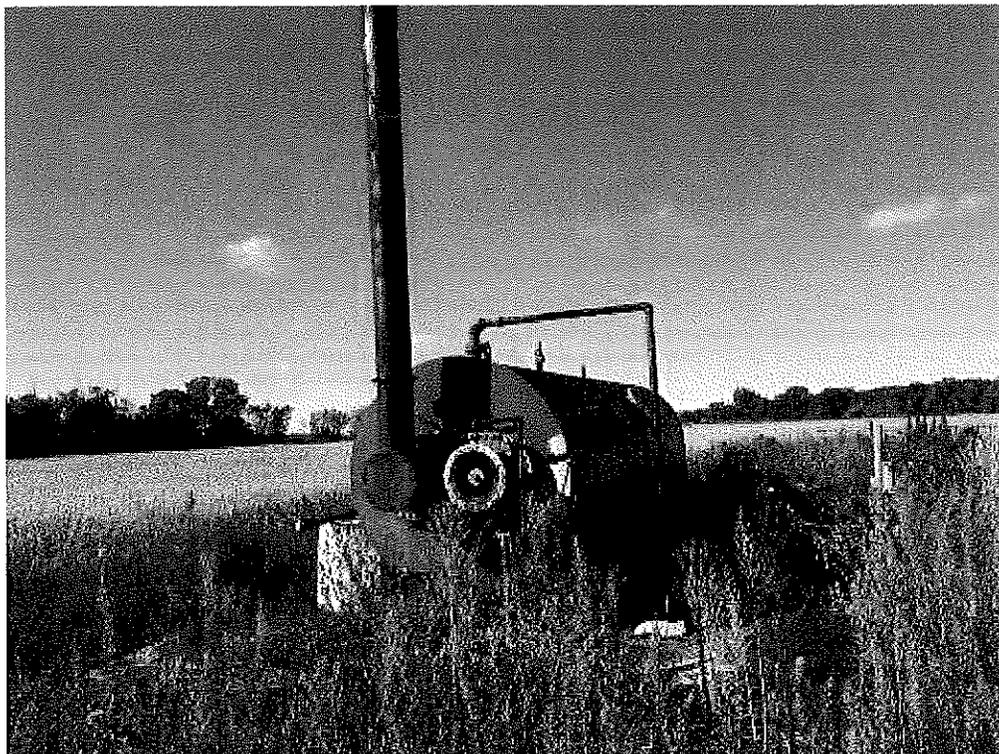
**Image 4(Photo 3.)** : Photo 3. Reference photo of heater treater system at the time of the 10/8/19 inspection.

Perspective facing west.

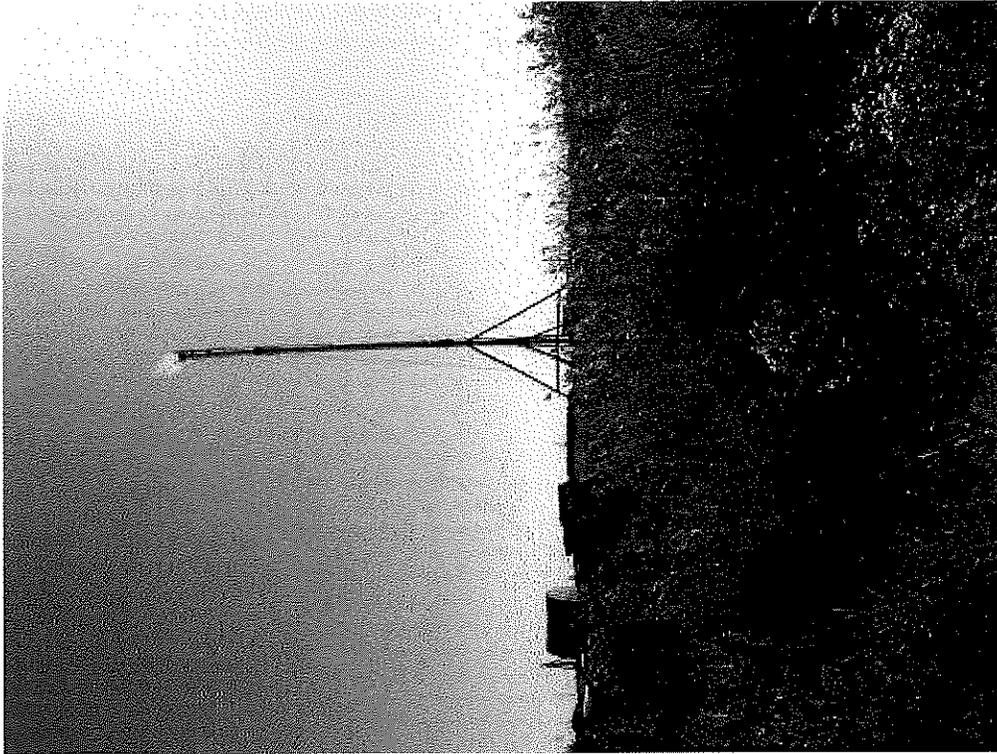
**Image 5(Photo 4.)** : Photo 4. Reference photo of flare control as it appeared at the time of the 10/8/19 inspection. Perspective facing northeast.
