**DEPARTMENT OF ENVIRONMENTAL QUALITY
AIR QUALITY DIVISION
ACTIVITY REPORT: Site Review**

FACILITY: Magna Mirrors Corporation		SRN / ID: N1781
LOCATION: 3575 128th Aveune, HOLLAND		DISTRICT: Grand Rapids
CITY: HOLLAND		COUNTY: OTTAWA
CONTACT: Andy Garceau , EHS Specialist		ACTIVITY DATE: 09/28/2020
STAFF: April Lazzaro	COMPLIANCE STATUS: Compliance	SOURCE CLASS: SM OPT OUT
SUBJECT: On-site Partial Compliance Inspection.		
RESOLVED COMPLAINTS:

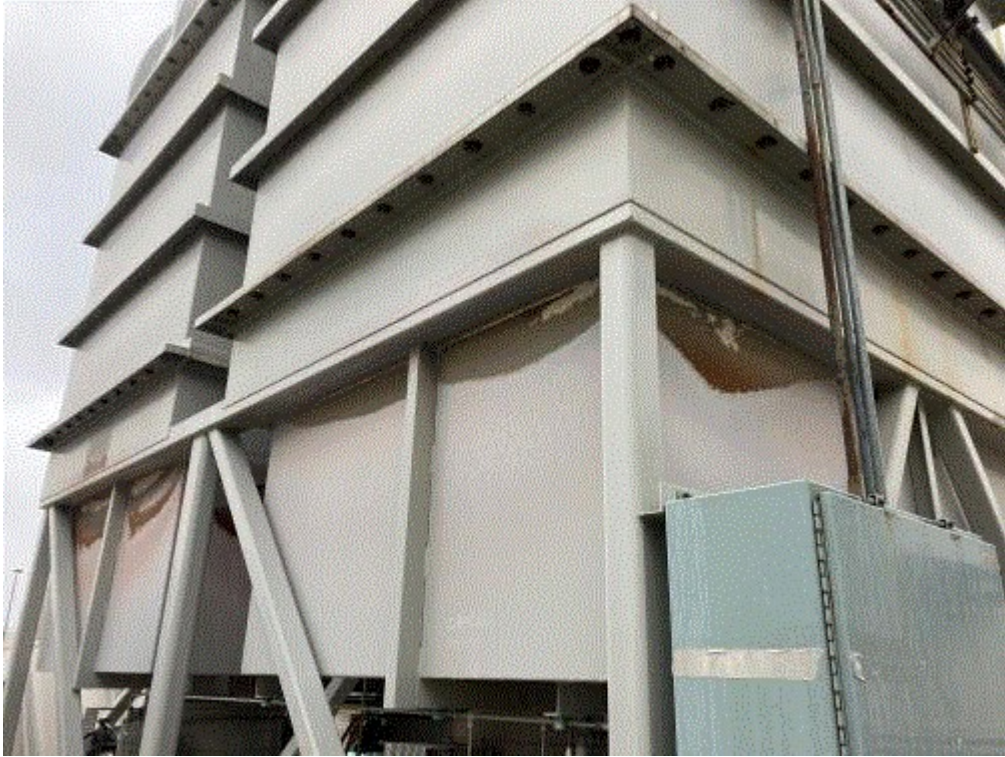
I conducted a visual inspection of the thermal oxidizer, with Ms. Philips accompanying me while it was raining steadily. There were several spots that appeared to show thermal wear on the exterior of the unit. (see attached photos.) I did not smell or hear any indication of significant issues, although my inspection was slightly shortened due to the rain. Mr. Garceau indicated that last year (October 2019) an annual inspection was conducted by Durr that included thermal imaging of the unit. This report was provided to the AQD, and the spots that indicate thermal wear did not show up as hot spots in the thermal images. It is noted however, that the Durr inspection did not include an internal inspection because the unit was operating. It is recommended that the next inspection be conducted at a time the unit is off and cooled down enough for an internal inspection including photos of the interior condition to ensure operational integrity.

Image 1(Mirrors Oxidizer) : Photo shows paint wear on sides of unit.

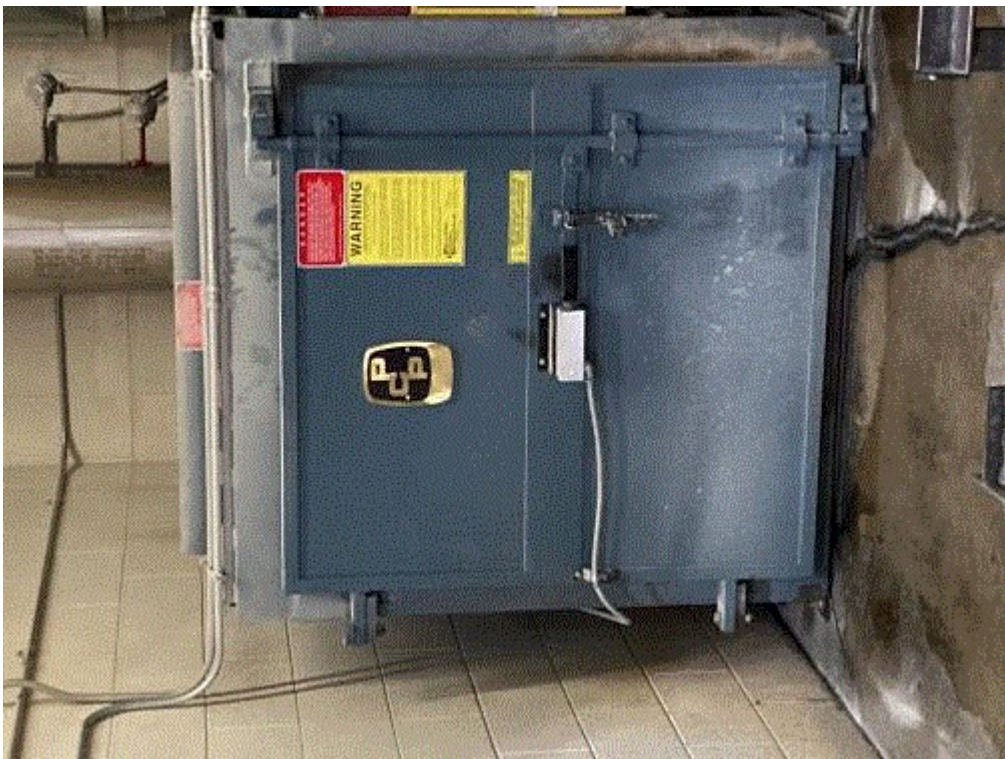
General Permit to Install No. 184-19 covers a small burn-off oven that is used to burn off powder coat paint from racks at the 128th north facility. The unit was in cool down mode during the inspection, and I took photos of the temperature display for the afterburner and the oven main chamber. This is a new Pollution Control Products unit, that operates per the design parameters. Photos were taken of the unit as well as the temperature displays (see attached photos). It is noted that this unit was permitted in November last year, and the annual MAERS emissions report needs to be updated going forward to remove the old unit and reflect that this is a new unit, and operates pursuant to PTI No. 184-19 and not the Rule 290 exemption.

Image 2(Burn off oven) : Image of burn off oven installed in 2019

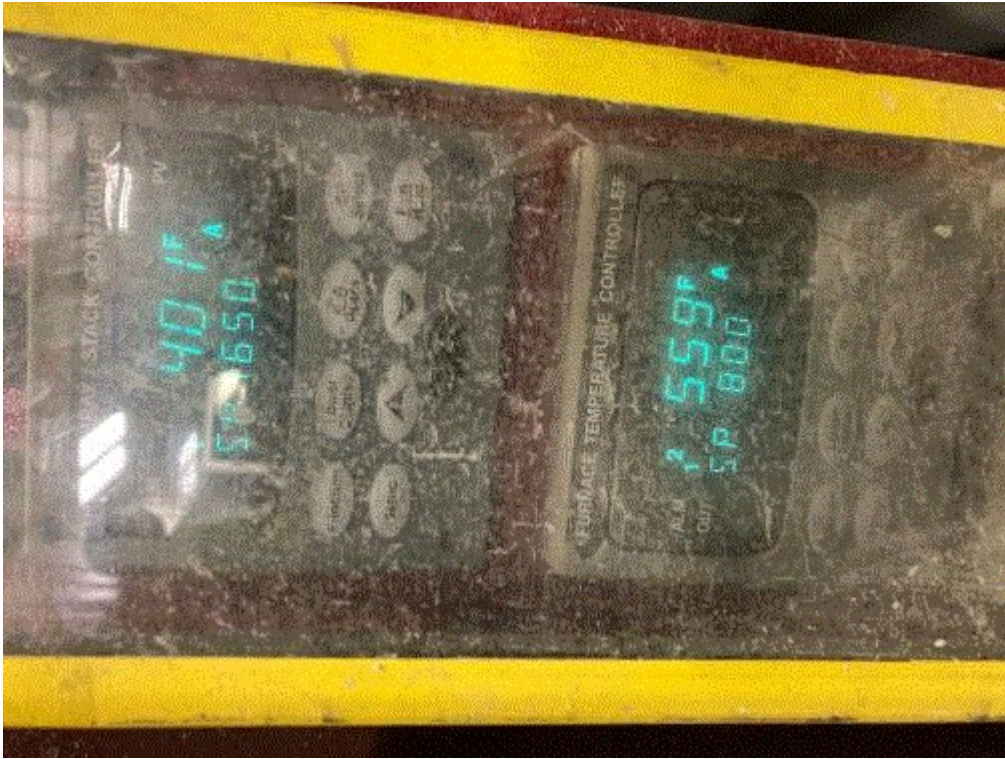
Image 3(Burn off oven temp): Burn off oven in cool down- top is AB temp, bottom is oven temp.
