DEPARTMENT OF ENVIRONMENTAL QUALITY
AIR QUALITY DIVISION
ACTIVITY REPORT: Scheduled Inspection

FACILITY: CRAMER TECH COATING INC		SRN / ID: N2417
LOCATION: 6055 JACKSON RD, DEXTER		DISTRICT: Jackson
CITY: DEXTER		COUNTY: WASHTENAW
CONTACT: Paul Cramer , President/Owner		ACTIVITY DATE: 08/31/2017
STAFF: Mike Kovalchick	COMPLIANCE STATUS: Compliance	SOURCE CLASS: MINOR
SUBJECT: Inspection of a facility with a paint booth.		
RESOLVED COMPLAINTS:

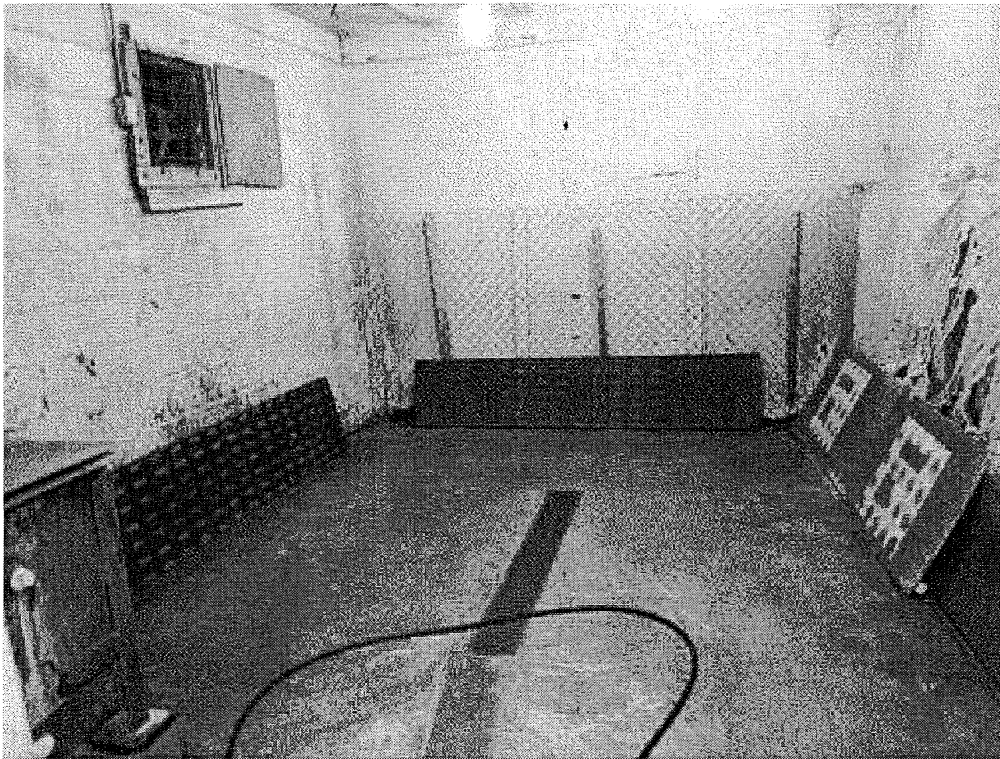
He showed me the phosphate parts cleaning room/booth. See attached photo. There is an exhaust fan on the wall this discharges into a vertical stack on the roof. I asked PC why the fan is necessary for this room. He indicated that the phosphate solution is at 130 deg F. and the room gets very warm and humid when an operator is power washing so mostly just for the comfort of the employee. A check of material safety data sheets shows that one of the chemicals in the power wash solution contains up to a few percent of phosphoric acid. It appears that the solution is probably barely acidic and doesn't appear to represent a potential problem with exhaust emissions. Also, the room where the power washing takes place is open and the exhaust fan isn't really a dedicated exhaust system so no issues regarding potential PTI applicability.

Image 1(Power washer room) : Power washer room with wall exhaust.

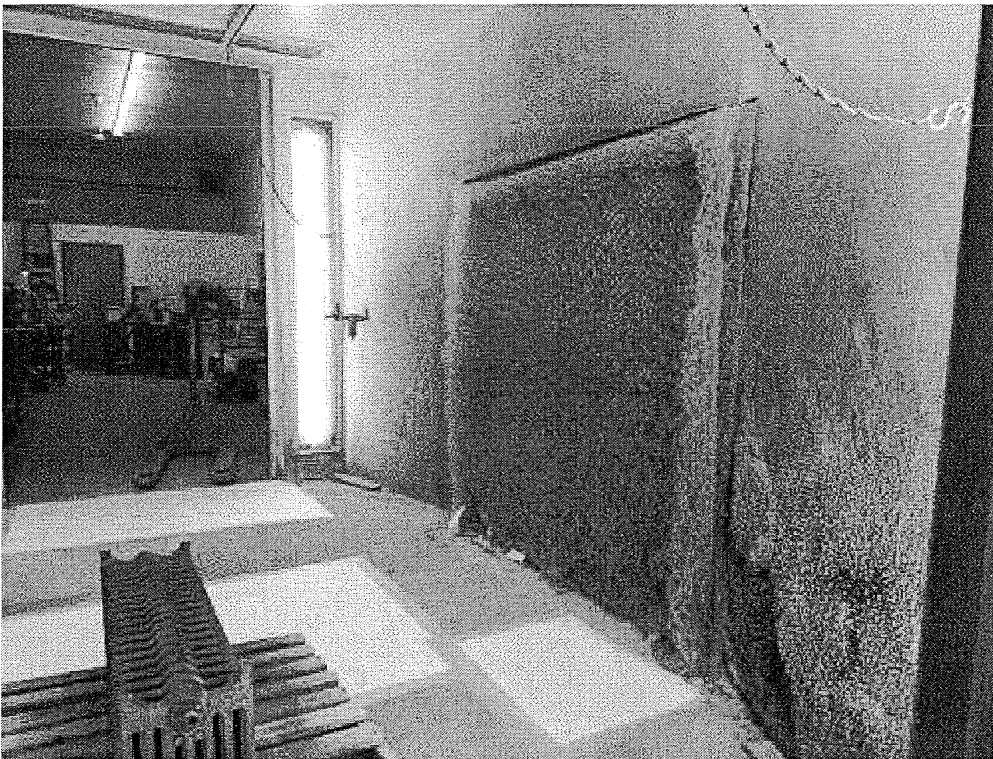
PC showed me the paint booth where metal parts are spray painted. See attached photo. The paint filter appeared to be okay shape. PC indicated that they change out the filter a couple of times a year.

PTI No. 75-90 covers a large coating spray booth for miscellaneous metal parts. Painting was not taking place during the inspection. The filters were observed to be in-place and in good condition. The PTI contains:

Image 2(Paint booth) : Paint booth for misc. metal parts.

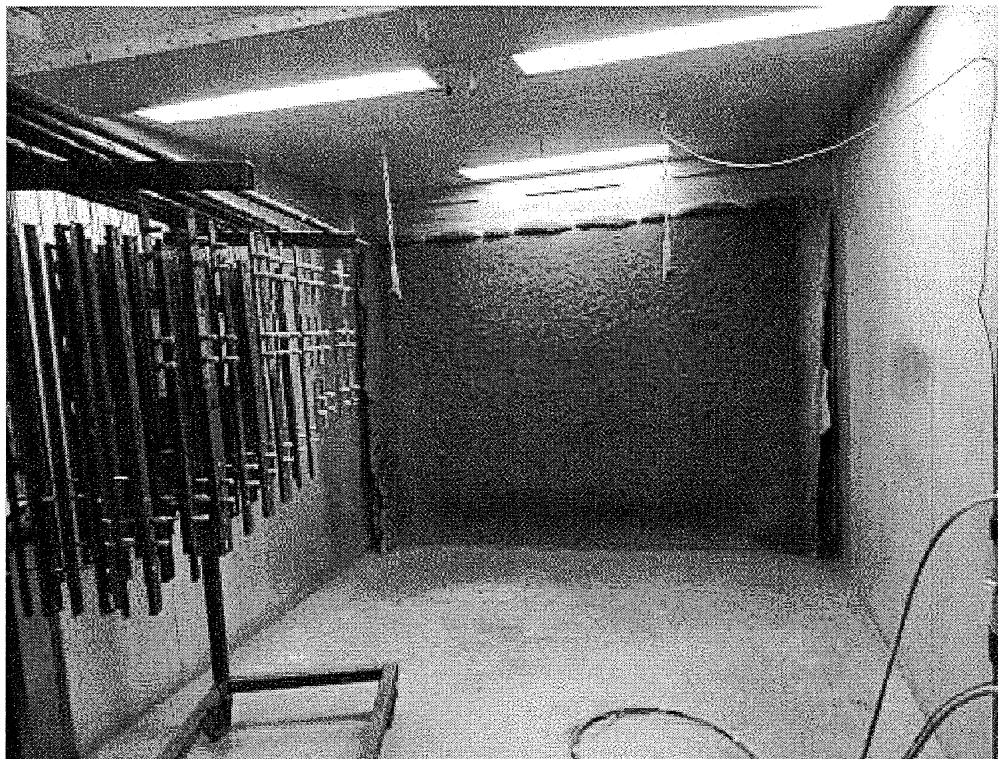
PC showed me the powder paint booth. See attached photo. (PTI exempt per Rule 287 (2) (d).) PC indicated that most of business is now from powder coating.

Image 3(Powder coating) : Powder coating booth.

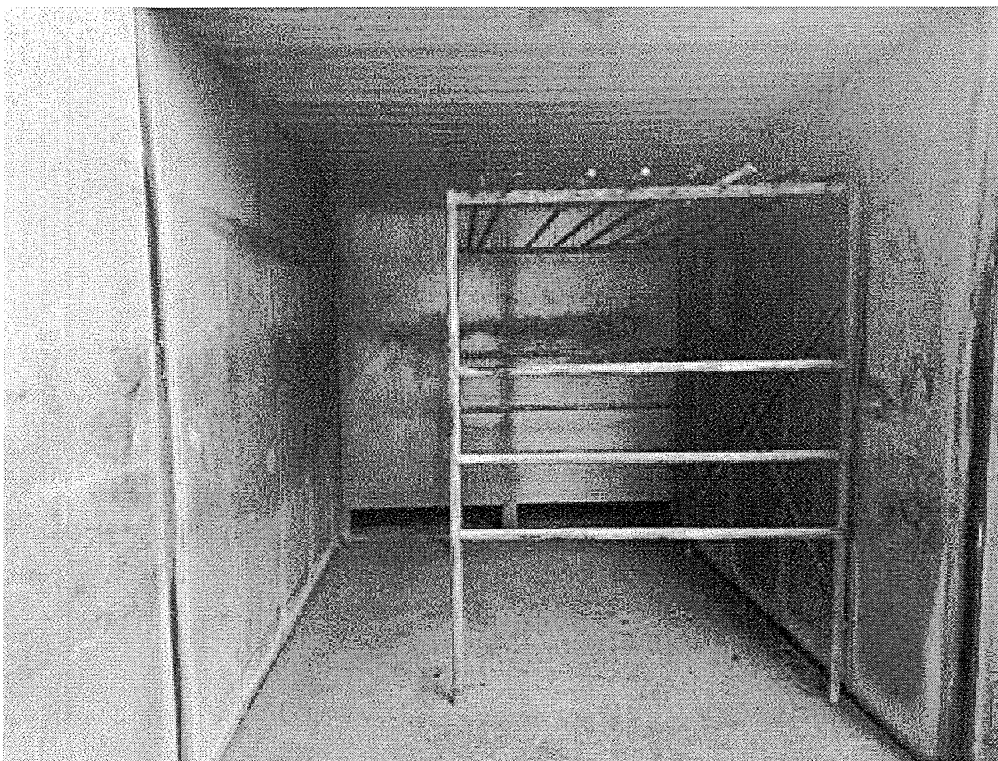
PC showed me the natural gas oven dryer associated with the power paint booth. See attached photo.

Image 4(Drying oven) : Drying oven for powder coating booth.
