**DEPARTMENT OF ENVIRONMENTAL QUALITY
AIR QUALITY DIVISION
ACTIVITY REPORT: Self Initiated Inspection**

FACILITY: Truck Collision Services, Inc.	SRN / ID: N3387
LOCATION: 16260 Felton Road, LANSING	DISTRICT: Lansing
CITY: LANSING	COUNTY: CLINTON
CONTACT: Ray Chatfield , Owner/Manager	ACTIVITY DATE: 08/15/2017
STAFF: Julie Brunner	SOURCE CLASS: MINOR
SUBJECT: Inspection for compliance with PTI 276-92	
RESOLVED COMPLAINTS:

PTI 276-92 for a 70' long by 20' wide and 16' tall dry filter paint spray booth.

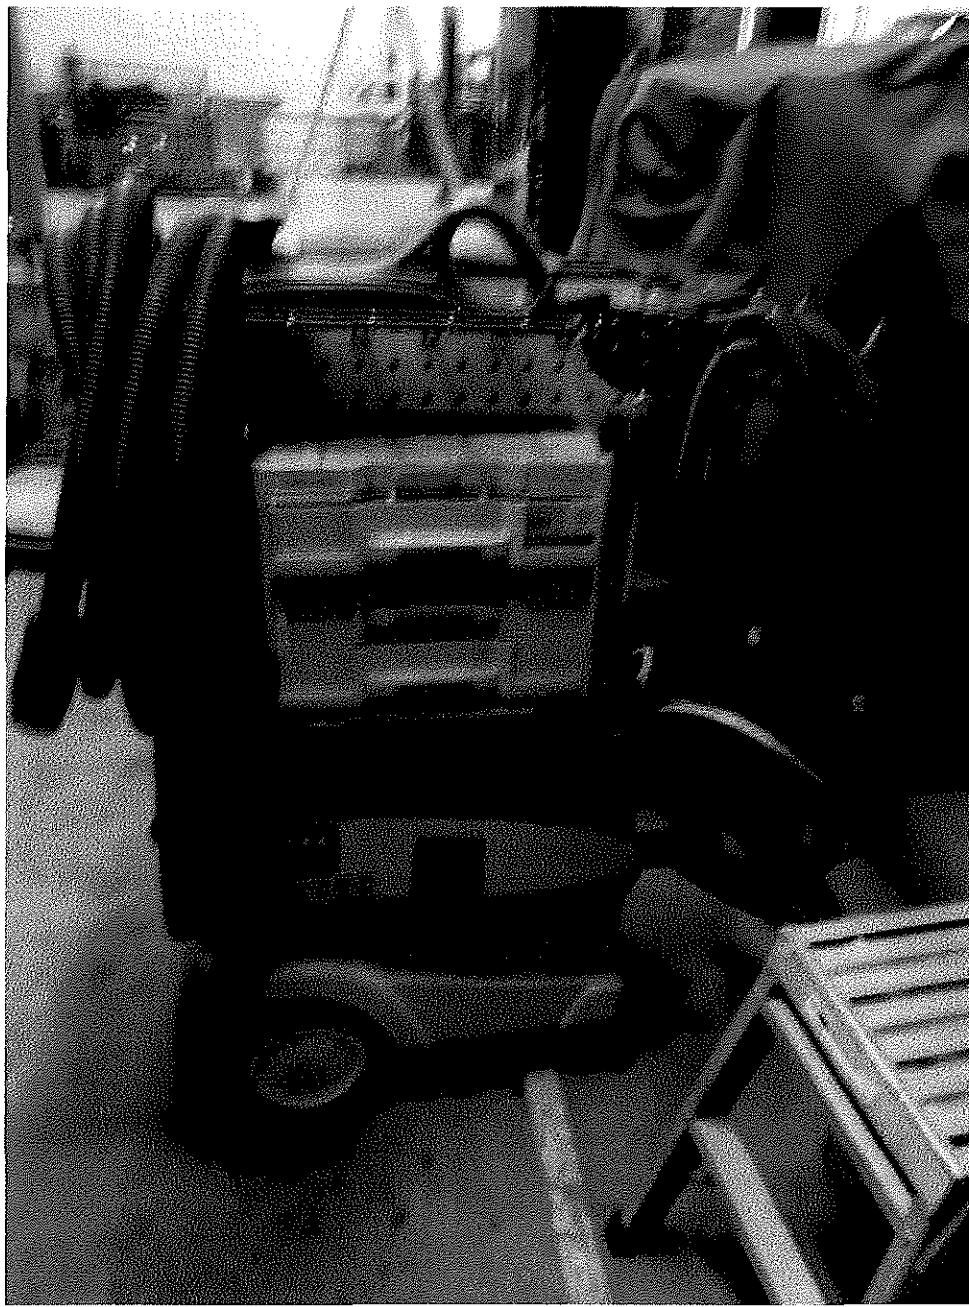
There is hand-held grinding done in the bays including surface grinding tables with HEPA filters. All internally vented and exempt from permitting per Rule 285(2)(l)(vi)(B).

Image 1(1) : Grinding table

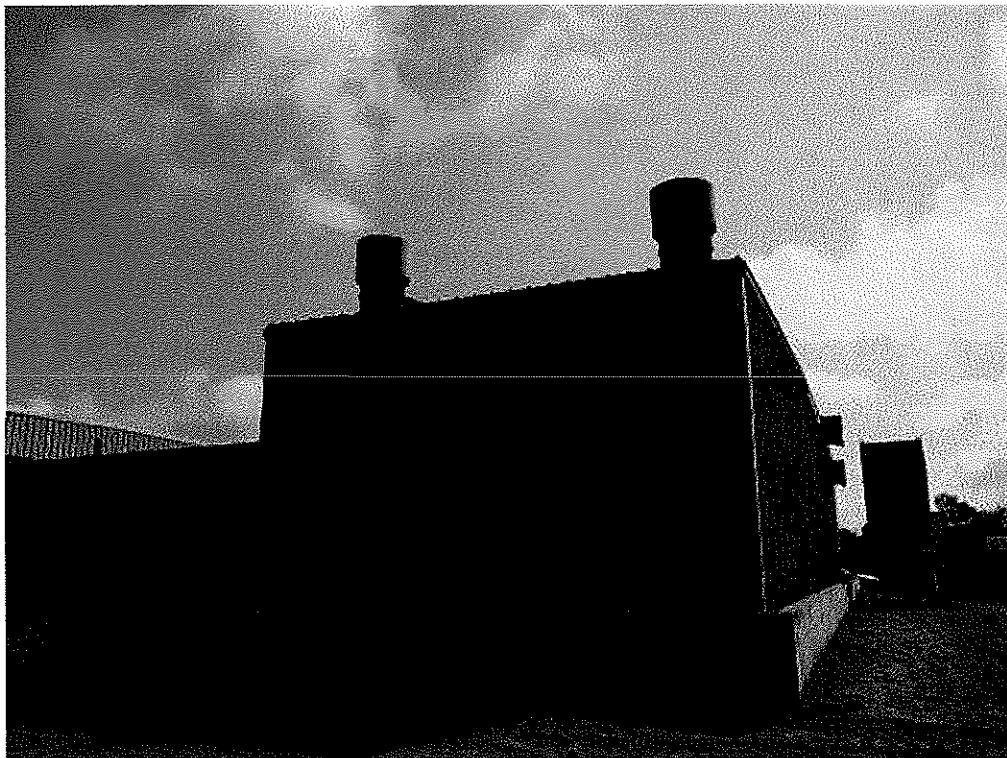
Image 3(3) : Exit of spray booth and stacks

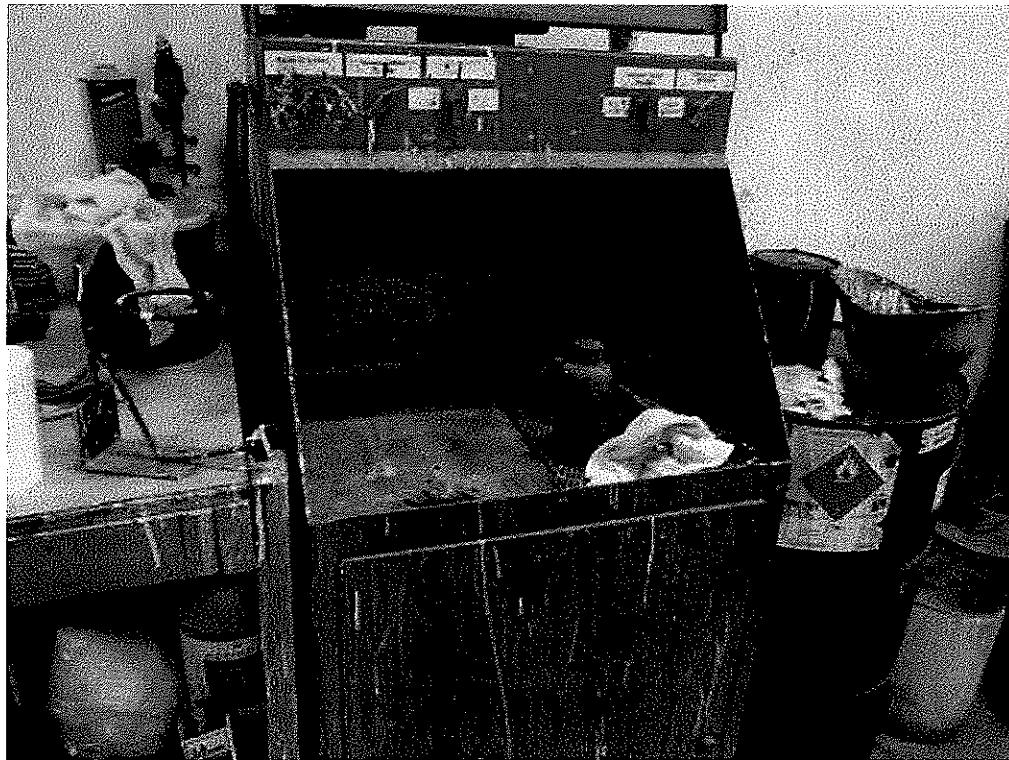
A gun cleaning station/cabinet is located outside of the paint booth. Solvent used in gun clean-up would fall under the permit and contribute to the 2.1 ton per year (tpy) VOC emission limit. The gun cleaning station was open. A 55-gallon drum with a funnel in the top was sitting beside the gun cleaning station. The spent solvent from the gun cleaning station is put in the 55-gallon drum. The permit doesn't have the now standard condition to minimize fugitive emissions and keep all containers closed. The paint station does have a covering/door in order to minimize fugitive emissions when not in use. The gun cleaning station and drum need to be closed when not in use.

Image 5(5) : Spray gun cleaning station
